Profile/Photo Observation Report

Street:	TAMARACK DR & MAGNOLIA DR	Flow Control:	Not Controlled
City:	Hobart, IN	Year Renewed:	
Location:	Sidewalk	Tape/Media #:	
Purpose:	Maintenance Related	Dia/Height:	8"
Use:	Sanitary	Material:	PVC
Drain Area:	NA	Lining:	Cured in Place
Category:	NA		
Comment:	Flow direction wrong.

Location Details:		Direction of Survey:	Downstream
US MH:	M-708-120	DS MH:	M-708-121
		Total Length Surveyed (ft):	125.7

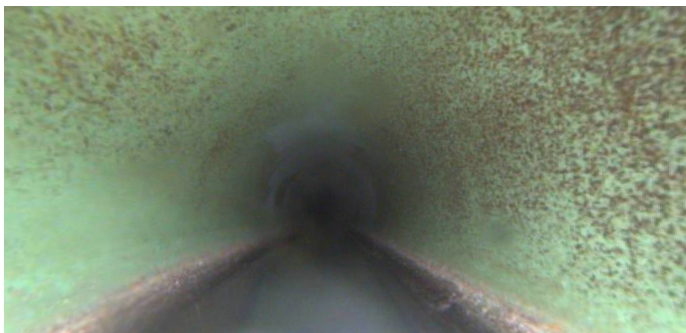
Code: **AMH**
Description: **Manhole**

Distance (ft): **.0**
Structural Grade: **0**
O&M Grade: **0**
Clock Start/From:
Clock To:
1st Value:
2nd Value:
Value Percent:
Continuous Index:
Within 8" of Joint: **NO**
Remarks: **M-708-120**

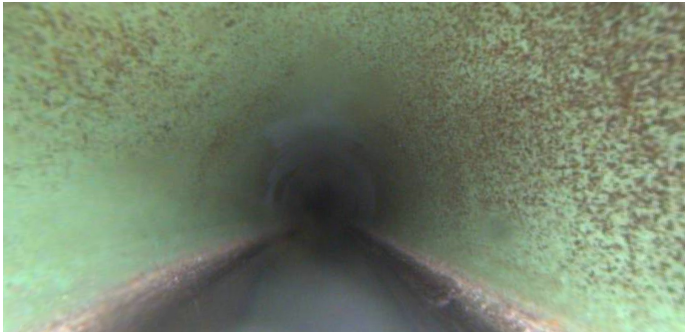
Code:	MWL
Description:	Water Level

Distance (ft):	.0
Structural Grade:	0
O&M Grade:	0
Clock Start/From:	
Clock To:	
1st Value:	
2nd Value:	
Value Percent:	10.000
Continuous Index:	
Within 8" of Joint:	NO
Remarks:

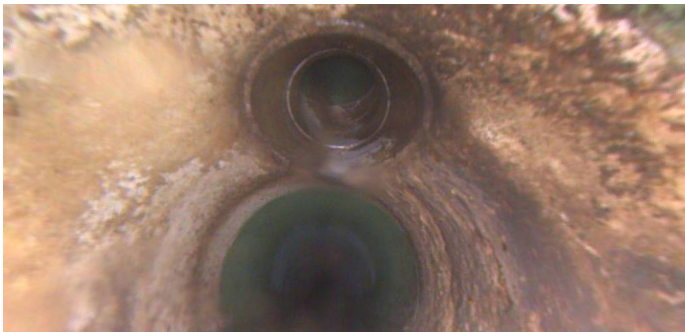
Code:	TF
Description:	Tap Factory

Distance (ft):	65.2
Structural Grade:	0
O&M Grade:	0
Clock Start/From:	12
Clock To:	
1st Value:	4.000
2nd Value:	
Value Percent:	
Continuous Index:	
Within 8" of Joint:	
Remarks:

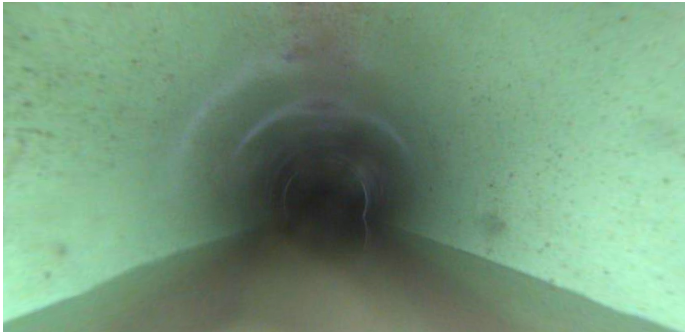
Code: **MWL**
Description: **Water Level**

Distance (ft): **95.9**
Structural Grade: **0**
O&M Grade: **0**
Clock Start/From:
Clock To:
1st Value:
2nd Value:
Value Percent: **25.000**
Continuous Index:
Within 8" of Joint: **NO**
Remarks:

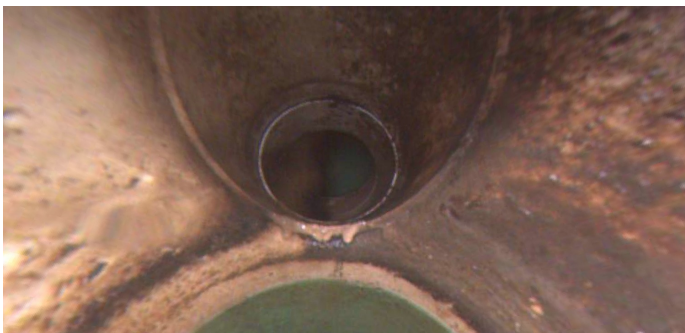
Code: **TFA**
Description: **Tap Factory Active**

Distance (ft): **113.4**
Structural Grade: **0**
O&M Grade: **0**
Clock Start/From: **12**
Clock To:
1st Value: **4.000**
2nd Value:
Value Percent:
Continuous Index:
Within 8" of Joint:
Remarks:

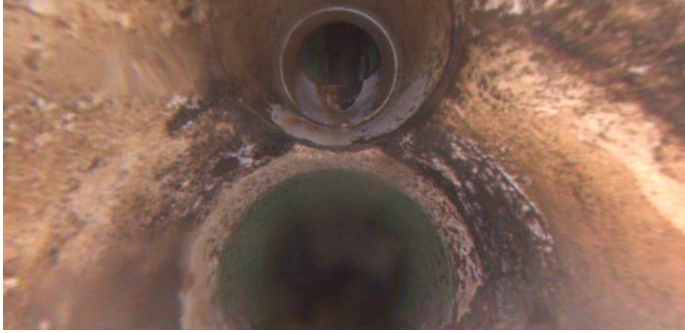
Code: **TF**
Description: **Tap Factory**

Distance (ft): **116.1**
Structural Grade: **0**
O&M Grade: **0**
Clock Start/From: **12**
Clock To:
1st Value: **4.000**
2nd Value:
Value Percent:
Continuous Index:
Within 8" of Joint:
Remarks:

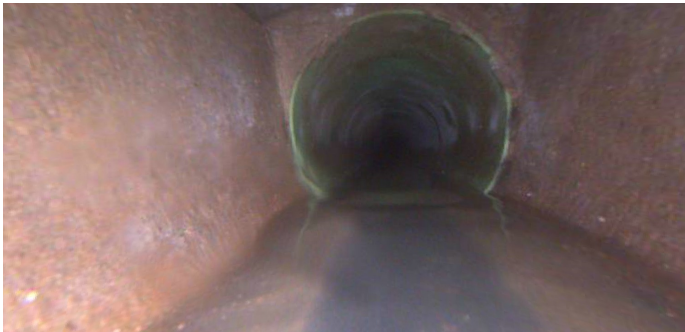
Code: **AMH**
Description: **Manhole**

Distance (ft): **125.7**
Structural Grade: **0**
O&M Grade: **0**
Clock Start/From:
Clock To:
1st Value:
2nd Value:
Value Percent:
Continuous Index:
Within 8" of Joint: **NO**
Remarks: **M-708-121**
