## Profile/Photo Observation Report

Street:	<b>MAGNOLIA DR</b>	Flow Control:	<b>Not Controlled</b>
City:	<b>Hobart, IN</b>	Year Renewed:	
Location:	<b>Sidewalk</b>	Tape/Media #:	
Purpose:	<b>Maintenance Related</b>	Dia/Height:	<b>8"</b>
Use:	<b>Sanitary</b>	Material:	<b>PVC</b>
Drain Area:	<b>NA</b>	Lining:	<b>Cured in Place</b>
Category:	<b>NA</b>		
Comment:	<b>Flow direction wrong.</b>

Location Details:		Direction of Survey:	<b>Downstream</b>
US MH:	<b>M-708-120</b>	DS MH:	<b>M-708-131</b>
		Total Length Surveyed (ft):	<b>149.8</b>

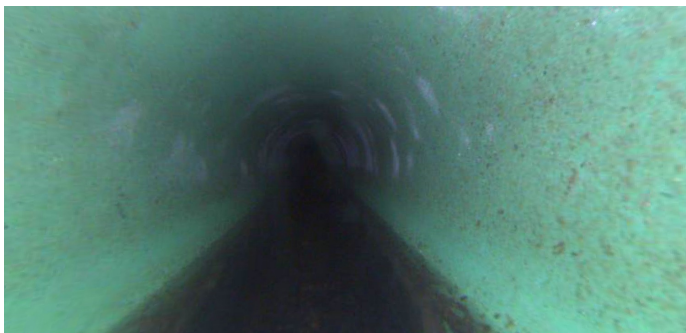
Code: **AMH**  
Description: **Manhole**

Distance (ft): **.0**  
Structural Grade: **0**  
O&M Grade: **0**  
Clock Start/From:  
Clock To:  
1st Value:  
2nd Value:  
Value Percent:  
Continuous Index:  
Within 8" of Joint: **NO**  
Remarks: **M-708-120**

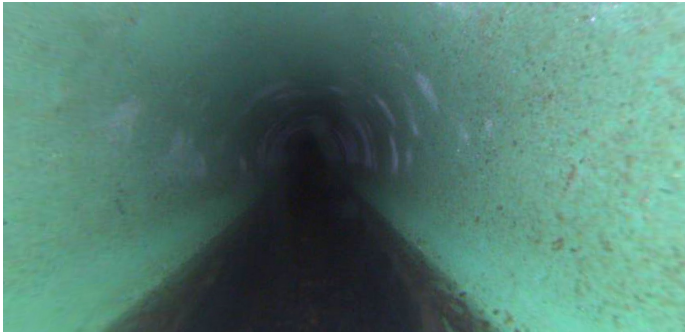
Code:	<b>MWL</b>
Description:	<b>Water Level</b>

Distance (ft):	<b>.0</b>
Structural Grade:	<b>0</b>
O&M Grade:	<b>0</b>
Clock Start/From:	
Clock To:	
1st Value:	
2nd Value:	
Value Percent:	<b>5.000</b>
Continuous Index:	
Within 8" of Joint:	<b>NO</b>
Remarks:

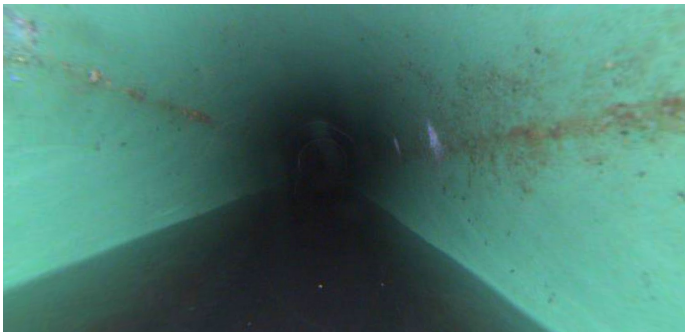
Code:	<b>MWL</b>
Description:	<b>Water Level</b>

Distance (ft):	<b>8.6</b>
Structural Grade:	<b>0</b>
O&M Grade:	<b>0</b>
Clock Start/From:	
Clock To:	
1st Value:	
2nd Value:	
Value Percent:	<b>30.000</b>
Continuous Index:	
Within 8" of Joint:	<b>NO</b>
Remarks:

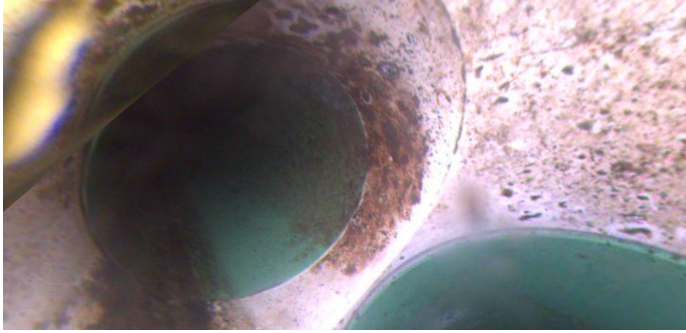
Code: **TF**  
Description: **Tap Factory**

Distance (ft): **32.6**  
Structural Grade: **0**  
O&M Grade: **0**  
Clock Start/From: **10**  
Clock To:  
1st Value: **4.000**  
2nd Value:  
Value Percent:  
Continuous Index:  
Within 8" of Joint:  
Remarks:

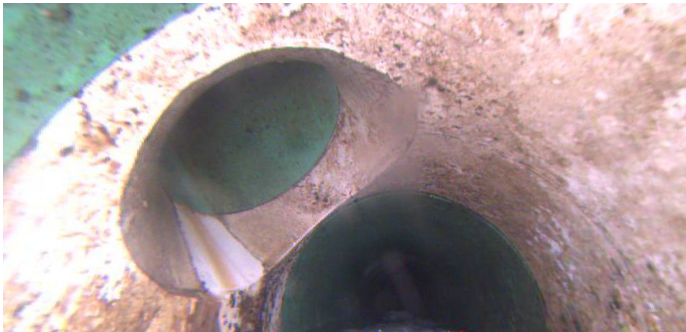
Code: **TF**  
Description: **Tap Factory**

Distance (ft): **95.5**  
Structural Grade: **0**  
O&M Grade: **0**  
Clock Start/From: **10**  
Clock To:  
1st Value: **4.000**  
2nd Value:  
Value Percent:  
Continuous Index:  
Within 8" of Joint:  
Remarks:

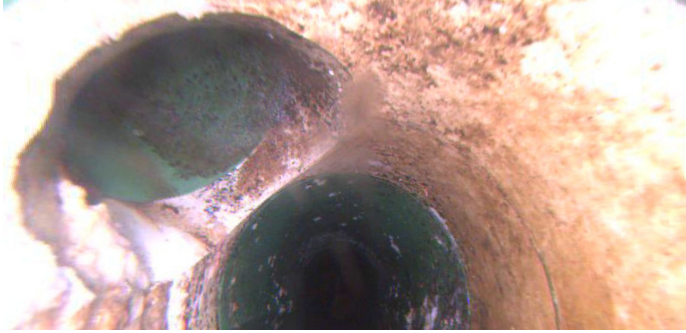
Code: **TF**  
Description: **Tap Factory**

Distance (ft): **140.7**  
Structural Grade: **0**  
O&M Grade: **0**  
Clock Start/From: **10**  
Clock To:  
1st Value: **4.000**  
2nd Value:  
Value Percent:  
Continuous Index:  
Within 8" of Joint:  
Remarks:

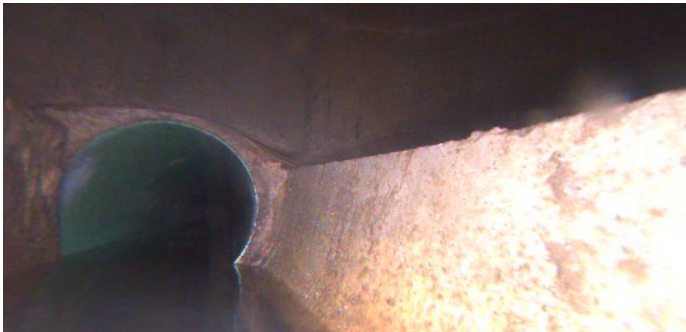
Code: **AMH**  
Description: **Manhole**

Distance (ft): **149.8**  
Structural Grade: **0**  
O&M Grade: **0**  
Clock Start/From:  
Clock To:  
1st Value:  
2nd Value:  
Value Percent:  
Continuous Index:  
Within 8" of Joint: **NO**  
Remarks: **M-708-131**
