Profile/Photo Observation Report

Date:	04/02/2018	Weather:		Coding:	PACP 6.0
Pipe Length (ft):	152.0	Owner:	NA	Pre Clean:	Not Known
P.O.#:		Surveyor:	Jen Costello	PSR:	P-708-131-120
Customer:		Clean Date:	01/01/1900	Shape:	C

Street:	Magnolia	Flow Control:	Not Controlled
City:	Hobart, IN	Year Renewed:	
Location:	Sidewalk	Tape/Media #:	
Purpose:	Maintenance Related	Dia/Height:	8"
Use:	Sanitary	Material:	PVC
Drain Area:	NA	Lining:	Cured in Place
Category:	NA		
Comment:	Flow direction wrong.

Location Details:		Direction of Survey:	Downstream
US MH:	M-708-120	DS MH:	M-708-131
		Total Length Surveyed (ft):	149.8

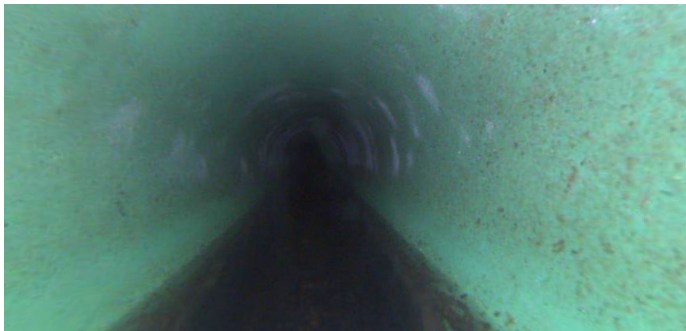
Code: **AMH**
Description: **Manhole**

Distance (ft): **.0**
Structural Grade: **0**
O&M Grade: **0**
Clock Start/From:
Clock To:
1st Value:
2nd Value:
Value Percent:
Continuous Index:
Within 8" of Joint: **NO**
Remarks: **M-708-120**

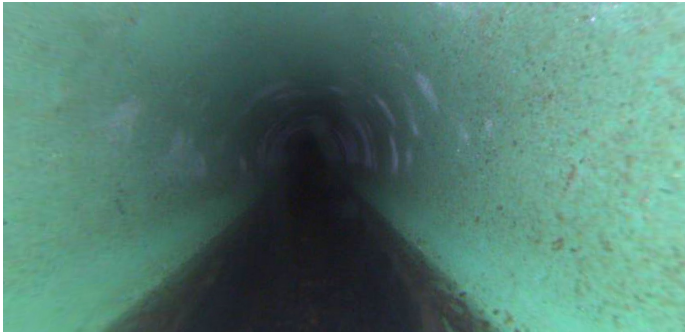
Code:	MWL
Description:	Water Level

Distance (ft):	.0
Structural Grade:	0
O&M Grade:	0
Clock Start/From:	
Clock To:	
1st Value:	
2nd Value:	
Value Percent:	5.000
Continuous Index:	
Within 8" of Joint:	NO
Remarks:

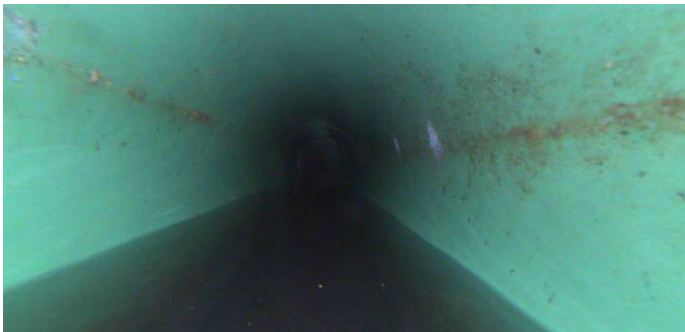
Code:	MWL
Description:	Water Level

Distance (ft):	8.6
Structural Grade:	0
O&M Grade:	0
Clock Start/From:	
Clock To:	
1st Value:	
2nd Value:	
Value Percent:	30.000
Continuous Index:	
Within 8" of Joint:	NO
Remarks:

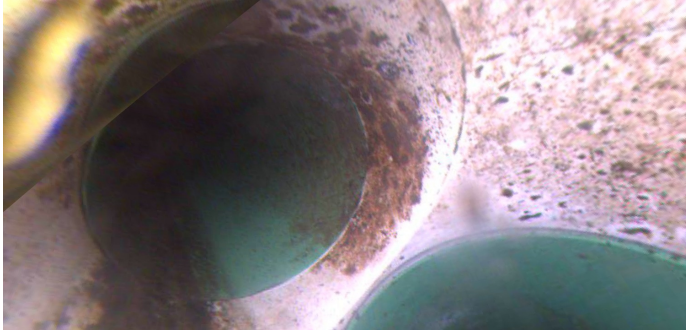
Code: **TF**
Description: **Tap Factory**

Distance (ft): **32.6**
Structural Grade: **0**
O&M Grade: **0**
Clock Start/From: **10**
Clock To:
1st Value: **4.000**
2nd Value:
Value Percent:
Continuous Index:
Within 8" of Joint:
Remarks:

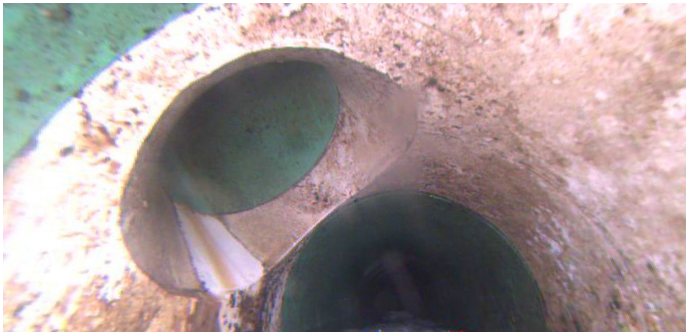
Code: **TF**
Description: **Tap Factory**

Distance (ft): **95.5**
Structural Grade: **0**
O&M Grade: **0**
Clock Start/From: **10**
Clock To:
1st Value: **4.000**
2nd Value:
Value Percent:
Continuous Index:
Within 8" of Joint:
Remarks:

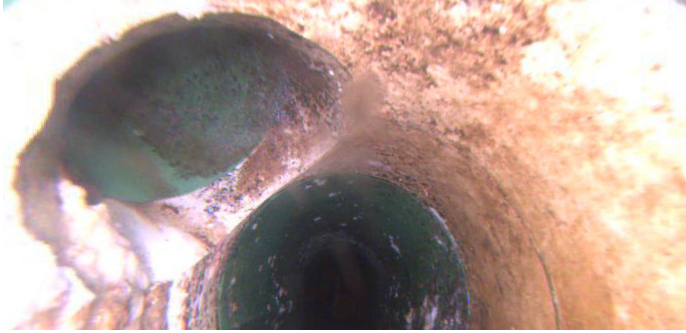
Code: **TF**
Description: **Tap Factory**

Distance (ft): **140.7**
Structural Grade: **0**
O&M Grade: **0**
Clock Start/From: **10**
Clock To:
1st Value: **4.000**
2nd Value:
Value Percent:
Continuous Index:
Within 8" of Joint:
Remarks:

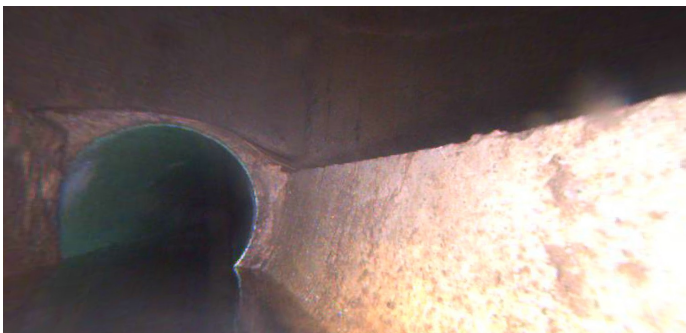
Code: **AMH**
Description: **Manhole**

Distance (ft): **149.8**
Structural Grade: **0**
O&M Grade: **0**
Clock Start/From:
Clock To:
1st Value:
2nd Value:
Value Percent:
Continuous Index:
Within 8" of Joint: **NO**
Remarks: **M-708-131**
