Profile/Photo Observation Report

Date:	04/02/2018	Weather:		Coding:	PACP 6.0
Pipe Length (ft):	281.4	Owner:	NA	Pre Clean:	Not Known
P.O.#:		Surveyor:	Jen Costello	PSR:	P-708-123-122
Customer:		Clean Date:	01/01/1900	Shape:	C

Street:	TAMARACK DR	Flow Control:	Not Controlled
City:	Hobart, IN	Year Renewed:	
Location:	Sidewalk	Tape/Media #:	
Purpose:	Maintenance Related	Dia/Height:	8"
Use:	Sanitary	Material:	PVC
Drain Area:	NA	Lining:	Cured in Place
Category:	NA		
Comment:	Flow direction wrong.

Location Details:		Direction of Survey:	Upstream
US MH:	M-708-122	DS MH:	M-708-123
		Total Length Surveyed (ft):	290.8

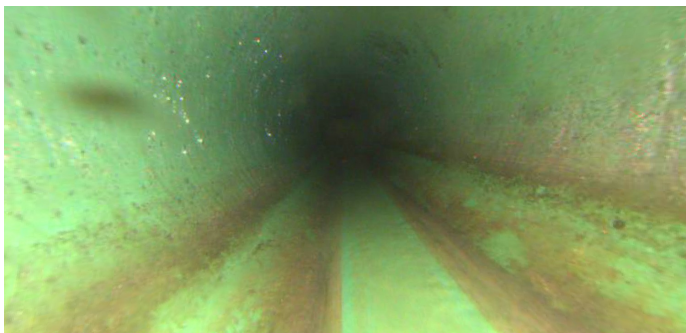
Code: **AMH**
Description: **Manhole**

Distance (ft): **.0**
Structural Grade: **0**
O&M Grade: **0**
Clock Start/From:
Clock To:
1st Value:
2nd Value:
Value Percent:
Continuous Index:
Within 8" of Joint: **NO**
Remarks: **M-708-123**

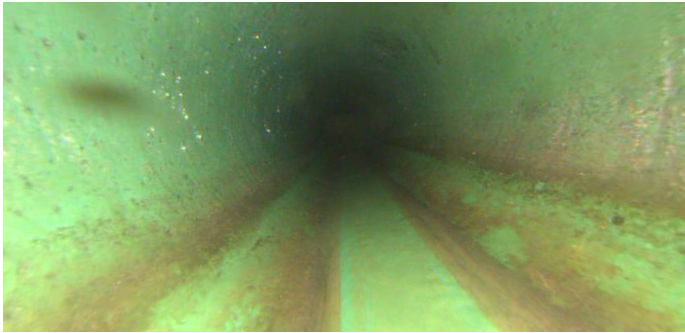
Code:	MWL
Description:	Water Level

Distance (ft):	.0
Structural Grade:	0
O&M Grade:	0
Clock Start/From:	
Clock To:	
1st Value:	
2nd Value:	
Value Percent:	5.000
Continuous Index:	
Within 8" of Joint:	NO
Remarks:

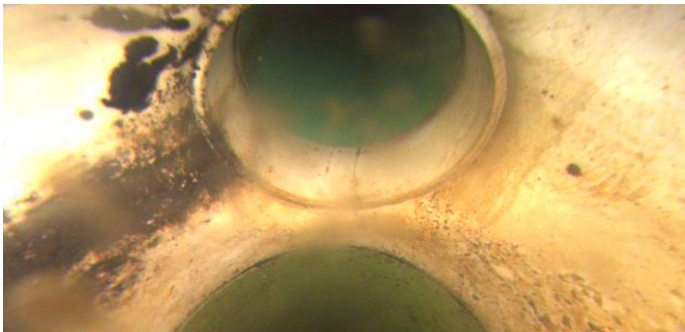
Code:	TF
Description:	Tap Factory

Distance (ft):	12.2
Structural Grade:	0
O&M Grade:	0
Clock Start/From:	12
Clock To:	
1st Value:	4.000
2nd Value:	
Value Percent:	
Continuous Index:	
Within 8" of Joint:	
Remarks:

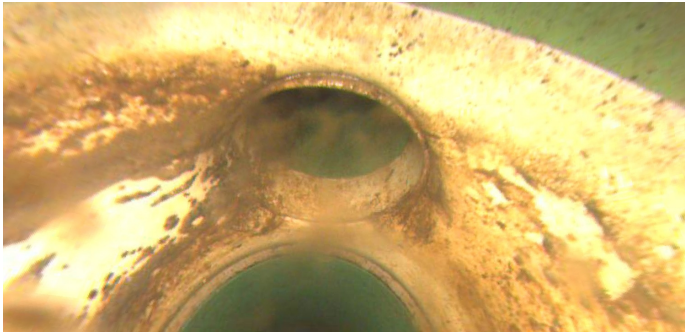
Code: **TF**
Description: **Tap Factory**

Distance (ft): **15.7**
Structural Grade: **0**
O&M Grade: **0**
Clock Start/From: **12**
Clock To:
1st Value: **4.000**
2nd Value:
Value Percent:
Continuous Index:
Within 8" of Joint:
Remarks:

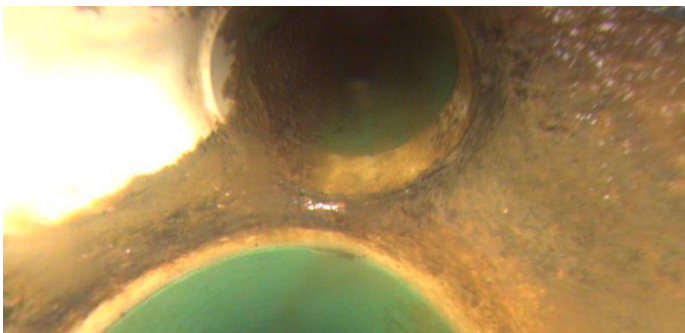
Code: **TF**
Description: **Tap Factory**

Distance (ft): **86.2**
Structural Grade: **0**
O&M Grade: **0**
Clock Start/From: **12**
Clock To:
1st Value: **4.000**
2nd Value:
Value Percent:
Continuous Index:
Within 8" of Joint:
Remarks:

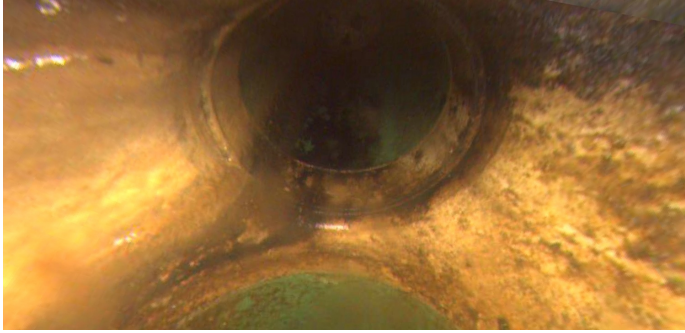
Code: **TF**
Description: **Tap Factory**

Distance (ft): **142.4**
Structural Grade: **0**
O&M Grade: **0**
Clock Start/From: **12**
Clock To:
1st Value: **4.000**
2nd Value:
Value Percent:
Continuous Index:
Within 8" of Joint:
Remarks:

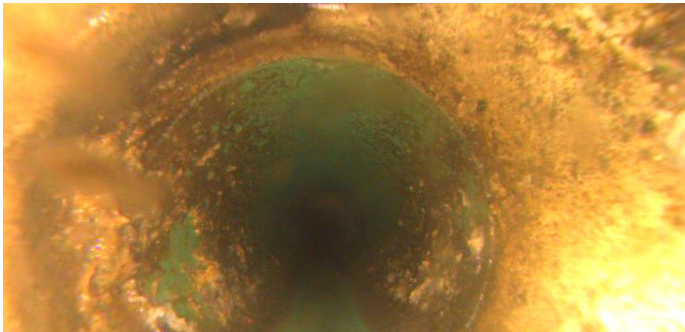
Code: **DAGS**
Description: **Deposits Attached Grease**

Distance (ft): **142.4**
Structural Grade: **0**
O&M Grade: **2**
Clock Start/From: **8**
Clock To: **4**
1st Value:
2nd Value:
Value Percent: **5.000**
Continuous Index:
Within 8" of Joint: **NO**
Remarks:

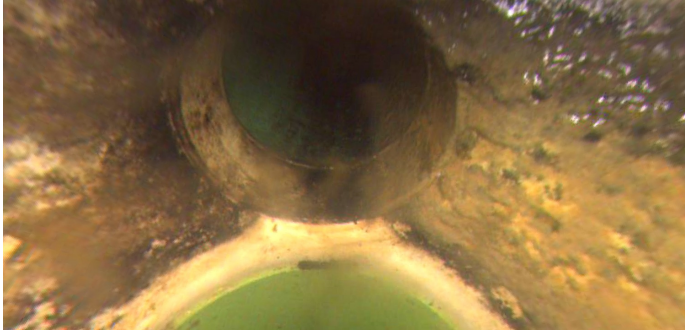
Code: **TF**
Description: **Tap Factory**

Distance (ft): **170.7**
Structural Grade: **0**
O&M Grade: **0**
Clock Start/From: **12**
Clock To:
1st Value: **4.000**
2nd Value:
Value Percent:
Continuous Index:
Within 8" of Joint:
Remarks:

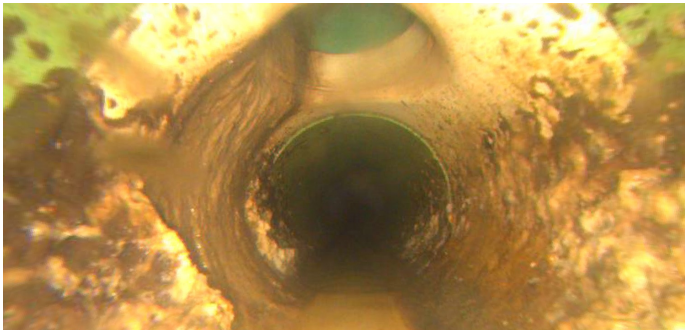
Code: **DAGS**
Description: **Deposits Attached Grease**

Distance (ft): **199.0**
Structural Grade: **0**
O&M Grade: **2**
Clock Start/From: **8**
Clock To: **4**
1st Value:
2nd Value:
Value Percent: **10.000**
Continuous Index:
Within 8" of Joint: **NO**
Remarks:

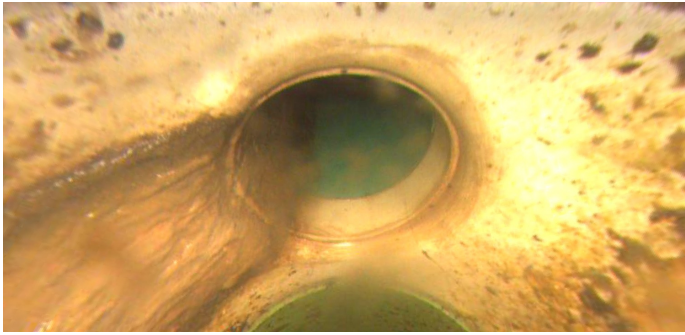
Code: **TF**
Description: **Tap Factory**

Distance (ft): **199.3**
Structural Grade: **0**
O&M Grade: **0**
Clock Start/From: **12**
Clock To:
1st Value: **4.000**
2nd Value:
Value Percent:
Continuous Index:
Within 8" of Joint:
Remarks:

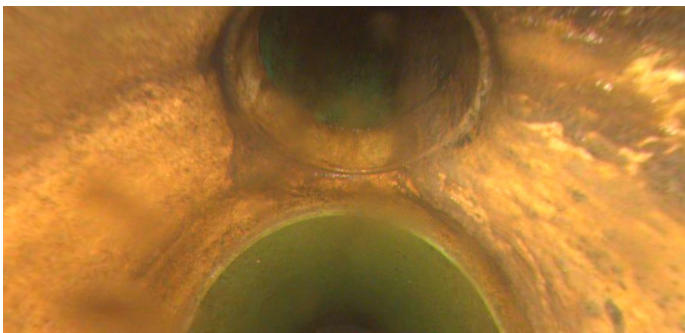
Code: **TF**
Description: **Tap Factory**

Distance (ft): **228.4**
Structural Grade: **0**
O&M Grade: **0**
Clock Start/From: **12**
Clock To:
1st Value: **4.000**
2nd Value:
Value Percent:
Continuous Index:
Within 8" of Joint:
Remarks:

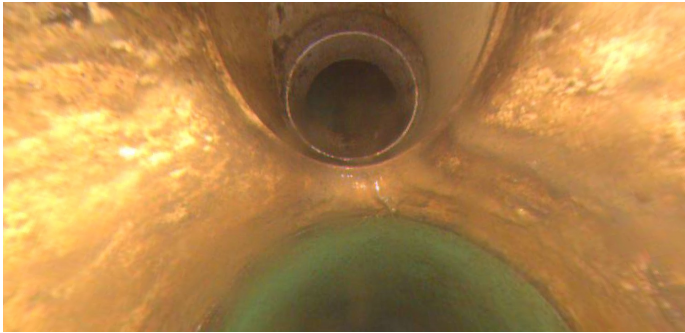
Code: **TF**
Description: **Tap Factory**

Distance (ft): **267.7**
Structural Grade: **0**
O&M Grade: **0**
Clock Start/From: **12**
Clock To:
1st Value: **4.000**
2nd Value:
Value Percent:
Continuous Index:
Within 8" of Joint:
Remarks:

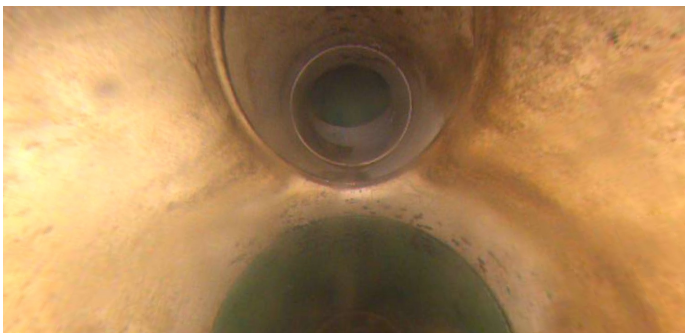
Code: **TF**
Description: **Tap Factory**

Distance (ft): **271.0**
Structural Grade: **0**
O&M Grade: **0**
Clock Start/From: **12**
Clock To:
1st Value: **4.000**
2nd Value:
Value Percent:
Continuous Index:
Within 8" of Joint:
Remarks:

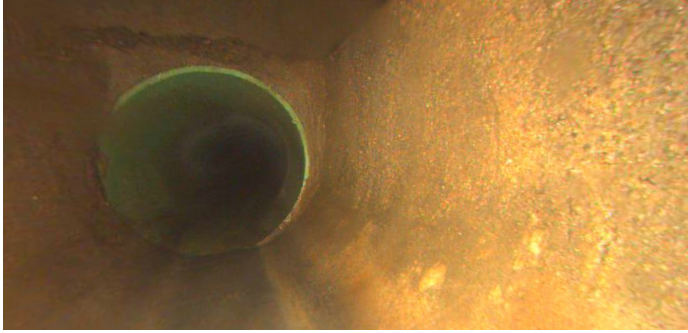
Code:	AMH
Description:	Manhole
Distance (ft):	290.8
Structural Grade:	0
O&M Grade:	0
Clock Start/From:	
Clock To:	
1st Value:	
2nd Value:	
Value Percent:	
Continuous Index:	
Within 8" of Joint:	NO
Remarks:	M-708-122
