Profile/Photo Observation Report

Street:	REDBUD DR	Flow Control:	Not Controlled
City:	Hobart, IN	Year Renewed:	
Location:	Sidewalk	Tape/Media #:	
Purpose:	Maintenance Related	Dia/Height:	8"
Use:	Sanitary	Material:	PVC
Drain Area:	NA	Lining:	Cured in Place
Category:	NA		
Comment:	Flow direction wrong.

Location Details:		Direction of Survey:	Downstream
US MH:	M-708-123	DS MH:	M-708-124
		Total Length Surveyed (ft):	268.6

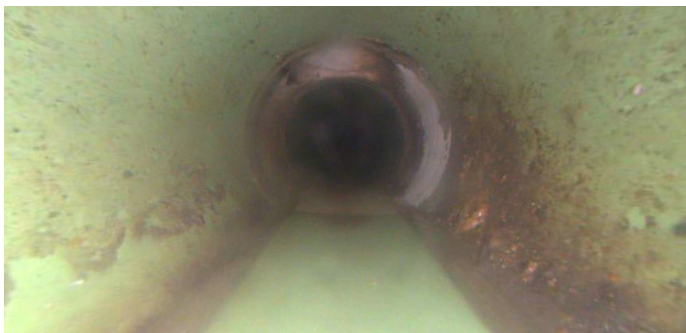
Code: **AMH**
Description: **Manhole**

Distance (ft): **.0**
Structural Grade: **0**
O&M Grade: **0**
Clock Start/From:
Clock To:
1st Value:
2nd Value:
Value Percent:
Continuous Index:
Within 8" of Joint: **NO**
Remarks: **M-708-123**

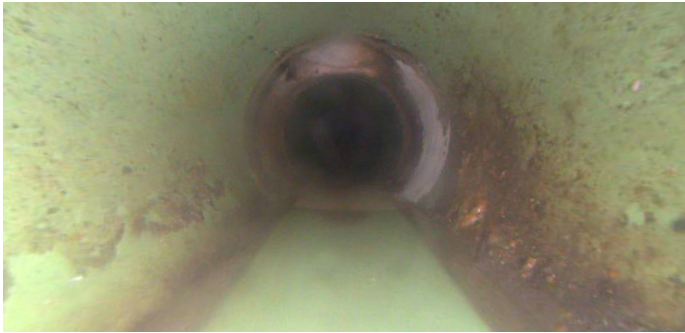
Code:	MWL
Description:	Water Level

Distance (ft):	.0
Structural Grade:	0
O&M Grade:	0
Clock Start/From:	
Clock To:	
1st Value:	
2nd Value:	
Value Percent:	10.000
Continuous Index:	
Within 8" of Joint:	NO
Remarks:

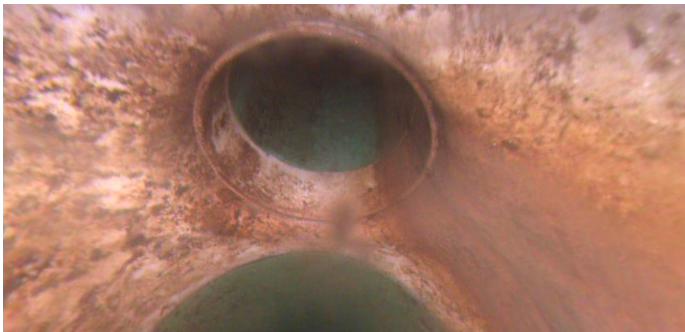
Code:	TF
Description:	Tap Factory

Distance (ft):	23.9
Structural Grade:	0
O&M Grade:	0
Clock Start/From:	12
Clock To:	
1st Value:	4.000
2nd Value:	
Value Percent:	
Continuous Index:	
Within 8" of Joint:	
Remarks:

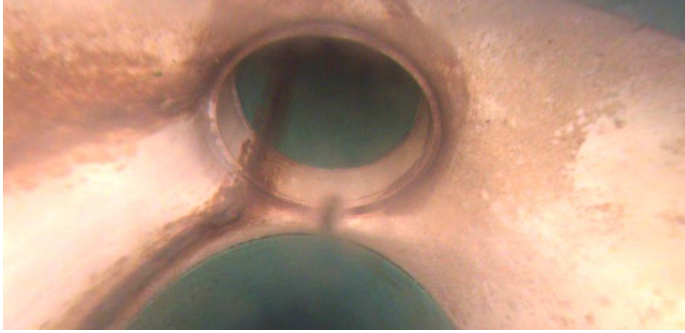
Code: **TF**
Description: **Tap Factory**

Distance (ft): **48.6**
Structural Grade: **0**
O&M Grade: **0**
Clock Start/From: **2**
Clock To:
1st Value: **4.000**
2nd Value:
Value Percent:
Continuous Index:
Within 8" of Joint:
Remarks:

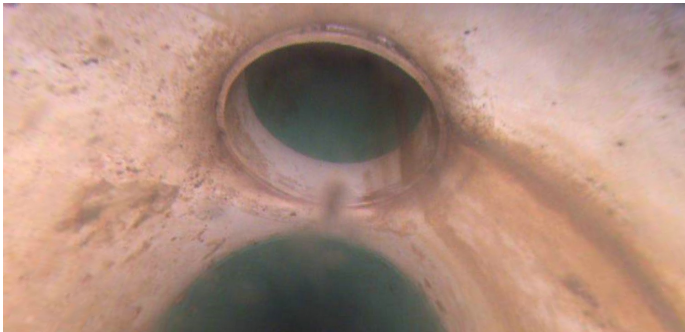
Code: **TF**
Description: **Tap Factory**

Distance (ft): **75.1**
Structural Grade: **0**
O&M Grade: **0**
Clock Start/From: **12**
Clock To:
1st Value: **4.000**
2nd Value:
Value Percent:
Continuous Index:
Within 8" of Joint:
Remarks:

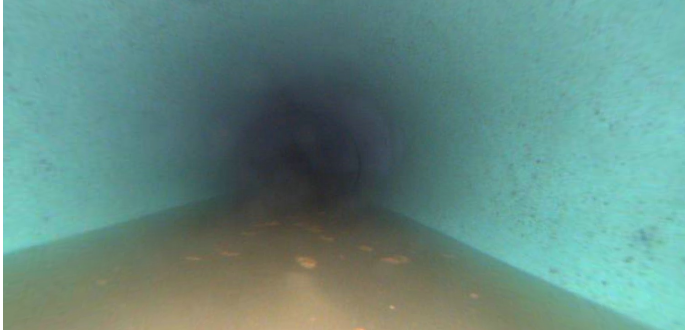
Code: **MWL**
Description: **Water Level**

Distance (ft): **86.4**
Structural Grade: **0**
O&M Grade: **0**
Clock Start/From:
Clock To:
1st Value:
2nd Value:
Value Percent: **40.000**
Continuous Index:
Within 8" of Joint: **NO**
Remarks:

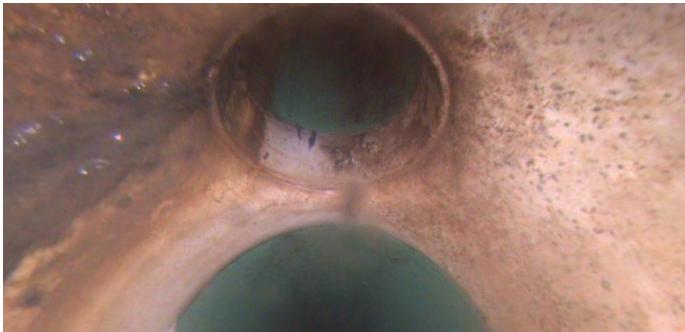
Code: **TF**
Description: **Tap Factory**

Distance (ft): **108.6**
Structural Grade: **0**
O&M Grade: **0**
Clock Start/From: **12**
Clock To:
1st Value: **4.000**
2nd Value:
Value Percent:
Continuous Index:
Within 8" of Joint:
Remarks:

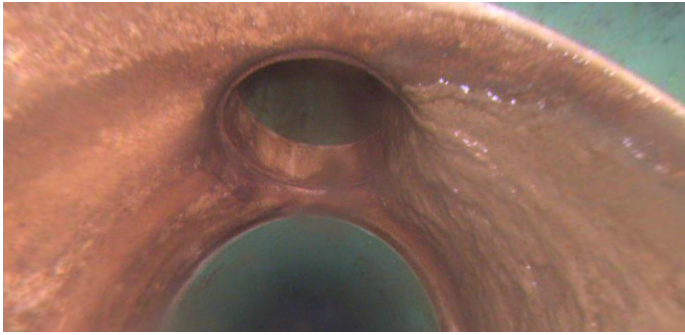
Code: **TF**
Description: **Tap Factory**

Distance (ft): **133.9**
Structural Grade: **0**
O&M Grade: **0**
Clock Start/From: **12**
Clock To:
1st Value: **4.000**
2nd Value:
Value Percent:
Continuous Index:
Within 8" of Joint:
Remarks:

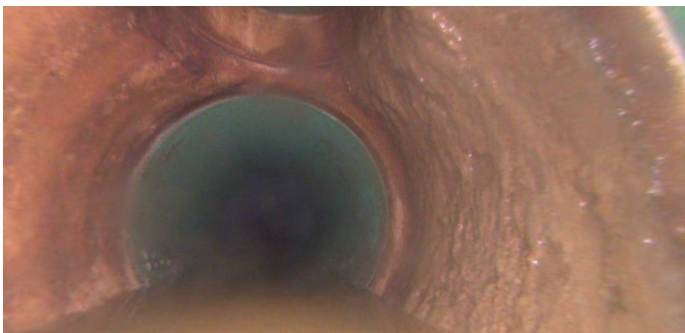
Code: **DAGS**
Description: **Deposits Attached Grease**

Distance (ft): **133.9**
Structural Grade: **0**
O&M Grade: **2**
Clock Start/From: **2**
Clock To: **4**
1st Value:
2nd Value:
Value Percent: **5.000**
Continuous Index:
Within 8" of Joint: **NO**
Remarks:

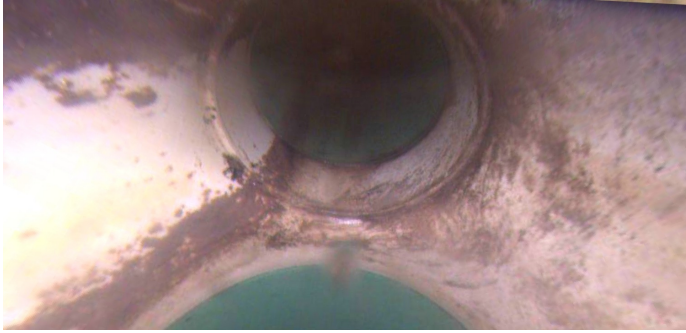
Code: **TF**
Description: **Tap Factory**

Distance (ft): **168.0**
Structural Grade: **0**
O&M Grade: **0**
Clock Start/From: **12**
Clock To:
1st Value: **4.000**
2nd Value:
Value Percent:
Continuous Index:
Within 8" of Joint:
Remarks:

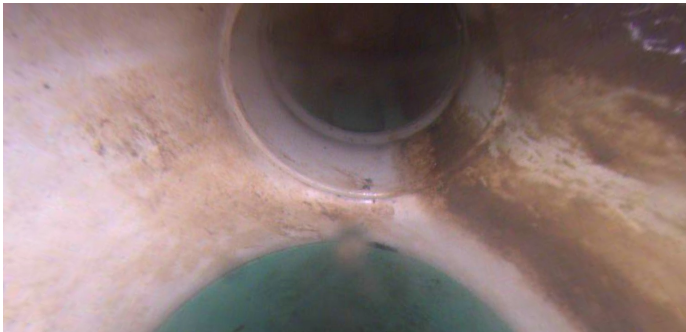
Code: **TF**
Description: **Tap Factory**

Distance (ft): **191.3**
Structural Grade: **0**
O&M Grade: **0**
Clock Start/From: **12**
Clock To:
1st Value: **4.000**
2nd Value:
Value Percent:
Continuous Index:
Within 8" of Joint:
Remarks:

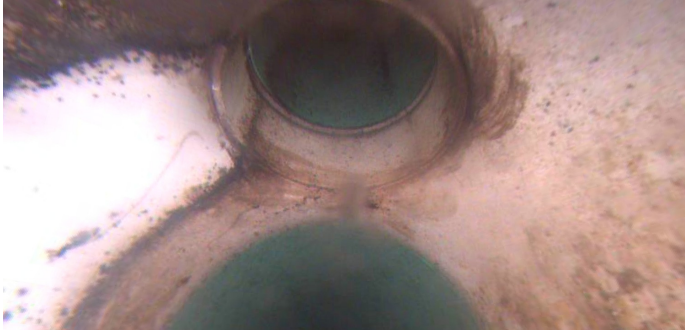
Code: **TF**
Description: **Tap Factory**

Distance (ft): **233.9**
Structural Grade: **0**
O&M Grade: **0**
Clock Start/From: **12**
Clock To:
1st Value: **4.000**
2nd Value:
Value Percent:
Continuous Index:
Within 8" of Joint:
Remarks:

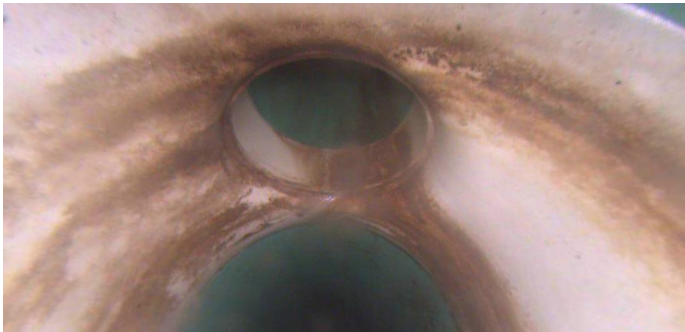
Code: **TF**
Description: **Tap Factory**

Distance (ft): **237.1**
Structural Grade: **0**
O&M Grade: **0**
Clock Start/From: **12**
Clock To:
1st Value: **4.000**
2nd Value:
Value Percent:
Continuous Index:
Within 8" of Joint:
Remarks:

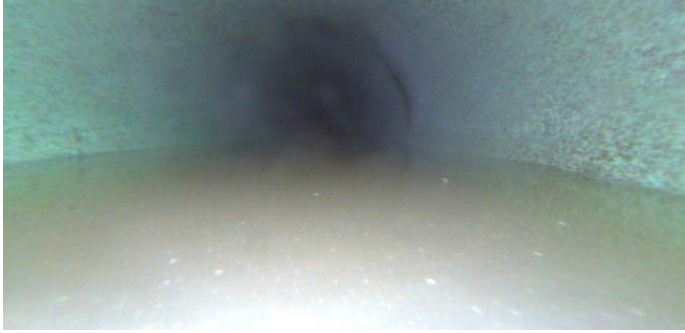
Code: **MWL**
Description: **Water Level**

Distance (ft): **241.8**
Structural Grade: **0**
O&M Grade: **0**
Clock Start/From:
Clock To:
1st Value:
2nd Value:
Value Percent: **40.000**
Continuous Index:
Within 8" of Joint: **NO**
Remarks:

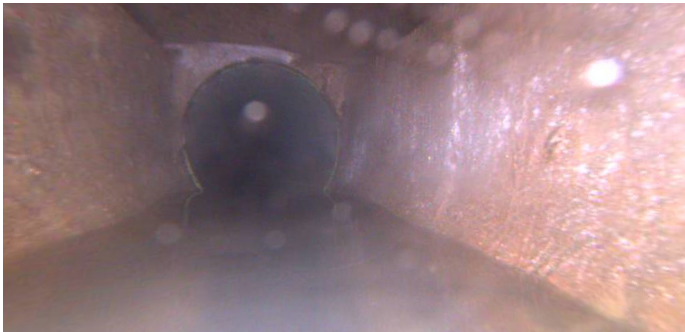
Code: **AMH**
Description: **Manhole**

Distance (ft): **268.6**
Structural Grade: **0**
O&M Grade: **0**
Clock Start/From:
Clock To:
1st Value:
2nd Value:
Value Percent:
Continuous Index:
Within 8" of Joint: **NO**
Remarks: **M-708-124**
