Profile/Photo Observation Report

Street:	Redbud	Flow Control:	Not Controlled
City:	Hobart, IN	Year Renewed:	
Location:	Sidewalk	Tape/Media #:	
Purpose:	Maintenance Related	Dia/Height:	8"
Use:	Sanitary	Material:	PVC
Drain Area:	NA	Lining:	Cured in Place
Category:	NA		
Comment:	Flow direction wrong.

Location Details:		Direction of Survey:	Downstream
US MH:	M-708-123	DS MH:	M-708-124
		Total Length Surveyed (ft):	268.6

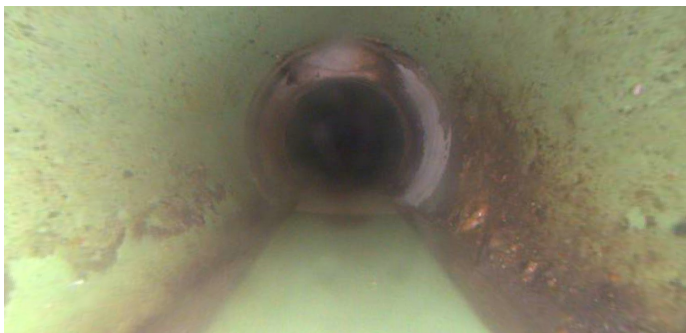
Code: **AMH**
Description: **Manhole**

Distance (ft): **.0**
Structural Grade: **0**
O&M Grade: **0**
Clock Start/From:
Clock To:
1st Value:
2nd Value:
Value Percent:
Continuous Index:
Within 8" of Joint: **NO**
Remarks: **M-708-123**

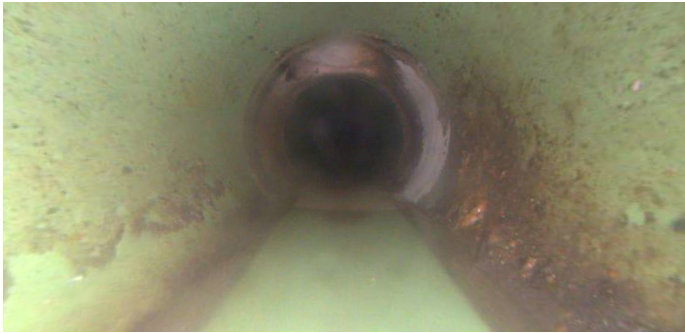
Code:	MWL
Description:	Water Level

Distance (ft):	.0
Structural Grade:	0
O&M Grade:	0
Clock Start/From:	
Clock To:	
1st Value:	
2nd Value:	
Value Percent:	10.000
Continuous Index:	
Within 8" of Joint:	NO
Remarks:

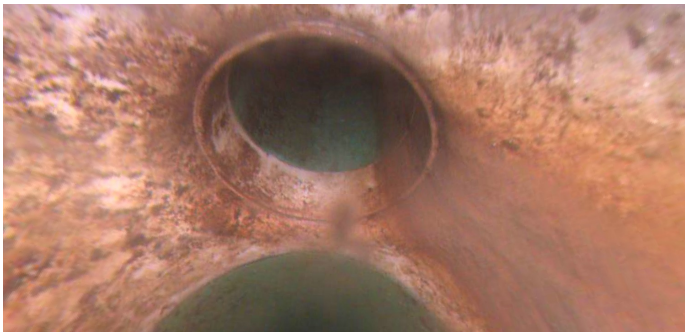
Code:	TF
Description:	Tap Factory

Distance (ft):	23.9
Structural Grade:	0
O&M Grade:	0
Clock Start/From:	12
Clock To:	
1st Value:	4.000
2nd Value:	
Value Percent:	
Continuous Index:	
Within 8" of Joint:	
Remarks:

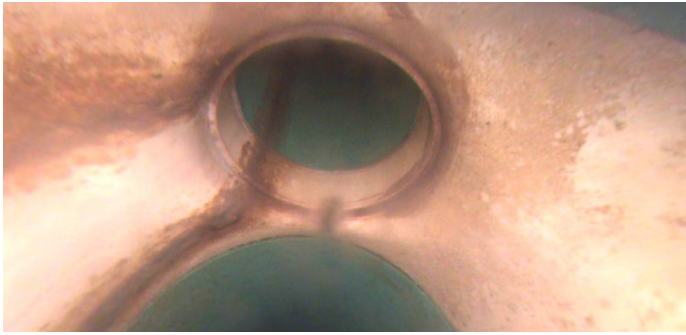
Code: **TF**
Description: **Tap Factory**

Distance (ft): **48.6**
Structural Grade: **0**
O&M Grade: **0**
Clock Start/From: **2**
Clock To:
1st Value: **4.000**
2nd Value:
Value Percent:
Continuous Index:
Within 8" of Joint:
Remarks:

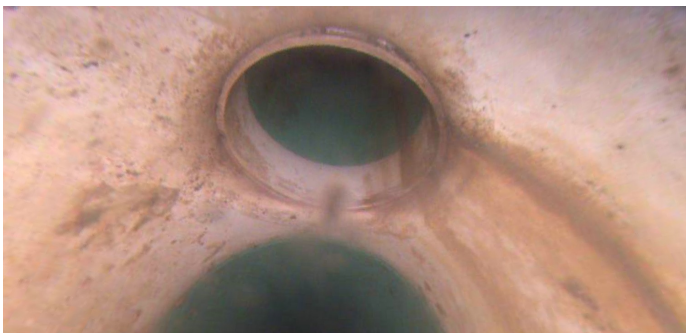
Code: **TF**
Description: **Tap Factory**

Distance (ft): **75.1**
Structural Grade: **0**
O&M Grade: **0**
Clock Start/From: **12**
Clock To:
1st Value: **4.000**
2nd Value:
Value Percent:
Continuous Index:
Within 8" of Joint:
Remarks:

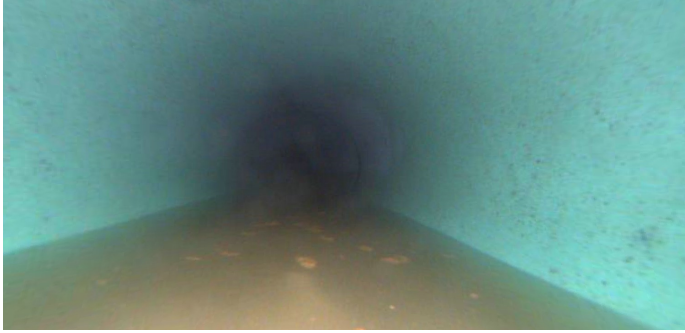
Code: **MWL**
Description: **Water Level**

Distance (ft): **86.4**
Structural Grade: **0**
O&M Grade: **0**
Clock Start/From:
Clock To:
1st Value:
2nd Value:
Value Percent: **40.000**
Continuous Index:
Within 8" of Joint: **NO**
Remarks:

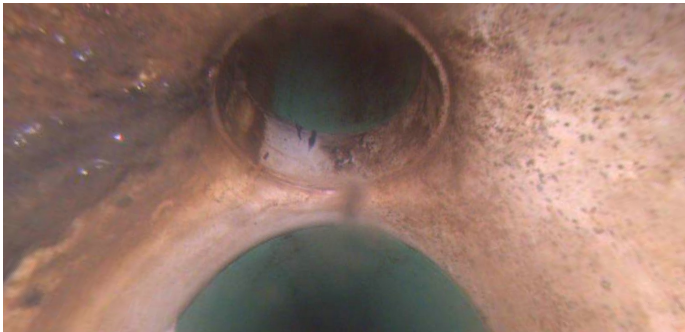
Code: **TF**
Description: **Tap Factory**

Distance (ft): **108.6**
Structural Grade: **0**
O&M Grade: **0**
Clock Start/From: **12**
Clock To:
1st Value: **4.000**
2nd Value:
Value Percent:
Continuous Index:
Within 8" of Joint:
Remarks:

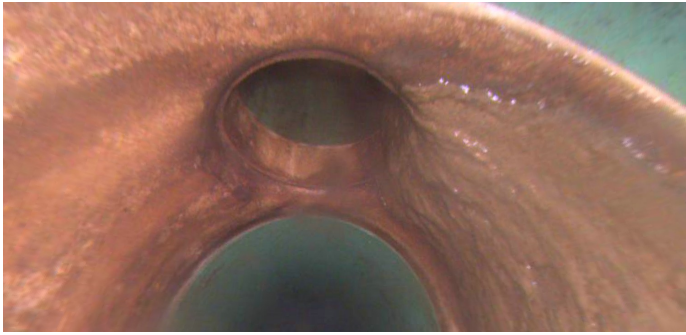
Code: **TF**
Description: **Tap Factory**

Distance (ft): **133.9**
Structural Grade: **0**
O&M Grade: **0**
Clock Start/From: **12**
Clock To:
1st Value: **4.000**
2nd Value:
Value Percent:
Continuous Index:
Within 8" of Joint:
Remarks:

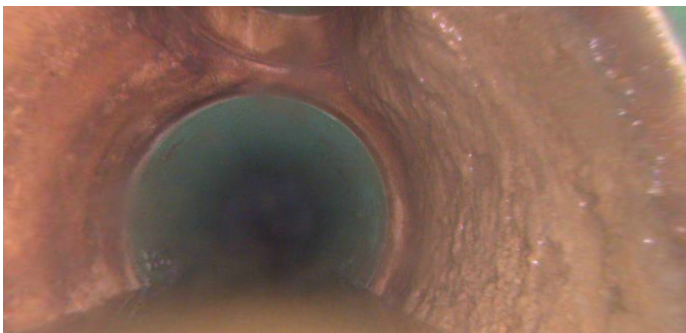
Code: **DAGS**
Description: **Deposits Attached Grease**

Distance (ft): **133.9**
Structural Grade: **0**
O&M Grade: **2**
Clock Start/From: **2**
Clock To: **4**
1st Value:
2nd Value:
Value Percent: **5.000**
Continuous Index:
Within 8" of Joint: **NO**
Remarks:

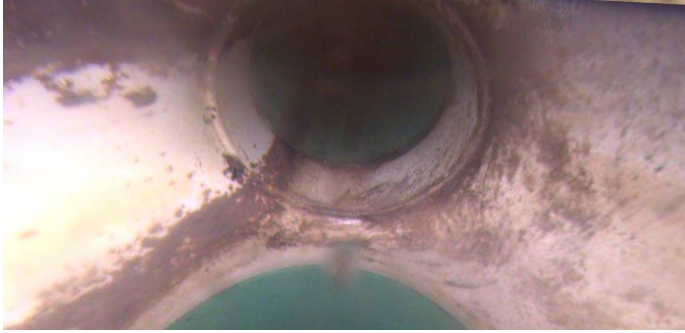
Code: **TF**
Description: **Tap Factory**

Distance (ft): **168.0**
Structural Grade: **0**
O&M Grade: **0**
Clock Start/From: **12**
Clock To:
1st Value: **4.000**
2nd Value:
Value Percent:
Continuous Index:
Within 8" of Joint:
Remarks:

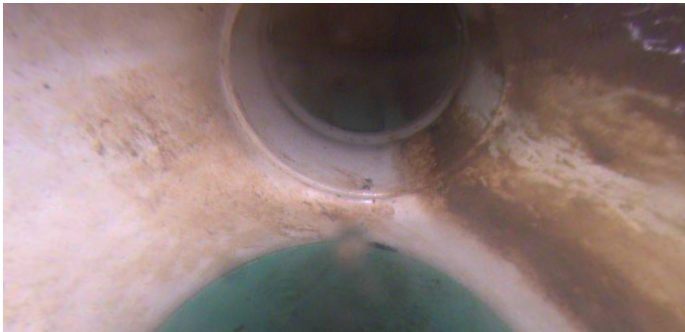
Code: **TF**
Description: **Tap Factory**

Distance (ft): **191.3**
Structural Grade: **0**
O&M Grade: **0**
Clock Start/From: **12**
Clock To:
1st Value: **4.000**
2nd Value:
Value Percent:
Continuous Index:
Within 8" of Joint:
Remarks:

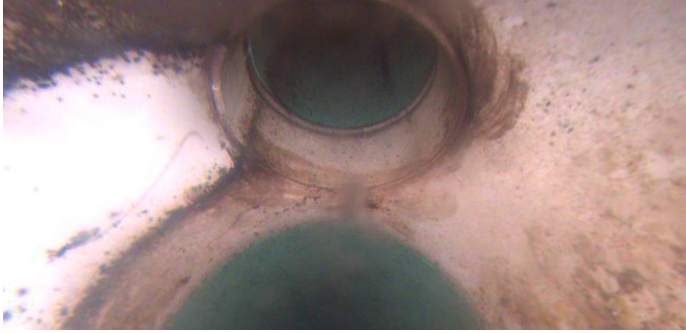
Code: **TF**
Description: **Tap Factory**

Distance (ft): **233.9**
Structural Grade: **0**
O&M Grade: **0**
Clock Start/From: **12**
Clock To:
1st Value: **4.000**
2nd Value:
Value Percent:
Continuous Index:
Within 8" of Joint:
Remarks:

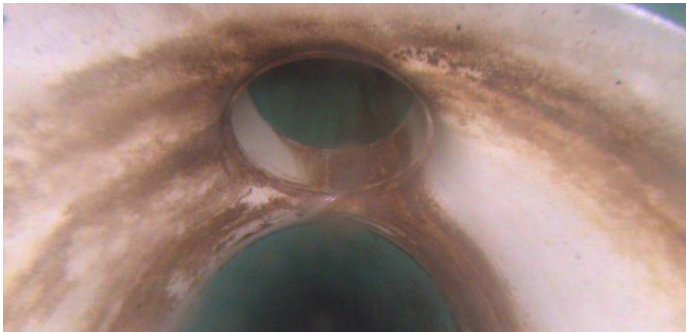
Code: **TF**
Description: **Tap Factory**

Distance (ft): **237.1**
Structural Grade: **0**
O&M Grade: **0**
Clock Start/From: **12**
Clock To:
1st Value: **4.000**
2nd Value:
Value Percent:
Continuous Index:
Within 8" of Joint:
Remarks:

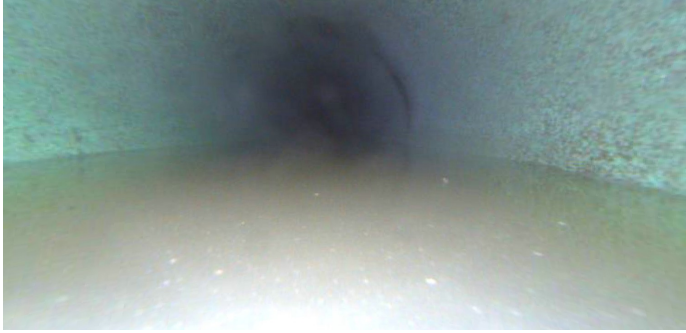
Code: **MWL**
Description: **Water Level**

Distance (ft): **241.8**
Structural Grade: **0**
O&M Grade: **0**
Clock Start/From:
Clock To:
1st Value:
2nd Value:
Value Percent: **40.000**
Continuous Index:
Within 8" of Joint: **NO**
Remarks:

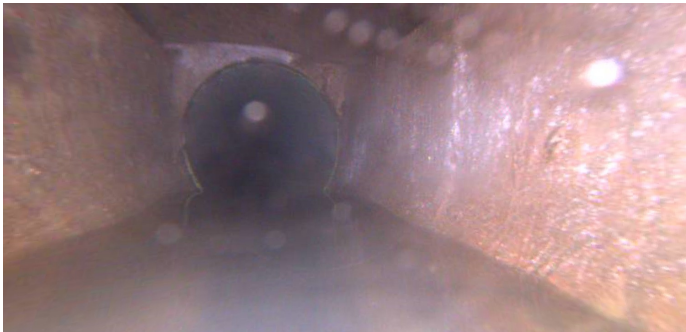
Code: **AMH**
Description: **Manhole**

Distance (ft): **268.6**
Structural Grade: **0**
O&M Grade: **0**
Clock Start/From:
Clock To:
1st Value:
2nd Value:
Value Percent:
Continuous Index:
Within 8" of Joint: **NO**
Remarks: **M-708-124**
