Profile/Photo Observation Report

Date:	10/12/2018	Weather:		Coding:	PACP 6.0
Pipe Length (ft):	80.1	Owner:	NA	Pre Clean:	Not Known
P.O.#:		Surveyor:	Selasie Honu	PSR:	P-708-128-127
Customer:		Clean Date:	01/01/1900	Shape:	C

Street:	REDBUD DR	Flow Control:	Not Controlled
City:	Hobart, IN	Year Renewed:	
Location:	Light Highway	Tape/Media #:	
Purpose:	Routine Assessment	Dia/Height:	8"
Use:	Sanitary	Material:	PVC
Drain Area:	NA	Lining:	
Category:	NA		
Comment:

Location Details:		Direction of Survey:	Upstream
US MH:	M-708-127	DS MH:	M-708-128
		Total Length Surveyed (ft):	83.1

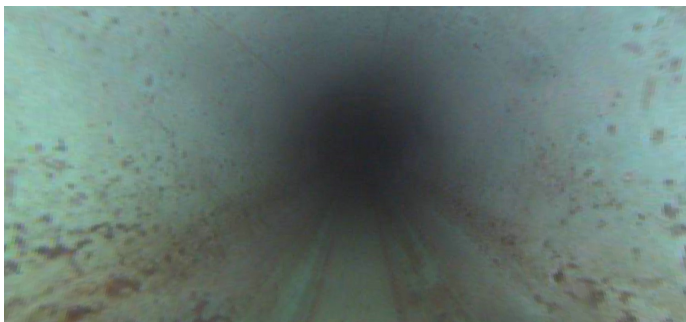
Code: **AMH**
Description: **Manhole**

Distance (ft): **.0**
Structural Grade: **0**
O&M Grade: **0**
Clock Start/From:
Clock To:
1st Value:
2nd Value:
Value Percent:
Continuous Index:
Within 8" of Joint: **NO**
Remarks: **M-708-128**

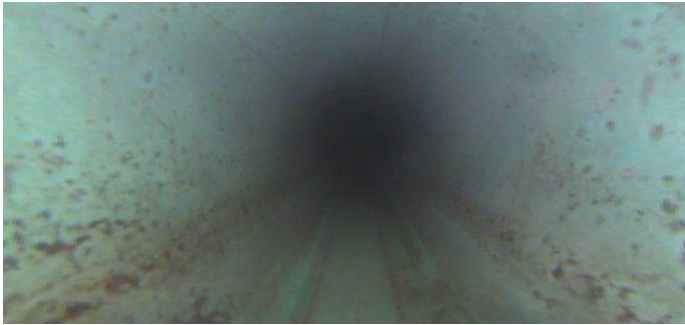
Code:	MWL
Description:	Water Level

Distance (ft):	.0
Structural Grade:	0
O&M Grade:	0
Clock Start/From:	
Clock To:	
1st Value:	
2nd Value:	
Value Percent:	5.000
Continuous Index:	
Within 8" of Joint:	NO
Remarks:

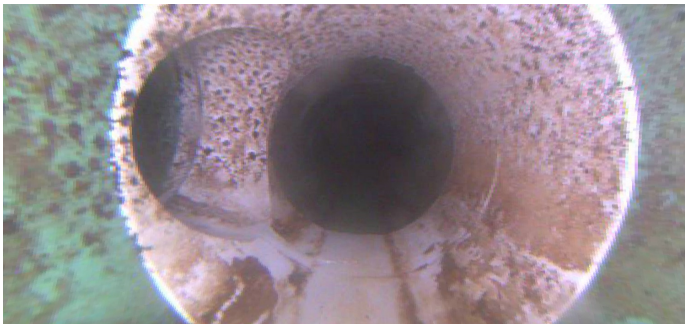
Code:	TF
Description:	Tap Factory

Distance (ft):	20.9
Structural Grade:	0
O&M Grade:	0
Clock Start/From:	9
Clock To:	
1st Value:	4.000
2nd Value:	
Value Percent:	
Continuous Index:	
Within 8" of Joint:	
Remarks:

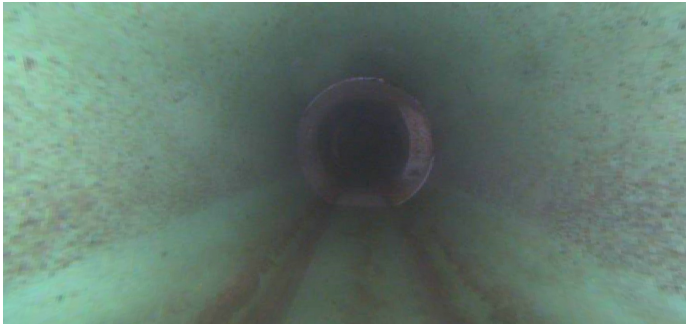
Code: **TF**
Description: **Tap Factory**

Distance (ft): **50.7**
Structural Grade: **0**
O&M Grade: **0**
Clock Start/From: **9**
Clock To:
1st Value: **4.000**
2nd Value:
Value Percent:
Continuous Index:
Within 8" of Joint:
Remarks:

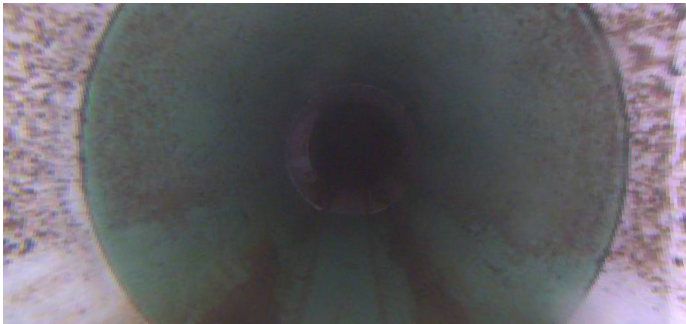
Code: **TF**
Description: **Tap Factory**

Distance (ft): **52.4**
Structural Grade: **0**
O&M Grade: **0**
Clock Start/From: **3**
Clock To:
1st Value: **4.000**
2nd Value:
Value Percent:
Continuous Index:
Within 8" of Joint:
Remarks:

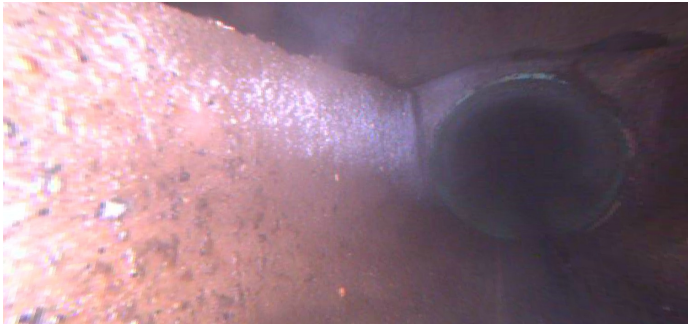
Code:	AMH
Description:	Manhole
Distance (ft):	83.1
Structural Grade:	0
O&M Grade:	0
Clock Start/From:	
Clock To:	
1st Value:	
2nd Value:	
Value Percent:	
Continuous Index:	
Within 8" of Joint:	NO
Remarks:	M-708-127
