## Profile/Photo Observation Report

Street:	<b>MAGNOLIA DR</b>	Flow Control:	<b>Not Controlled</b>
City:	<b>Hobart, IN</b>	Year Renewed:	
Location:	<b>Light Highway</b>	Tape/Media #:	
Purpose:	<b>Routine Assessment</b>	Dia/Height:	<b>8"</b>
Use:	<b>Sanitary</b>	Material:	<b>PVC</b>
Drain Area:	<b>NA</b>	Lining:	
Category:	<b>NA</b>		
Comment:

Location Details:		Direction of Survey:	<b>Downstream</b>
US MH:	<b>M-708-131</b>	DS MH:	<b>M-708-132</b>
		Total Length Surveyed (ft):	<b>133.5</b>

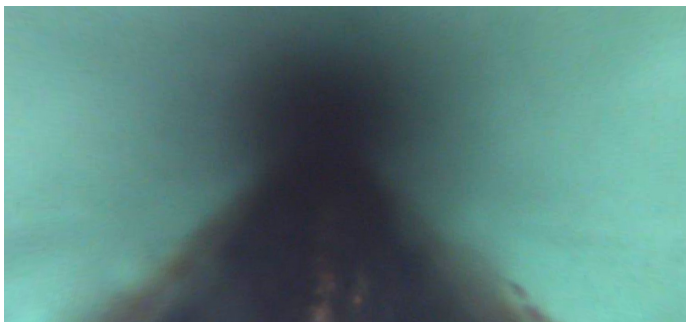
Code: **AMH**  
Description: **Manhole**

Distance (ft): **.0**  
Structural Grade: **0**  
O&M Grade: **0**  
Clock Start/From:  
Clock To:  
1st Value:  
2nd Value:  
Value Percent:  
Continuous Index:  
Within 8" of Joint: **NO**  
Remarks: **M-708-131**

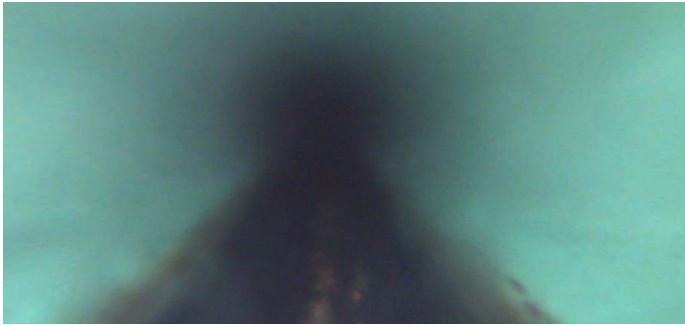
Code:	<b>MWL</b>
Description:	<b>Water Level</b>

Distance (ft):	<b>.0</b>
Structural Grade:	<b>0</b>
O&M Grade:	<b>0</b>
Clock Start/From:	
Clock To:	
1st Value:	
2nd Value:	
Value Percent:	<b>5.000</b>
Continuous Index:	
Within 8" of Joint:	<b>NO</b>
Remarks:

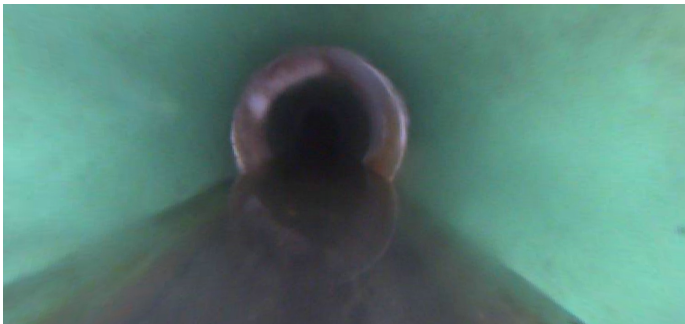
Code:	<b>TF</b>
Description:	<b>Tap Factory</b>

Distance (ft):	<b>62.1</b>
Structural Grade:	<b>0</b>
O&M Grade:	<b>0</b>
Clock Start/From:	<b>10</b>
Clock To:	
1st Value:	<b>4.000</b>
2nd Value:	
Value Percent:	
Continuous Index:	
Within 8" of Joint:	
Remarks:

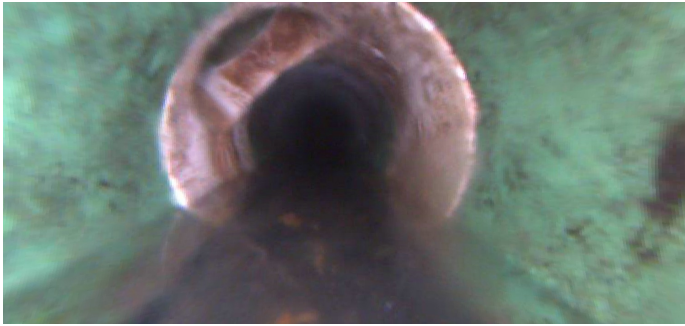
Code: **TF**  
Description: **Tap Factory**

Distance (ft): **121.1**  
Structural Grade: **0**  
O&M Grade: **0**  
Clock Start/From: **10**  
Clock To:  
1st Value: **4.000**  
2nd Value:  
Value Percent:  
Continuous Index:  
Within 8" of Joint:  
Remarks:

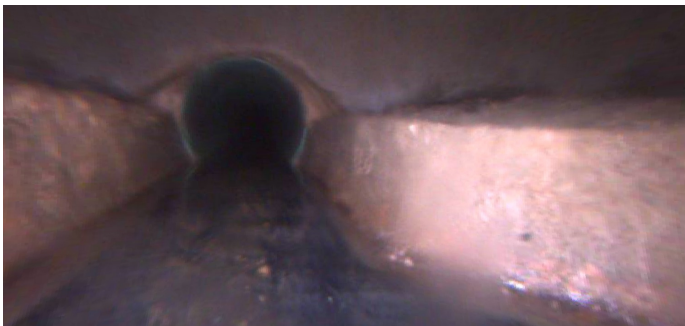
Code: **AMH**  
Description: **Manhole**

Distance (ft): **133.5**  
Structural Grade: **0**  
O&M Grade: **0**  
Clock Start/From:  
Clock To:  
1st Value:  
2nd Value:  
Value Percent:  
Continuous Index:  
Within 8" of Joint: **NO**  
Remarks: **M-708-132**
