Profile/Photo Observation Report

Street:	MAGNOLIA DR & HEATHER LN	Flow Control:	Not Controlled
City:	Hobart, IN	Year Renewed:	
Location:	Sidewalk	Tape/Media #:	
Purpose:	Maintenance Related	Dia/Height:	8"
Use:	Sanitary	Material:	PVC
Drain Area:	NA	Lining:	Cured in Place
Category:	NA		
Comment:	Flow direction wrong.

Location Details:		Direction of Survey:	Upstream
US MH:	M-708-132	DS MH:	M-708-133
		Total Length Surveyed (ft):	129.5

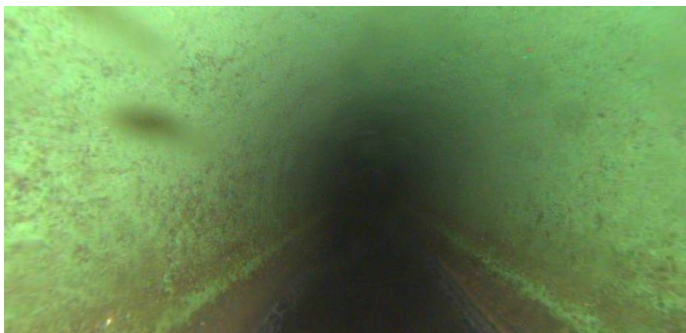
Code: **AMH**
Description: **Manhole**

Distance (ft): **.0**
Structural Grade: **0**
O&M Grade: **0**
Clock Start/From:
Clock To:
1st Value:
2nd Value:
Value Percent:
Continuous Index:
Within 8" of Joint: **NO**
Remarks: **M-708-133**

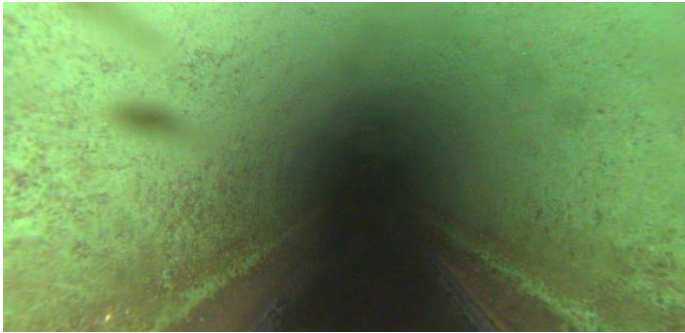
Code:	MWL
Description:	Water Level

Distance (ft):	.0
Structural Grade:	0
O&M Grade:	0
Clock Start/From:	
Clock To:	
1st Value:	
2nd Value:	
Value Percent:	5.000
Continuous Index:	
Within 8" of Joint:	NO
Remarks:

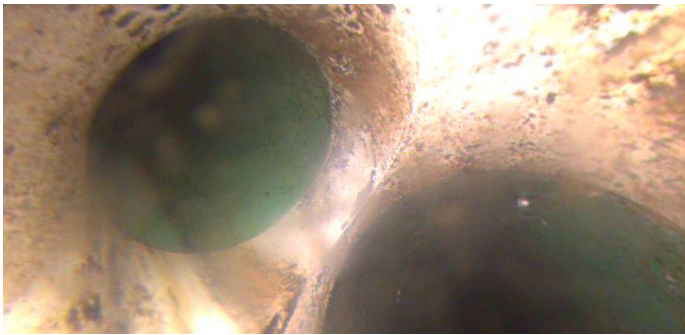
Code:	TF
Description:	Tap Factory

Distance (ft):	9.4
Structural Grade:	0
O&M Grade:	0
Clock Start/From:	2
Clock To:	
1st Value:	4.000
2nd Value:	
Value Percent:	
Continuous Index:	
Within 8" of Joint:	
Remarks:

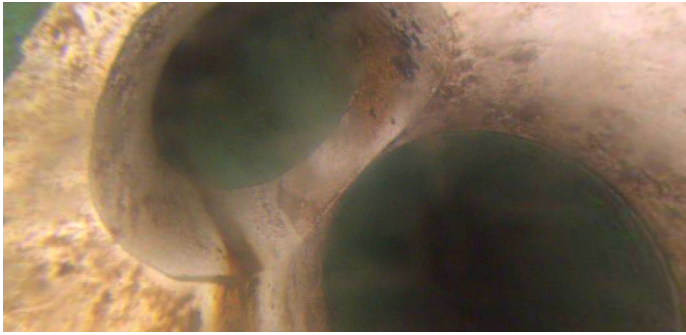
Code: **TF**
Description: **Tap Factory**

Distance (ft): **64.5**
Structural Grade: **0**
O&M Grade: **0**
Clock Start/From: **2**
Clock To:
1st Value: **4.000**
2nd Value:
Value Percent:
Continuous Index:
Within 8" of Joint:
Remarks:

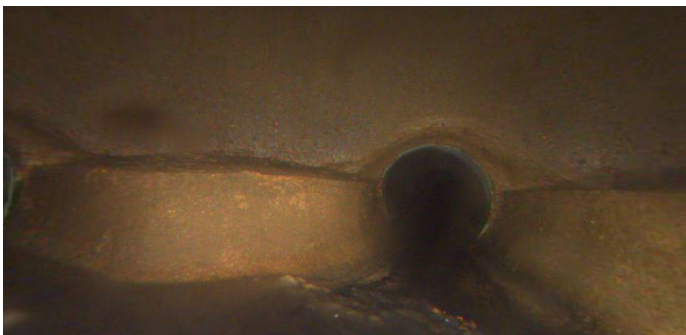
Code: **AMH**
Description: **Manhole**

Distance (ft): **129.5**
Structural Grade: **0**
O&M Grade: **0**
Clock Start/From:
Clock To:
1st Value:
2nd Value:
Value Percent:
Continuous Index:
Within 8" of Joint: **NO**
Remarks: **M-708-132**
