Profile/Photo Observation Report

Date:	10/21/2021	Weather:		Coding:	PACP 6.0
Pipe Length (ft):		Owner:	Hobart, IN	Pre Clean:	Not Known
P.O.#:	947_1	Surveyor:	M. Pielacha	PSR:	P-708-137-132
Customer:	Hobart, IN	Clean Date:		Shape:	C

Location Details:		Direction of Survey:	Downstream
US MH:	M-708-132	DS MH:	M-708-137
		Total Length Surveyed (ft):	172.9

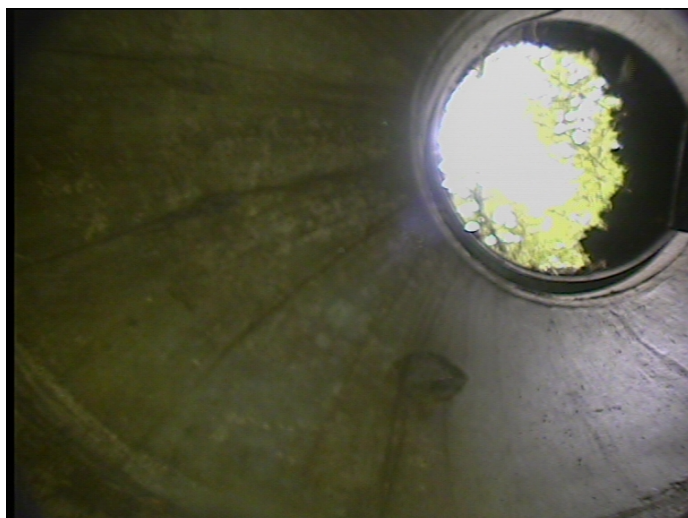
Code: **AMH**
Description: **Manhole**

Distance (ft): **.0**
Structural Grade: **0**
O&M Grade: **0**
Clock Start/From:
Clock To:
1st Value:
2nd Value:
Value Percent:
Continuous Index:
Within 8" of Joint: **NO**
Remarks: **M-708-132**

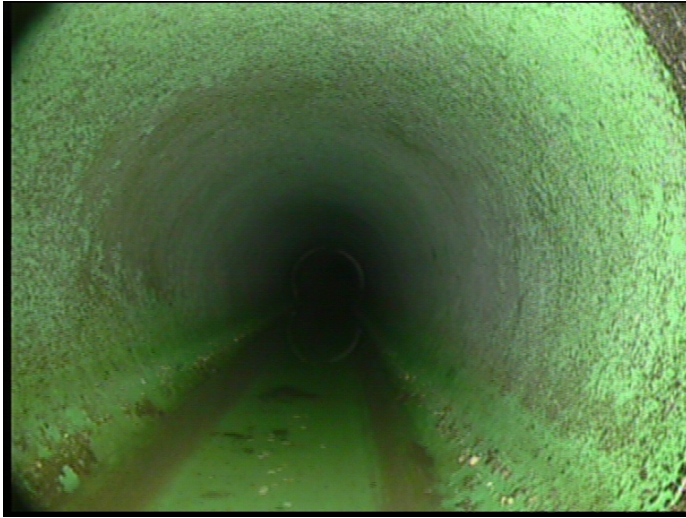
Code:	MWL
Description:	Water Level
Distance (ft):	.0
Structural Grade:	0
O&M Grade:	0
Clock Start/From:	
Clock To:	
1st Value:	
2nd Value:	
Value Percent:	5.000
Continuous Index:	
Within 8" of Joint:	NO
Remarks:

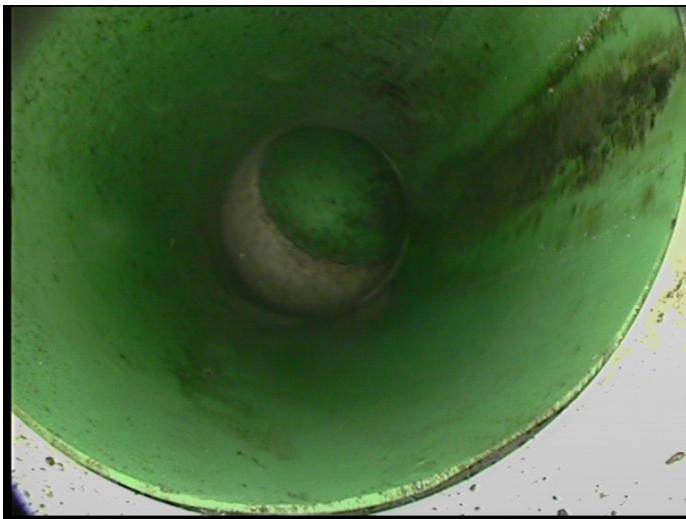
Code:	TF
Description:	Tap Factory
Distance (ft):	7.6
Structural Grade:	0
O&M Grade:	0
Clock Start/From:	3
Clock To:	
1st Value:	4.000
2nd Value:	
Value Percent:	
Continuous Index:	
Within 8" of Joint:	NO
Remarks:

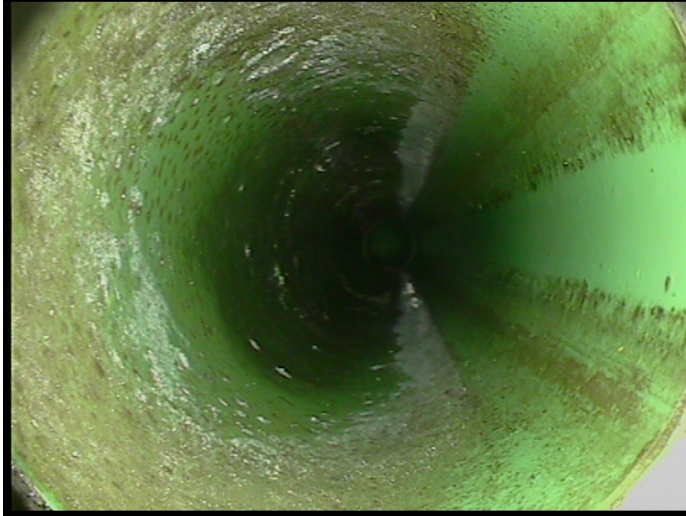
Code: **TF**
Description: **Tap Factory**

Distance (ft): **42.6**
Structural Grade: **0**
O&M Grade: **0**
Clock Start/From: **3**
Clock To:
1st Value: **4.000**
2nd Value:
Value Percent:
Continuous Index:
Within 8" of Joint: **NO**
Remarks:

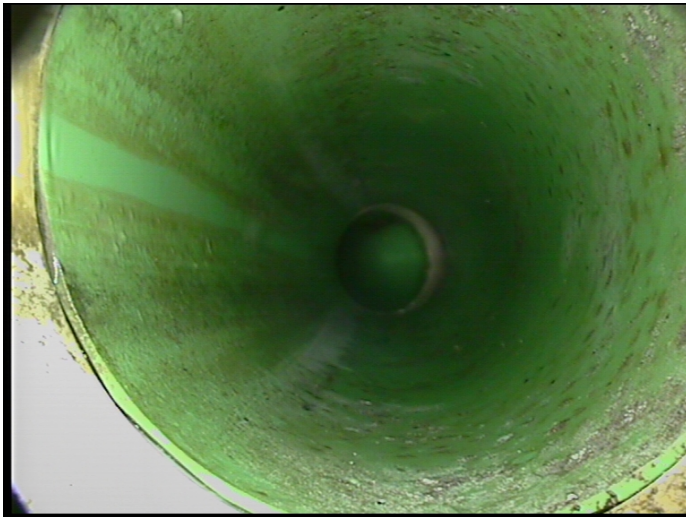
Code: **TF**
Description: **Tap Factory**

Distance (ft): **74.8**
Structural Grade: **0**
O&M Grade: **0**
Clock Start/From: **9**
Clock To:
1st Value: **4.000**
2nd Value:
Value Percent:
Continuous Index:
Within 8" of Joint: **NO**
Remarks:

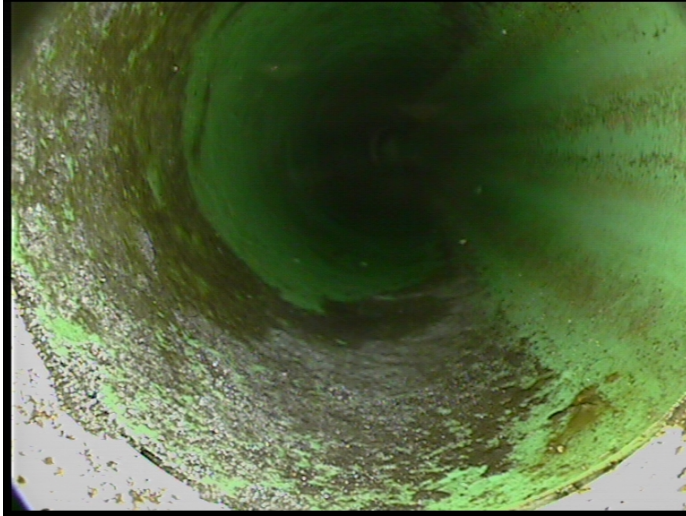
Code: **TF**
Description: **Tap Factory**

Distance (ft): **101.4**
Structural Grade: **0**
O&M Grade: **0**
Clock Start/From: **3**
Clock To:
1st Value: **4.000**
2nd Value:
Value Percent:
Continuous Index:
Within 8" of Joint: **NO**
Remarks:

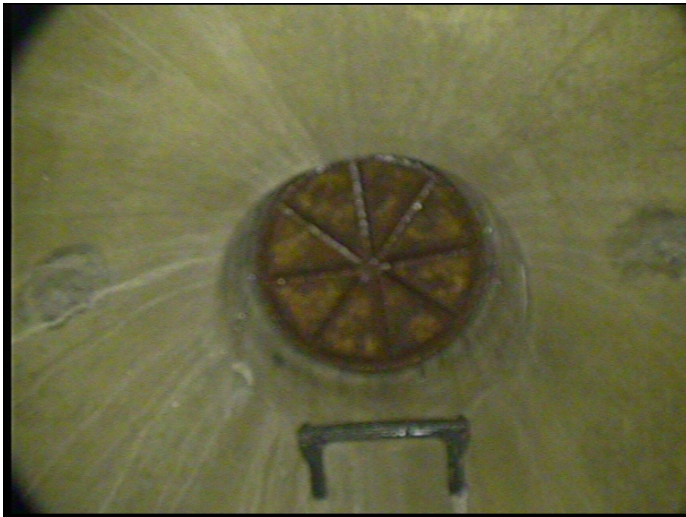
Code: **AMH**
Description: **Manhole**

Distance (ft): **172.9**
Structural Grade: **0**
O&M Grade: **0**
Clock Start/From:
Clock To:
1st Value:
2nd Value:
Value Percent:
Continuous Index:
Within 8" of Joint: **NO**
Remarks: **M-708-137**
