Profile/Photo Observation Report

Street:	Heather	Flow Control:	Not Controlled
City:	Hobart, IN	Year Renewed:	
Location:	Sidewalk	Tape/Media #:	
Purpose:	Maintenance Related	Dia/Height:	8"
Use:	Sanitary	Material:	PVC
Drain Area:	NA	Lining:	Cured in Place
Category:	NA		
Comment:	Flow direction wrong.

Location Details:		Direction of Survey:	Upstream
US MH:	M-708-137	DS MH:	M-708-138
		Total Length Surveyed (ft):	130.7

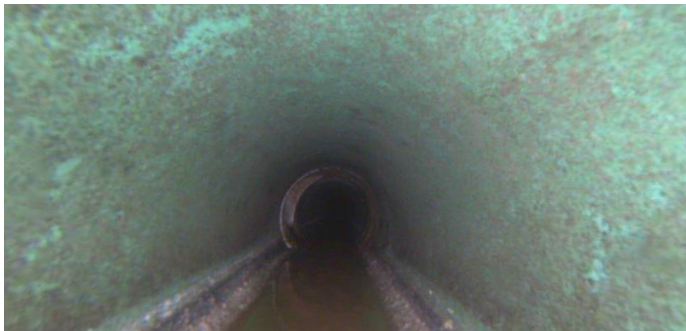
Code: **AMH**
Description: **Manhole**

Distance (ft): **.0**
Structural Grade: **0**
O&M Grade: **0**
Clock Start/From:
Clock To:
1st Value:
2nd Value:
Value Percent:
Continuous Index:
Within 8" of Joint: **NO**
Remarks: **M-708-138**

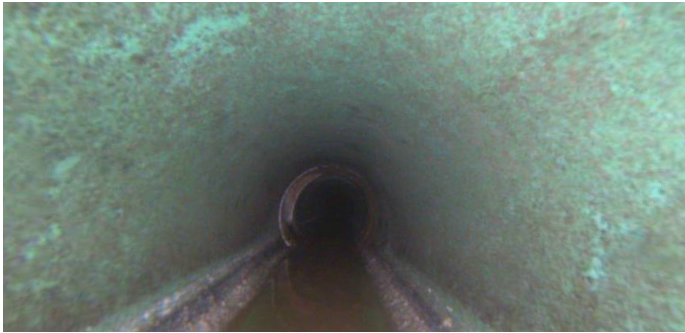
Code:	MWL
Description:	Water Level

Distance (ft):	.0
Structural Grade:	0
O&M Grade:	0
Clock Start/From:	
Clock To:	
1st Value:	
2nd Value:	
Value Percent:	5.000
Continuous Index:	
Within 8" of Joint:	NO
Remarks:

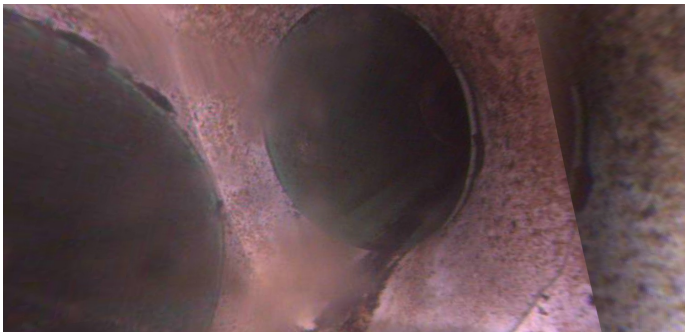
Code:	TF
Description:	Tap Factory

Distance (ft):	2.7
Structural Grade:	0
O&M Grade:	0
Clock Start/From:	10
Clock To:	
1st Value:	4.000
2nd Value:	
Value Percent:	
Continuous Index:	
Within 8" of Joint:	
Remarks:

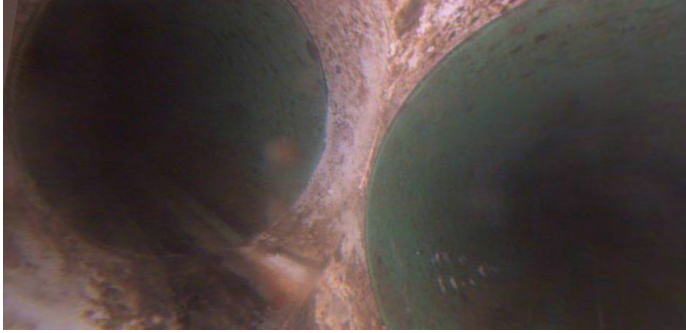
Code: **TF**
Description: **Tap Factory**

Distance (ft): **40.2**
Structural Grade: **0**
O&M Grade: **0**
Clock Start/From: **3**
Clock To:
1st Value: **4.000**
2nd Value:
Value Percent:
Continuous Index:
Within 8" of Joint:
Remarks:

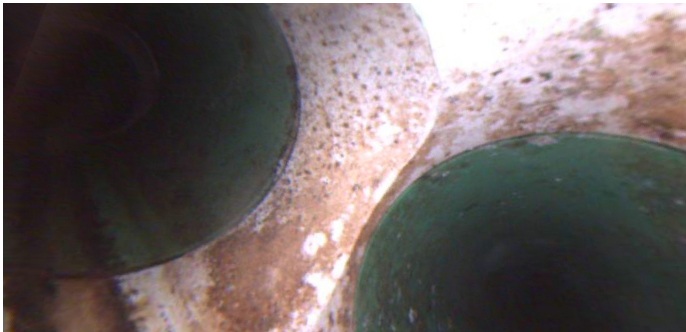
Code: **TF**
Description: **Tap Factory**

Distance (ft): **59.3**
Structural Grade: **0**
O&M Grade: **0**
Clock Start/From: **10**
Clock To:
1st Value: **4.000**
2nd Value:
Value Percent:
Continuous Index:
Within 8" of Joint:
Remarks:

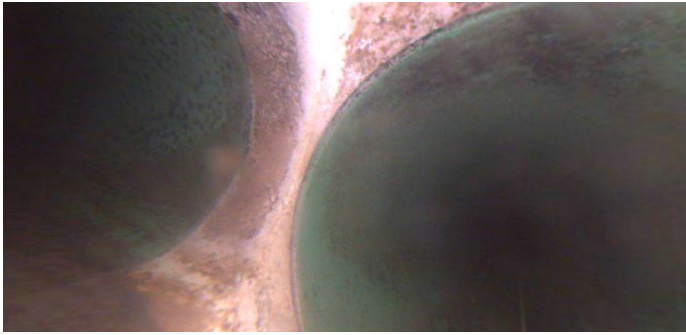
Code: **TF**
Description: **Tap Factory**

Distance (ft): **85.1**
Structural Grade: **0**
O&M Grade: **0**
Clock Start/From: **3**
Clock To:
1st Value: **4.000**
2nd Value:
Value Percent:
Continuous Index:
Within 8" of Joint:
Remarks:

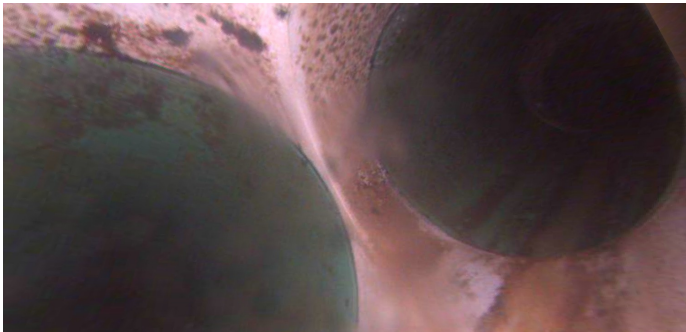
Code: **TF**
Description: **Tap Factory**

Distance (ft): **122.3**
Structural Grade: **0**
O&M Grade: **0**
Clock Start/From: **10**
Clock To:
1st Value: **4.000**
2nd Value:
Value Percent:
Continuous Index:
Within 8" of Joint:
Remarks:

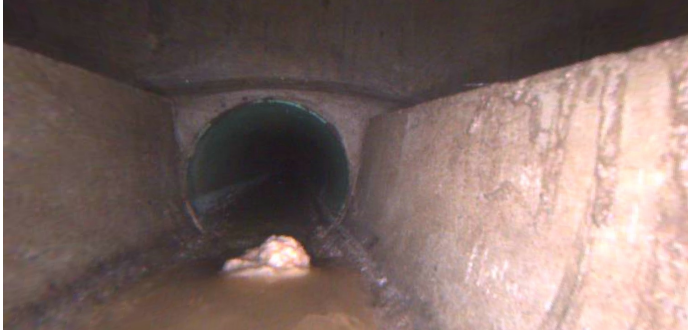
Code:	AMH
Description:	Manhole
Distance (ft):	130.7
Structural Grade:	0
O&M Grade:	0
Clock Start/From:	
Clock To:	
1st Value:	
2nd Value:	
Value Percent:	
Continuous Index:	
Within 8" of Joint:	NO
Remarks:	M-708-137
