Profile/Photo Observation Report

Date:	04/02/2018	Weather:		Coding:	PACP 6.0
Pipe Length (ft):	147.3	Owner:	NA	Pre Clean:	Not Known
P.O.#:		Surveyor:	Jen Costello	PSR:	P-708-139-138
Customer:		Clean Date:	01/01/1900	Shape:	C

Street:	HEATHER LN	Flow Control:	Not Controlled
City:	Hobart, IN	Year Renewed:	
Location:	Sidewalk	Tape/Media #:	
Purpose:	Maintenance Related	Dia/Height:	8"
Use:	Sanitary	Material:	PVC
Drain Area:	NA	Lining:	Cured in Place
Category:	NA		
Comment:	Flow direction wrong.

Location Details:		Direction of Survey:	Downstream
US MH:	M-708-138	DS MH:	M-708-139
		Total Length Surveyed (ft):	139.4

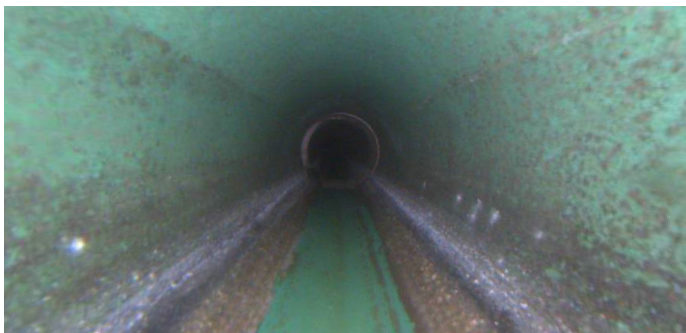
Code: **AMH**
Description: **Manhole**

Distance (ft): **.0**
Structural Grade: **0**
O&M Grade: **0**
Clock Start/From:
Clock To:
1st Value:
2nd Value:
Value Percent:
Continuous Index:
Within 8" of Joint: **NO**
Remarks: **M-708-138**

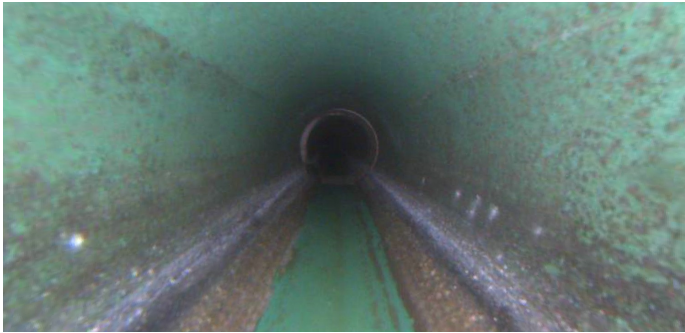
Code:	MWL
Description:	Water Level

Distance (ft):	.0
Structural Grade:	0
O&M Grade:	0
Clock Start/From:	
Clock To:	
1st Value:	
2nd Value:	
Value Percent:	5.000
Continuous Index:	
Within 8" of Joint:	NO
Remarks:

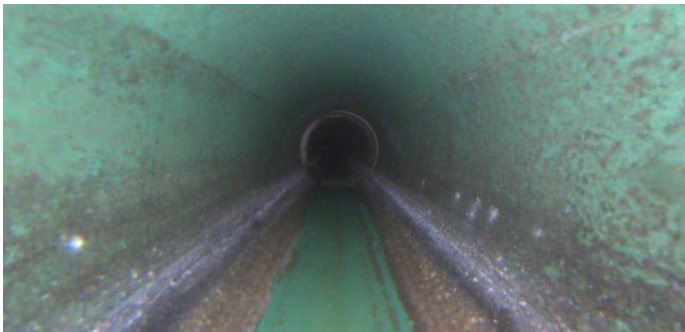
Code:	DAGS
Description:	Deposits Attached Grease

Distance (ft):	.0
Structural Grade:	0
O&M Grade:	2
Clock Start/From:	7
Clock To:	5
1st Value:	
2nd Value:	
Value Percent:	5.000
Continuous Index:	S01
Within 8" of Joint:	NO
Remarks:

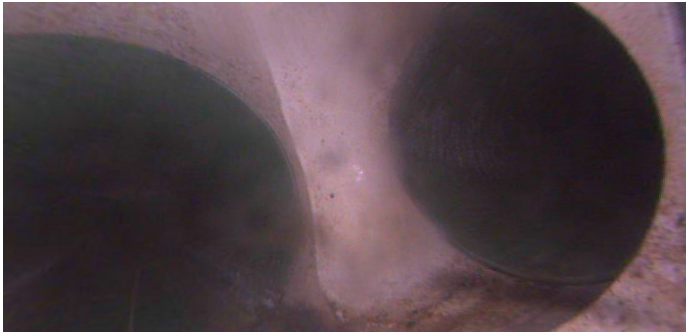
Code: **TF**
Description: **Tap Factory**

Distance (ft): **3.3**
Structural Grade: **0**
O&M Grade: **0**
Clock Start/From: **9**
Clock To:
1st Value: **4.000**
2nd Value:
Value Percent:
Continuous Index:
Within 8" of Joint:
Remarks:

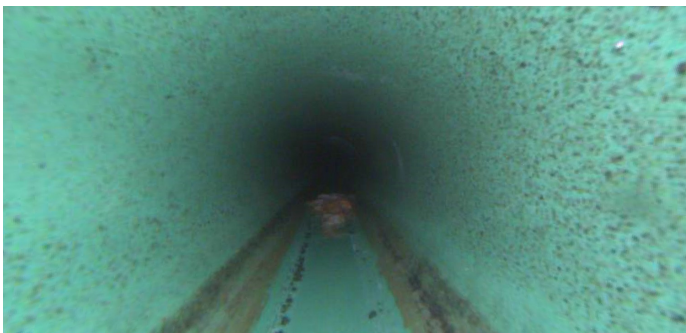
Code: **DAGS**
Description: **Deposits Attached Grease**

Distance (ft): **19.1**
Structural Grade: **0**
O&M Grade: **2**
Clock Start/From: **7**
Clock To: **5**
1st Value:
2nd Value:
Value Percent: **5.000**
Continuous Index: **F01**
Within 8" of Joint: **NO**
Remarks:

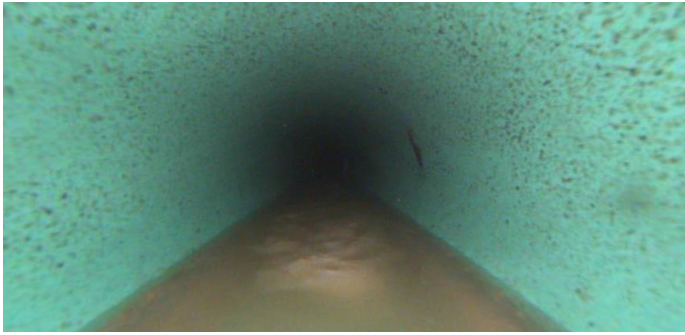
Code: **MWL**
Description: **Water Level**

Distance (ft): **35.3**
Structural Grade: **0**
O&M Grade: **0**
Clock Start/From:
Clock To:
1st Value:
2nd Value:
Value Percent: **20.000**
Continuous Index:
Within 8" of Joint: **NO**
Remarks:

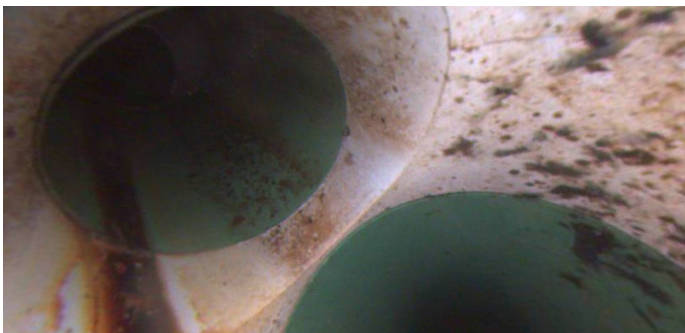
Code: **TF**
Description: **Tap Factory**

Distance (ft): **46.6**
Structural Grade: **0**
O&M Grade: **0**
Clock Start/From: **10**
Clock To:
1st Value: **4.000**
2nd Value:
Value Percent:
Continuous Index:
Within 8" of Joint:
Remarks:

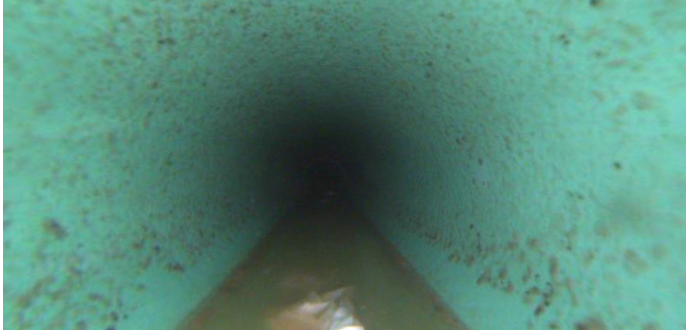
Code: **MWL**
Description: **Water Level**

Distance (ft): **61.0**
Structural Grade: **0**
O&M Grade: **0**
Clock Start/From:
Clock To:
1st Value:
2nd Value:
Value Percent: **5.000**
Continuous Index:
Within 8" of Joint: **NO**
Remarks:

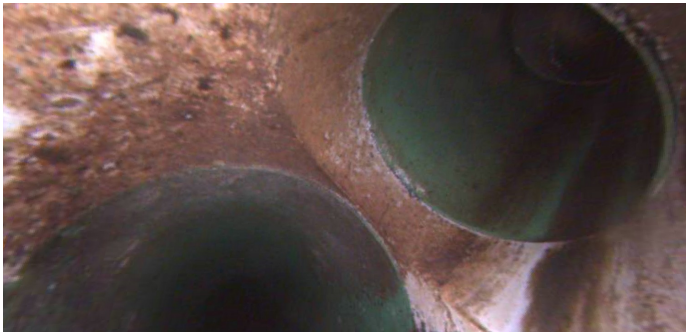
Code: **TF**
Description: **Tap Factory**

Distance (ft): **72.1**
Structural Grade: **0**
O&M Grade: **0**
Clock Start/From: **2**
Clock To:
1st Value: **4.000**
2nd Value:
Value Percent:
Continuous Index:
Within 8" of Joint:
Remarks:

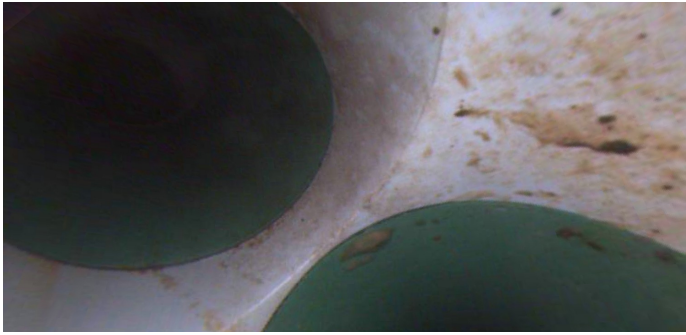
Code: **TF**
Description: **Tap Factory**

Distance (ft): **98.7**
Structural Grade: **0**
O&M Grade: **0**
Clock Start/From: **10**
Clock To:
1st Value: **4.000**
2nd Value:
Value Percent:
Continuous Index:
Within 8" of Joint:
Remarks:

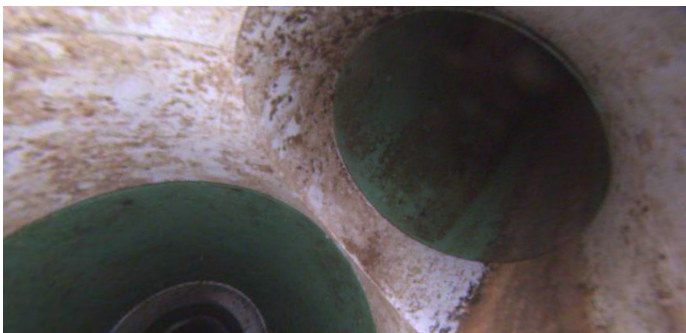
Code: **TF**
Description: **Tap Factory**

Distance (ft): **128.9**
Structural Grade: **0**
O&M Grade: **0**
Clock Start/From: **2**
Clock To:
1st Value: **4.000**
2nd Value:
Value Percent:
Continuous Index:
Within 8" of Joint:
Remarks:

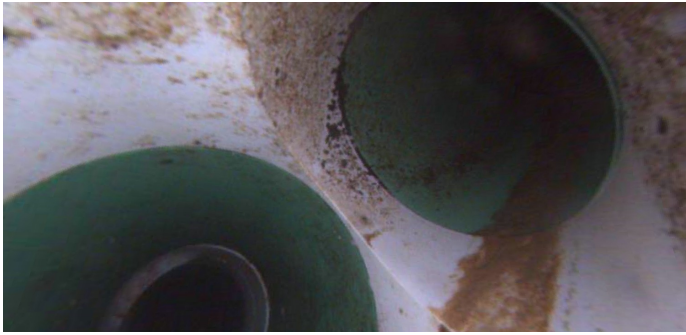
Code: **TF**
Description: **Tap Factory**

Distance (ft): **130.5**
Structural Grade: **0**
O&M Grade: **0**
Clock Start/From: **2**
Clock To:
1st Value: **4.000**
2nd Value:
Value Percent:
Continuous Index:
Within 8" of Joint:
Remarks:

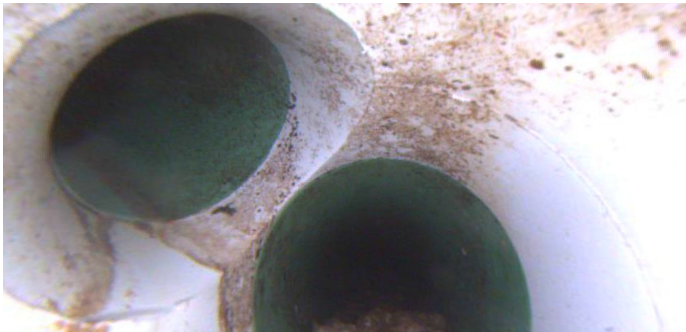
Code: **TF**
Description: **Tap Factory**

Distance (ft): **132.0**
Structural Grade: **0**
O&M Grade: **0**
Clock Start/From: **10**
Clock To:
1st Value: **4.000**
2nd Value:
Value Percent:
Continuous Index:
Within 8" of Joint:
Remarks:

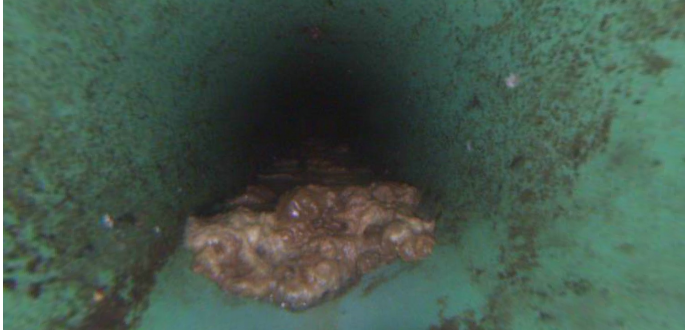
Code: **DSZ**
Description: **Deposits Settled Other**

Distance (ft): **132.7**
Structural Grade: **0**
O&M Grade: **3**
Clock Start/From: **4**
Clock To: **8**
1st Value:
2nd Value:
Value Percent: **20.000**
Continuous Index:
Within 8" of Joint: **NO**
Remarks: **misc**

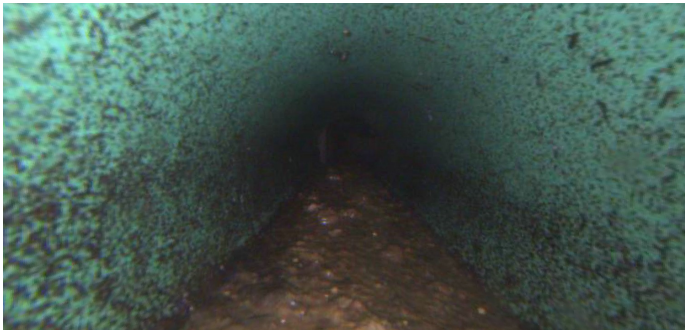
Code: **MWL**
Description: **Water Level**

Distance (ft): **134.9**
Structural Grade: **0**
O&M Grade: **0**
Clock Start/From:
Clock To:
1st Value:
2nd Value:
Value Percent: **10.000**
Continuous Index:
Within 8" of Joint: **NO**
Remarks:
