## Profile/Photo Observation Report

Date:	<b>04/02/2018</b>	Weather:		Coding:	<b>PACP 6.0</b>
Pipe Length (ft):	<b>147.3</b>	Owner:	<b>NA</b>	Pre Clean:	<b>Not Known</b>
P.O.#:		Surveyor:	<b>Jen Costello</b>	PSR:	<b>P-708-139-138</b>
Customer:		Clean Date:	<b>01/01/1900</b>	Shape:	<b>C</b>

Street:	<b>Heather</b>	Flow Control:	<b>Not Controlled</b>
City:	<b>Hobart, IN</b>	Year Renewed:	
Location:	<b>Sidewalk</b>	Tape/Media #:	
Purpose:	<b>Maintenance Related</b>	Dia/Height:	<b>8"</b>
Use:	<b>Sanitary</b>	Material:	<b>PVC</b>
Drain Area:	<b>NA</b>	Lining:	<b>Cured in Place</b>
Category:	<b>NA</b>		
Comment:	<b>Flow direction wrong.</b>

Location Details:		Direction of Survey:	<b>Downstream</b>
US MH:	<b>M-708-138</b>	DS MH:	<b>M-708-139</b>
		Total Length Surveyed (ft):	<b>139.4</b>

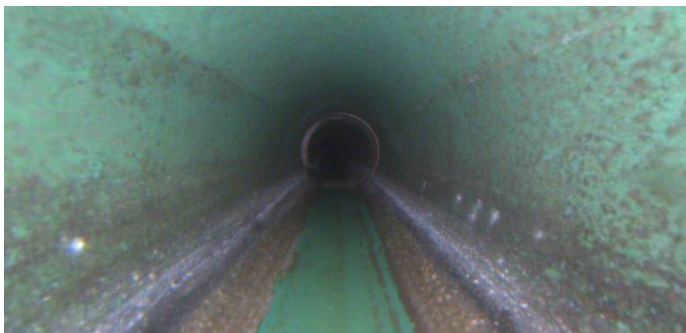
Code: **AMH**  
Description: **Manhole**

Distance (ft): **.0**  
Structural Grade: **0**  
O&M Grade: **0**  
Clock Start/From:  
Clock To:  
1st Value:  
2nd Value:  
Value Percent:  
Continuous Index:  
Within 8" of Joint: **NO**  
Remarks: **M-708-138**

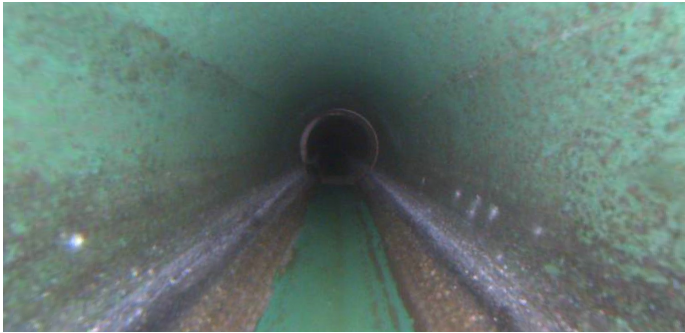
Code:	<b>MWL</b>
Description:	<b>Water Level</b>

Distance (ft):	<b>.0</b>
Structural Grade:	<b>0</b>
O&M Grade:	<b>0</b>
Clock Start/From:	
Clock To:	
1st Value:	
2nd Value:	
Value Percent:	<b>5.000</b>
Continuous Index:	
Within 8" of Joint:	<b>NO</b>
Remarks:

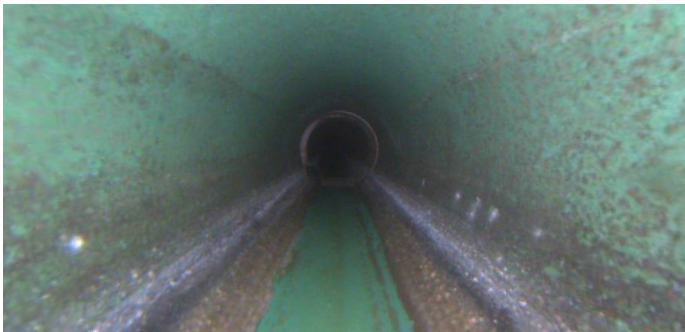
Code:	<b>DAGS</b>
Description:	<b>Deposits Attached Grease</b>

Distance (ft):	<b>.0</b>
Structural Grade:	<b>0</b>
O&M Grade:	<b>2</b>
Clock Start/From:	<b>7</b>
Clock To:	<b>5</b>
1st Value:	
2nd Value:	
Value Percent:	<b>5.000</b>
Continuous Index:	<b>S01</b>
Within 8" of Joint:	<b>NO</b>
Remarks:

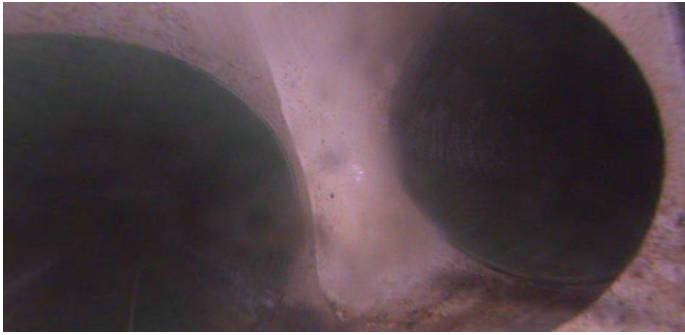
Code: **TF**  
Description: **Tap Factory**

Distance (ft): **3.3**  
Structural Grade: **0**  
O&M Grade: **0**  
Clock Start/From: **9**  
Clock To:  
1st Value: **4.000**  
2nd Value:  
Value Percent:  
Continuous Index:  
Within 8" of Joint:  
Remarks:

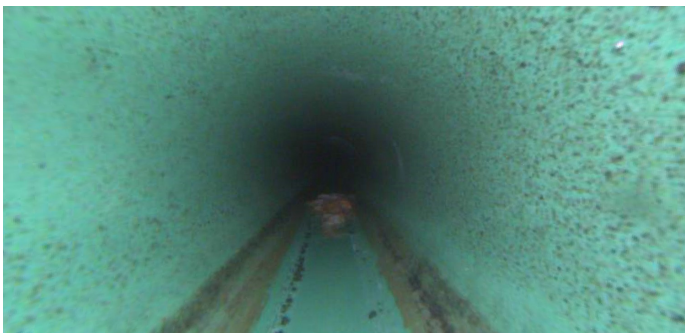
Code: **DAGS**  
Description: **Deposits Attached Grease**

Distance (ft): **19.1**  
Structural Grade: **0**  
O&M Grade: **2**  
Clock Start/From: **7**  
Clock To: **5**  
1st Value:  
2nd Value:  
Value Percent: **5.000**  
Continuous Index: **F01**  
Within 8" of Joint: **NO**  
Remarks:

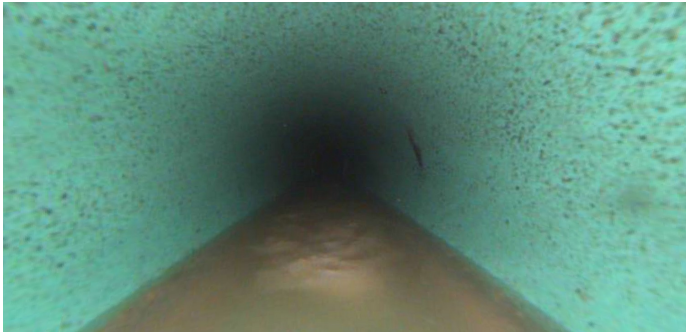
Code: **MWL**  
Description: **Water Level**

Distance (ft): **35.3**  
Structural Grade: **0**  
O&M Grade: **0**  
Clock Start/From:  
Clock To:  
1st Value:  
2nd Value:  
Value Percent: **20.000**  
Continuous Index:  
Within 8" of Joint: **NO**  
Remarks:

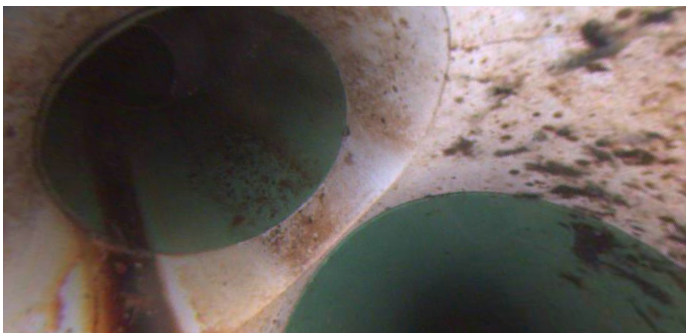
Code: **TF**  
Description: **Tap Factory**

Distance (ft): **46.6**  
Structural Grade: **0**  
O&M Grade: **0**  
Clock Start/From: **10**  
Clock To:  
1st Value: **4.000**  
2nd Value:  
Value Percent:  
Continuous Index:  
Within 8" of Joint:  
Remarks:

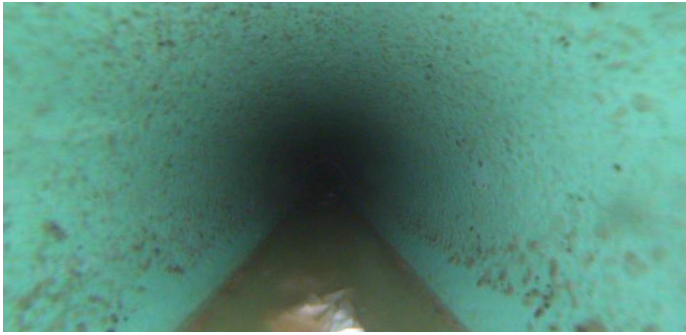
Code: **MWL**  
Description: **Water Level**

Distance (ft): **61.0**  
Structural Grade: **0**  
O&M Grade: **0**  
Clock Start/From:  
Clock To:  
1st Value:  
2nd Value:  
Value Percent: **5.000**  
Continuous Index:  
Within 8" of Joint: **NO**  
Remarks:

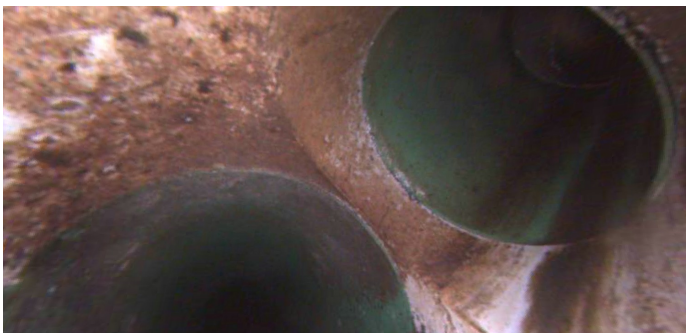
Code: **TF**  
Description: **Tap Factory**

Distance (ft): **72.1**  
Structural Grade: **0**  
O&M Grade: **0**  
Clock Start/From: **2**  
Clock To:  
1st Value: **4.000**  
2nd Value:  
Value Percent:  
Continuous Index:  
Within 8" of Joint:  
Remarks:

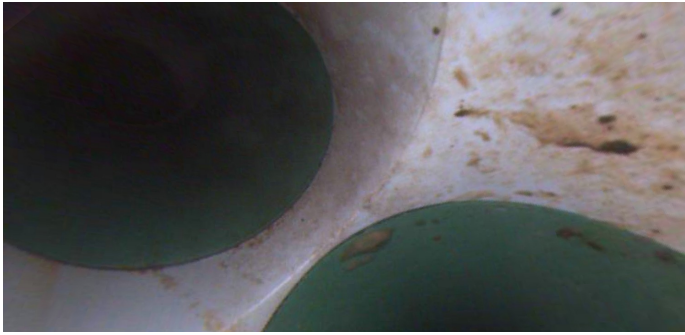
Code: **TF**  
Description: **Tap Factory**

Distance (ft): **98.7**  
Structural Grade: **0**  
O&M Grade: **0**  
Clock Start/From: **10**  
Clock To:  
1st Value: **4.000**  
2nd Value:  
Value Percent:  
Continuous Index:  
Within 8" of Joint:  
Remarks:

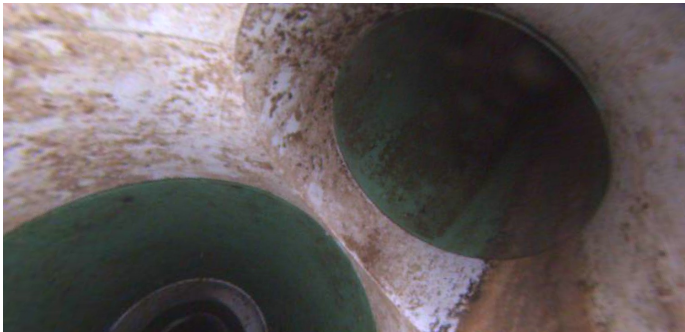
Code: **TF**  
Description: **Tap Factory**

Distance (ft): **128.9**  
Structural Grade: **0**  
O&M Grade: **0**  
Clock Start/From: **2**  
Clock To:  
1st Value: **4.000**  
2nd Value:  
Value Percent:  
Continuous Index:  
Within 8" of Joint:  
Remarks:

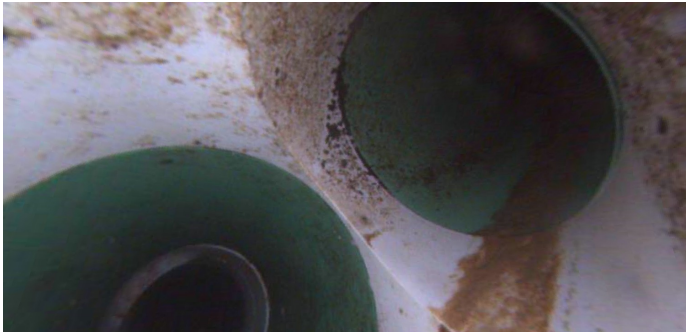
Code: **TF**  
Description: **Tap Factory**

Distance (ft): **130.5**  
Structural Grade: **0**  
O&M Grade: **0**  
Clock Start/From: **2**  
Clock To:  
1st Value: **4.000**  
2nd Value:  
Value Percent:  
Continuous Index:  
Within 8" of Joint:  
Remarks:

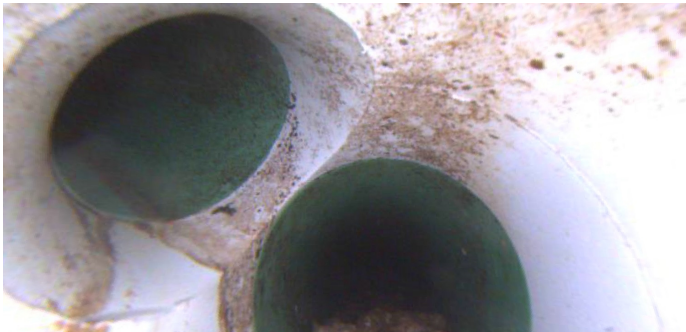
Code: **TF**  
Description: **Tap Factory**

Distance (ft): **132.0**  
Structural Grade: **0**  
O&M Grade: **0**  
Clock Start/From: **10**  
Clock To:  
1st Value: **4.000**  
2nd Value:  
Value Percent:  
Continuous Index:  
Within 8" of Joint:  
Remarks:

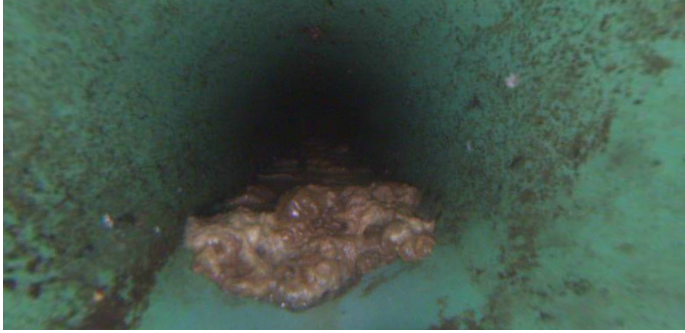
Code: **DSZ**  
Description: **Deposits Settled Other**

Distance (ft): **132.7**  
Structural Grade: **0**  
O&M Grade: **3**  
Clock Start/From: **4**  
Clock To: **8**  
1st Value:  
2nd Value:  
Value Percent: **20.000**  
Continuous Index:  
Within 8" of Joint: **NO**  
Remarks: **misc**

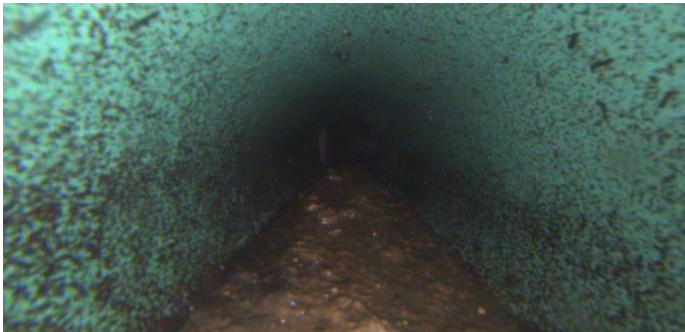
Code: **MWL**  
Description: **Water Level**

Distance (ft): **134.9**  
Structural Grade: **0**  
O&M Grade: **0**  
Clock Start/From:  
Clock To:  
1st Value:  
2nd Value:  
Value Percent: **10.000**  
Continuous Index:  
Within 8" of Joint: **NO**  
Remarks:
