## Profile/Photo Observation Report

Street:	<b>LAKE ST</b>	Flow Control:	<b>Not Controlled</b>
City:	<b>Hobart, IN</b>	Year Renewed:	
Location:	<b>Light Highway</b>	Tape/Media #:	
Purpose:	<b>Maintenance Related</b>	Dia/Height:	<b>8"</b>
Use:	<b>Sanitary</b>	Material:	<b>PVC</b>
Drain Area:	<b>NA</b>	Lining:	<b>Cured in Place</b>
Category:	<b>NA</b>		
Comment:

Location Details:		Direction of Survey:	<b>Upstream</b>
US MH:	<b>M-708-142</b>	DS MH:	<b>M-708-143</b>
		Total Length Surveyed (ft):	<b>99.2</b>

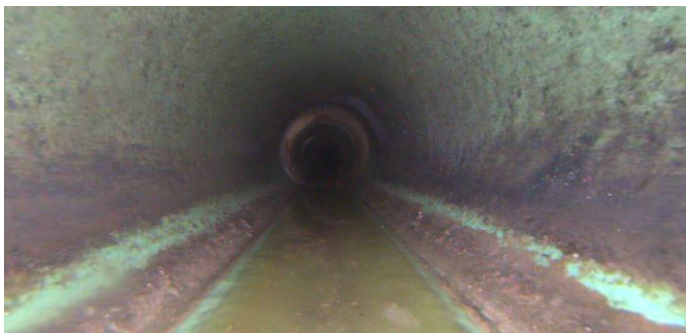
Code: **AMH**  
Description: **Manhole**

Distance (ft): **.0**  
Structural Grade: **0**  
O&M Grade: **0**  
Clock Start/From:  
Clock To:  
1st Value:  
2nd Value:  
Value Percent:  
Continuous Index:  
Within 8" of Joint: **NO**  
Remarks: **M-708-143**

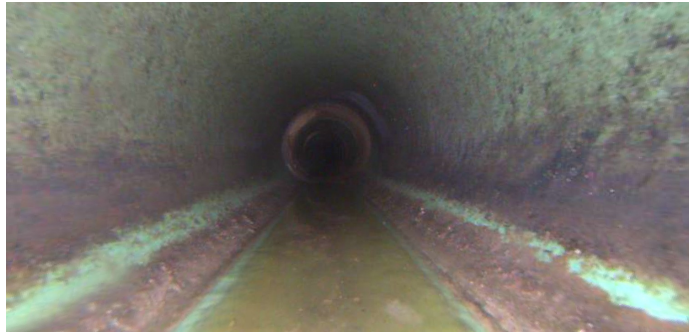
Code: **MWL**  
Description: **Water Level**

Distance (ft): **.0**  
Structural Grade: **0**  
O&M Grade: **0**  
Clock Start/From:  
Clock To:  
1st Value:  
2nd Value:  
Value Percent: **5.000**  
Continuous Index:  
Within 8" of Joint: **NO**  
Remarks:

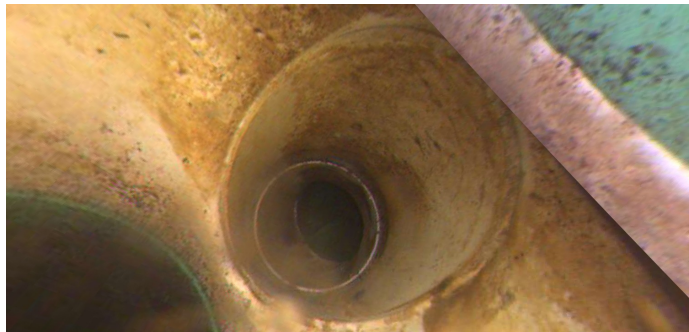
Code: **TF**  
Description: **Tap Factory**

Distance (ft): **4.5**  
Structural Grade: **0**  
O&M Grade: **0**  
Clock Start/From: **10**  
Clock To:  
1st Value: **4.000**  
2nd Value:  
Value Percent:  
Continuous Index:  
Within 8" of Joint:  
Remarks:

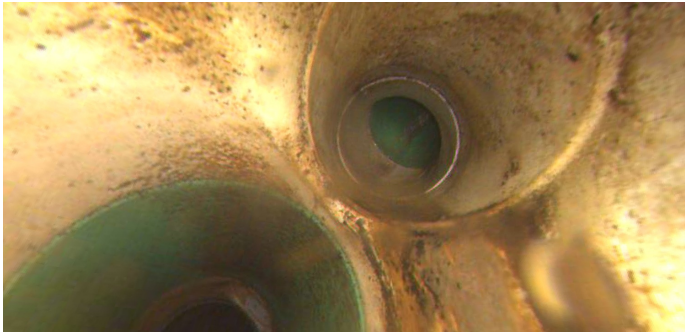
Code: **TF**  
Description: **Tap Factory**

Distance (ft): **6.9**  
Structural Grade: **0**  
O&M Grade: **0**  
Clock Start/From: **10**  
Clock To:  
1st Value: **4.000**  
2nd Value:  
Value Percent:  
Continuous Index:  
Within 8" of Joint:  
Remarks:

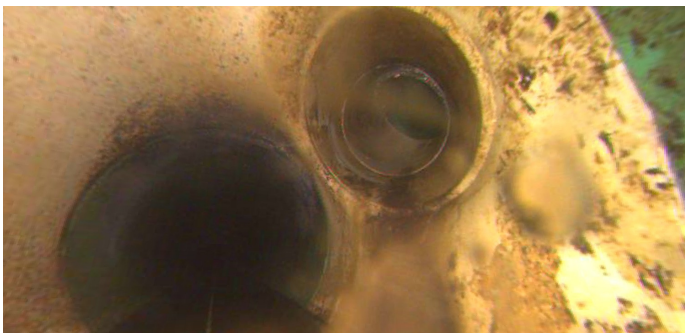
Code: **TF**  
Description: **Tap Factory**

Distance (ft): **66.8**  
Structural Grade: **0**  
O&M Grade: **0**  
Clock Start/From: **10**  
Clock To:  
1st Value: **4.000**  
2nd Value:  
Value Percent:  
Continuous Index:  
Within 8" of Joint:  
Remarks:

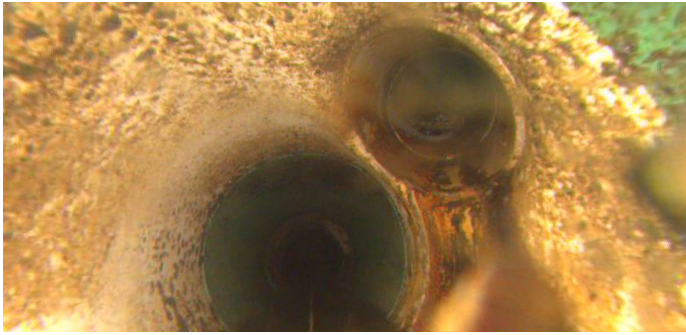
Code: **TF**  
Description: **Tap Factory**

Distance (ft): **69.8**  
Structural Grade: **0**  
O&M Grade: **0**  
Clock Start/From: **10**  
Clock To:  
1st Value: **4.000**  
2nd Value:  
Value Percent:  
Continuous Index:  
Within 8" of Joint:  
Remarks:

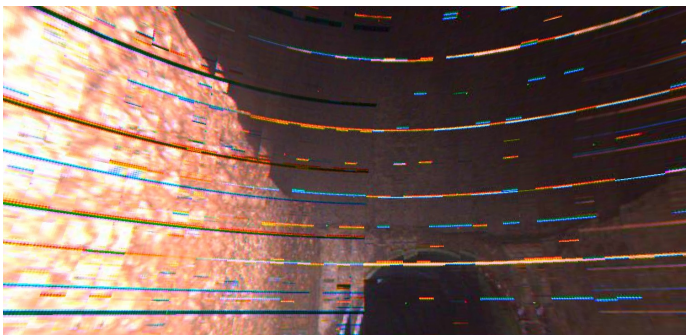
Code: **AMH**  
Description: **Manhole**

Distance (ft): **99.2**  
Structural Grade: **0**  
O&M Grade: **0**  
Clock Start/From:  
Clock To:  
1st Value:  
2nd Value:  
Value Percent:  
Continuous Index:  
Within 8" of Joint: **NO**  
Remarks: **M-708-142**
