Profile/Photo Observation Report

Date:	03/31/2018	Weather:		Coding:	PACP 6.0
Pipe Length (ft):	101.1	Owner:	NA	Pre Clean:	Not Known
P.O.#:		Surveyor:	Jen Costello	PSR:	P-708-143-142
Customer:		Clean Date:	01/01/1900	Shape:	C

Street:	Lake	Flow Control:	Not Controlled
City:	Hobart, IN	Year Renewed:	
Location:	Light Highway	Tape/Media #:	
Purpose:	Maintenance Related	Dia/Height:	8"
Use:	Sanitary	Material:	PVC
Drain Area:	NA	Lining:	Cured in Place
Category:	NA		
Comment:

Location Details:		Direction of Survey:	Upstream
US MH:	M-708-142	DS MH:	M-708-143
		Total Length Surveyed (ft):	99.2

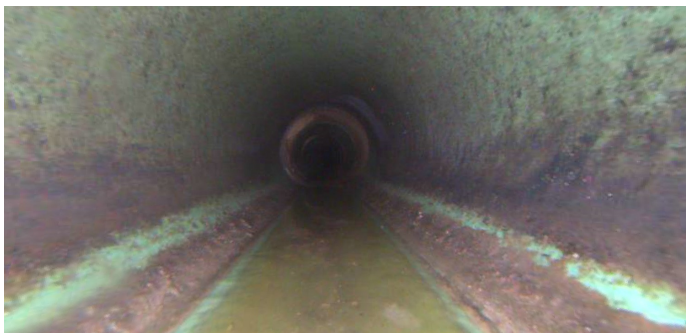
Code: **AMH**
Description: **Manhole**

Distance (ft): **.0**
Structural Grade: **0**
O&M Grade: **0**
Clock Start/From:
Clock To:
1st Value:
2nd Value:
Value Percent:
Continuous Index:
Within 8" of Joint: **NO**
Remarks: **M-708-143**

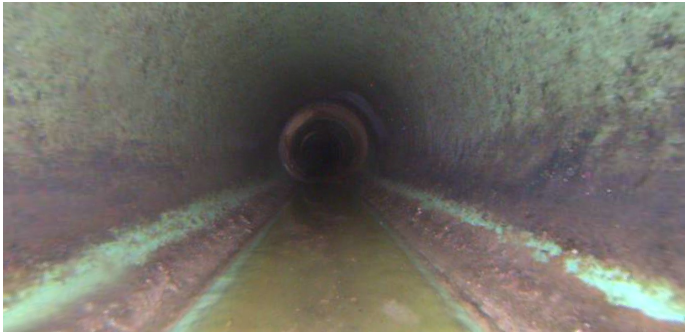
Code:	MWL
Description:	Water Level

Distance (ft):	.0
Structural Grade:	0
O&M Grade:	0
Clock Start/From:	
Clock To:	
1st Value:	
2nd Value:	
Value Percent:	5.000
Continuous Index:	
Within 8" of Joint:	NO
Remarks:

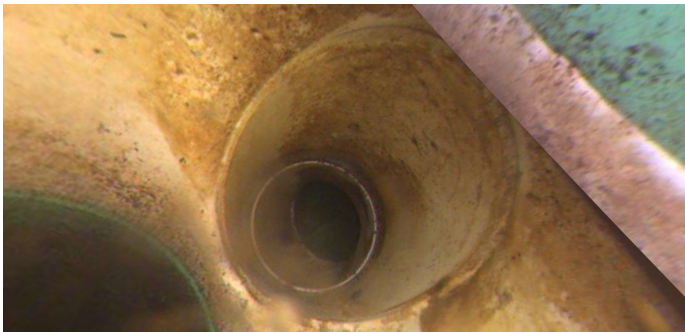
Code:	TF
Description:	Tap Factory

Distance (ft):	4.5
Structural Grade:	0
O&M Grade:	0
Clock Start/From:	10
Clock To:	
1st Value:	4.000
2nd Value:	
Value Percent:	
Continuous Index:	
Within 8" of Joint:	
Remarks:

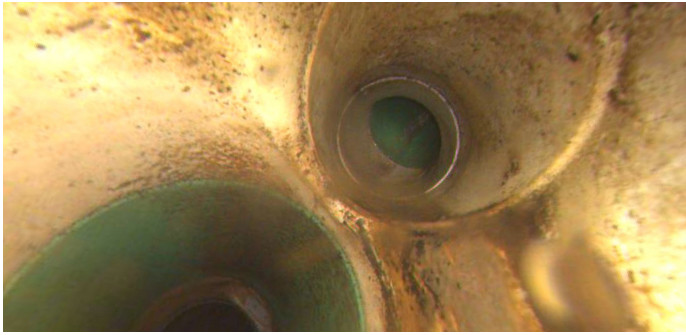
Code: **TF**
Description: **Tap Factory**

Distance (ft): **6.9**
Structural Grade: **0**
O&M Grade: **0**
Clock Start/From: **10**
Clock To:
1st Value: **4.000**
2nd Value:
Value Percent:
Continuous Index:
Within 8" of Joint:
Remarks:

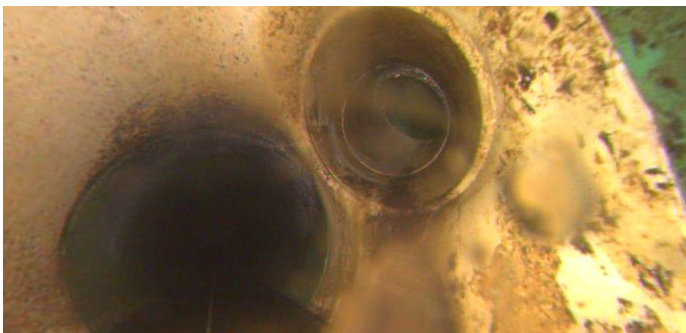
Code: **TF**
Description: **Tap Factory**

Distance (ft): **66.8**
Structural Grade: **0**
O&M Grade: **0**
Clock Start/From: **10**
Clock To:
1st Value: **4.000**
2nd Value:
Value Percent:
Continuous Index:
Within 8" of Joint:
Remarks:

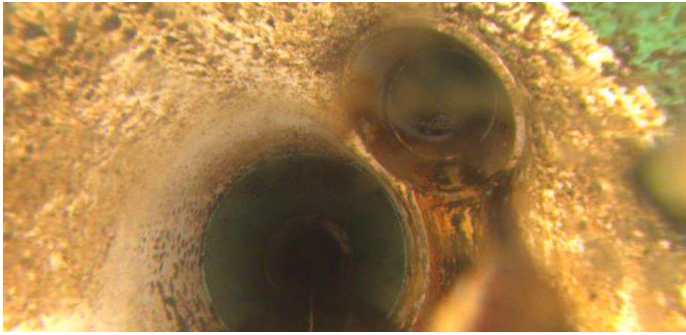
Code: **TF**
Description: **Tap Factory**

Distance (ft): **69.8**
Structural Grade: **0**
O&M Grade: **0**
Clock Start/From: **10**
Clock To:
1st Value: **4.000**
2nd Value:
Value Percent:
Continuous Index:
Within 8" of Joint:
Remarks:

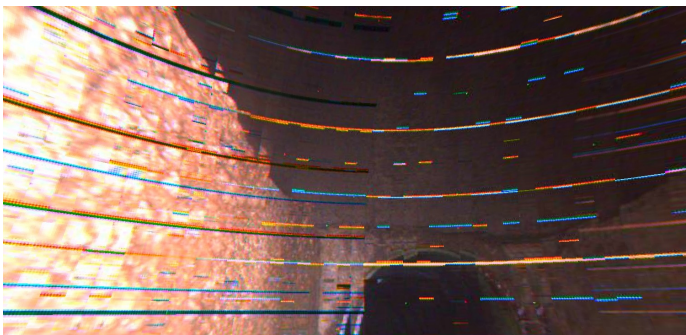
Code: **AMH**
Description: **Manhole**

Distance (ft): **99.2**
Structural Grade: **0**
O&M Grade: **0**
Clock Start/From:
Clock To:
1st Value:
2nd Value:
Value Percent:
Continuous Index:
Within 8" of Joint: **NO**
Remarks: **M-708-142**
