## Profile/Photo Observation Report

Street:	<b>LAKE ST</b>	Flow Control:	<b>Not Controlled</b>
City:	<b>Hobart, IN</b>	Year Renewed:	
Location:	<b>Light Highway</b>	Tape/Media #:	
Purpose:	<b>Maintenance Related</b>	Dia/Height:	<b>8"</b>
Use:	<b>Sanitary</b>	Material:	<b>PVC</b>
Drain Area:	<b>NA</b>	Lining:	<b>Cured in Place</b>
Category:	<b>NA</b>		
Comment:	<b>Flow direction wrong.</b>

Location Details:		Direction of Survey:	<b>Downstream</b>
US MH:	<b>M-708-143</b>	DS MH:	<b>M-708-144</b>
		Total Length Surveyed (ft):	<b>95.5</b>

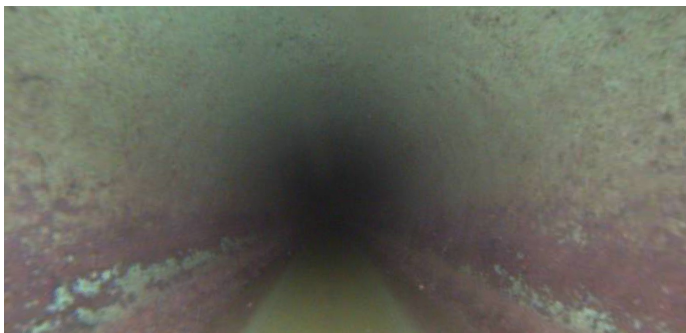
Code: **AMH**  
Description: **Manhole**

Distance (ft): **.0**  
Structural Grade: **0**  
O&M Grade: **0**  
Clock Start/From:  
Clock To:  
1st Value:  
2nd Value:  
Value Percent:  
Continuous Index:  
Within 8" of Joint: **NO**  
Remarks: **M-708-143**

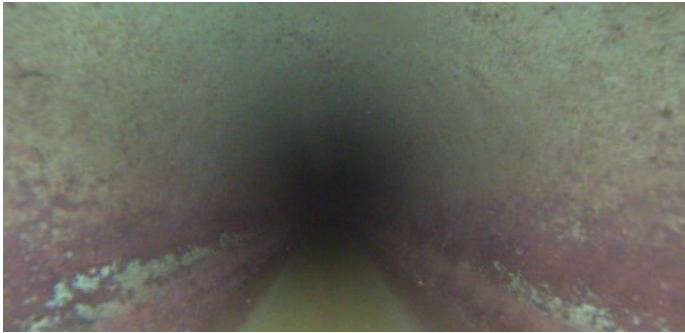
Code:	<b>MWL</b>
Description:	<b>Water Level</b>

Distance (ft):	<b>.0</b>
Structural Grade:	<b>0</b>
O&M Grade:	<b>0</b>
Clock Start/From:	
Clock To:	
1st Value:	
2nd Value:	
Value Percent:	<b>5.000</b>
Continuous Index:	
Within 8" of Joint:	<b>NO</b>
Remarks:

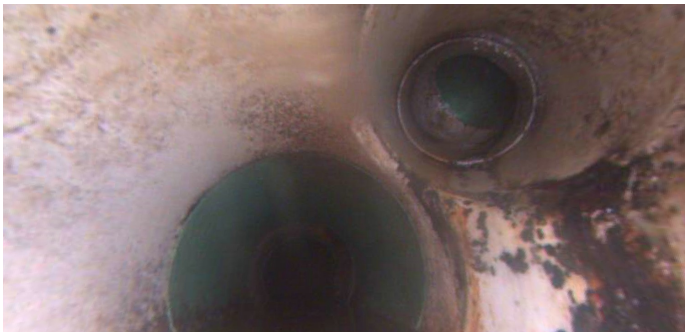
Code:	<b>TF</b>
Description:	<b>Tap Factory</b>

Distance (ft):	<b>42.2</b>
Structural Grade:	<b>0</b>
O&M Grade:	<b>0</b>
Clock Start/From:	<b>2</b>
Clock To:	
1st Value:	<b>4.000</b>
2nd Value:	
Value Percent:	
Continuous Index:	
Within 8" of Joint:	
Remarks:

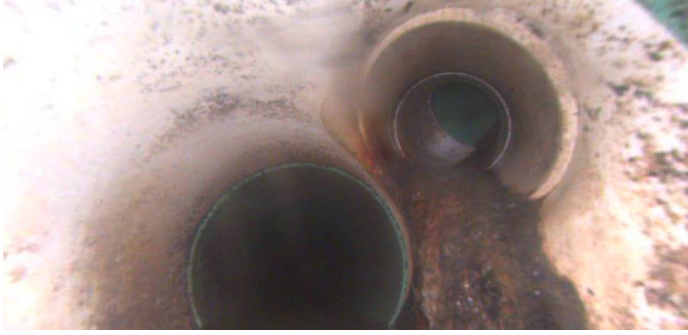
Code: **TF**  
Description: **Tap Factory**

Distance (ft): **44.3**  
Structural Grade: **0**  
O&M Grade: **0**  
Clock Start/From: **2**  
Clock To:  
1st Value: **4.000**  
2nd Value:  
Value Percent:  
Continuous Index:  
Within 8" of Joint:  
Remarks:

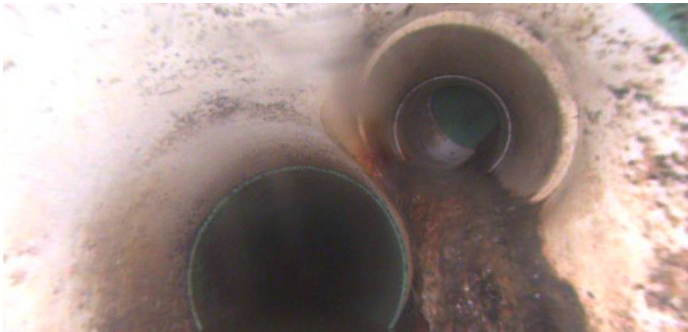
Code: **DAE**  
Description: **Deposits Attached Encrustation**

Distance (ft): **44.3**  
Structural Grade: **0**  
O&M Grade: **2**  
Clock Start/From: **2**  
Clock To: **4**  
1st Value:  
2nd Value:  
Value Percent: **5.000**  
Continuous Index:  
Within 8" of Joint: **NO**  
Remarks:

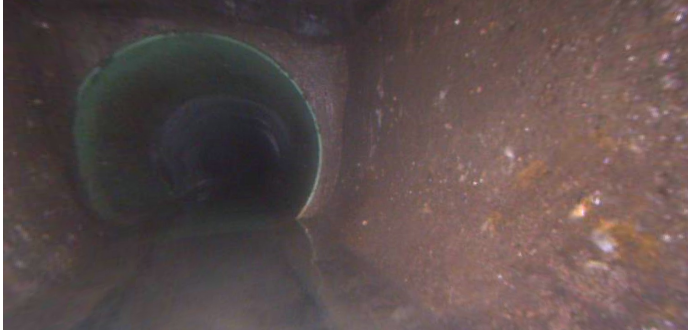
Code:	AMH
Description:	Manhole
Distance (ft):	95.5
Structural Grade:	0
O&M Grade:	0
Clock Start/From:	
Clock To:	
1st Value:	
2nd Value:	
Value Percent:	
Continuous Index:	
Within 8" of Joint:	NO
Remarks:	M-708-144
