Profile/Photo Observation Report

Street:	LAKE ST & CORAL CV	Flow Control:	Not Controlled
City:	Hobart, IN	Year Renewed:	
Location:	Sidewalk	Tape/Media #:	
Purpose:	Maintenance Related	Dia/Height:	12"
Use:	Sanitary	Material:	PVC
Drain Area:	NA	Lining:	Cured in Place
Category:	NA		
Comment:

Location Details:		Direction of Survey:	Upstream
US MH:	M-708-144	DS MH:	M-708-145
		Total Length Surveyed (ft):	158.5

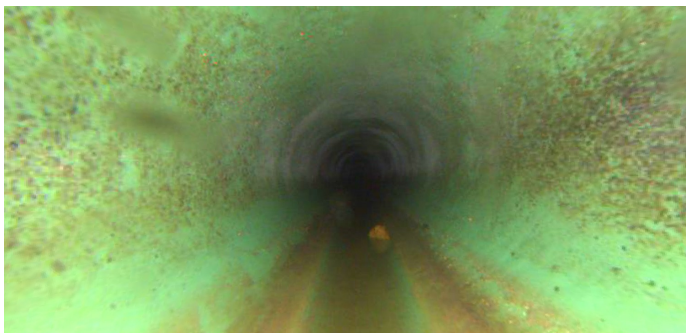
Code: **AMH**
Description: **Manhole**

Distance (ft): **.0**
Structural Grade: **0**
O&M Grade: **0**
Clock Start/From:
Clock To:
1st Value:
2nd Value:
Value Percent:
Continuous Index:
Within 8" of Joint: **NO**
Remarks: **M-708-145**

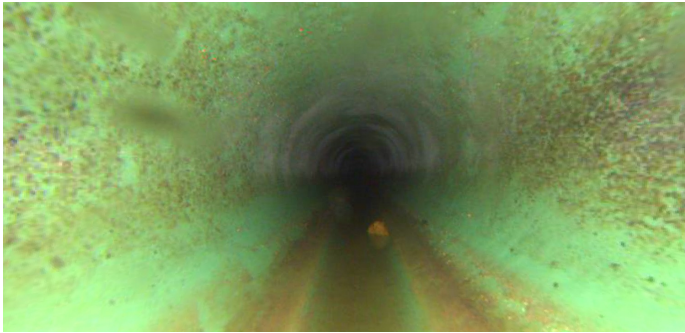
Code:	MWL
Description:	Water Level

Distance (ft):	.0
Structural Grade:	0
O&M Grade:	0
Clock Start/From:	
Clock To:	
1st Value:	
2nd Value:	
Value Percent:	5.000
Continuous Index:	
Within 8" of Joint:	NO
Remarks:

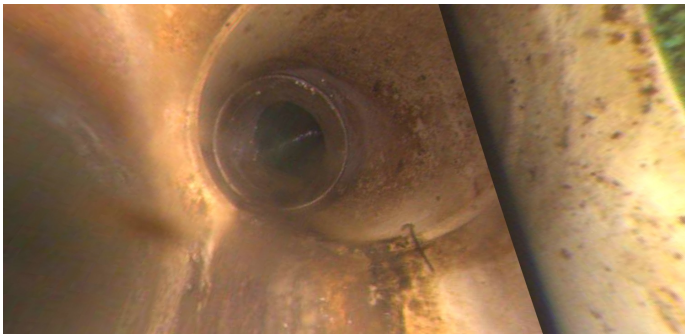
Code:	TF
Description:	Tap Factory

Distance (ft):	59.3
Structural Grade:	0
O&M Grade:	0
Clock Start/From:	10
Clock To:	
1st Value:	4.000
2nd Value:	
Value Percent:	
Continuous Index:	
Within 8" of Joint:	
Remarks:

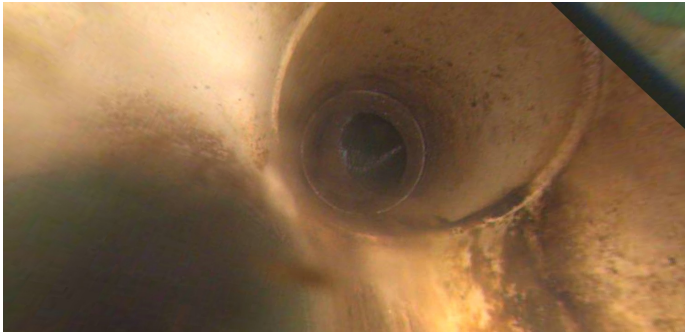
Code: **TF**
Description: **Tap Factory**

Distance (ft): **62.0**
Structural Grade: **0**
O&M Grade: **0**
Clock Start/From: **10**
Clock To:
1st Value: **4.000**
2nd Value:
Value Percent:
Continuous Index:
Within 8" of Joint:
Remarks:

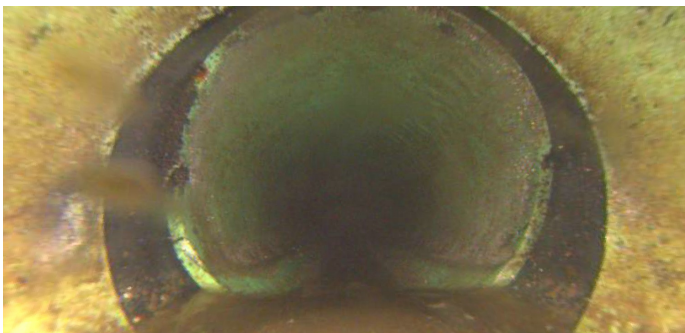
Code: **JSL**
Description: **Joint Separated Large**

Distance (ft): **118.0**
Structural Grade: **2**
O&M Grade: **0**
Clock Start/From:
Clock To:
1st Value:
2nd Value:
Value Percent:
Continuous Index:
Within 8" of Joint: **NO**
Remarks:

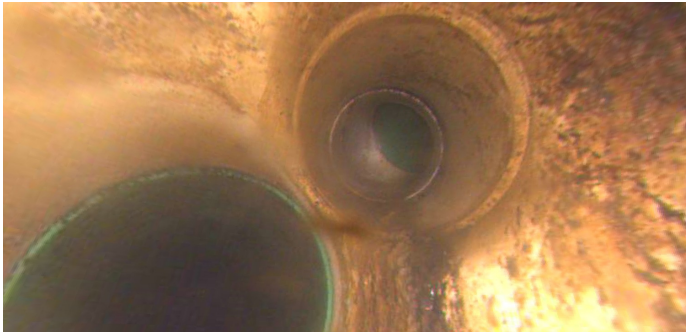
Code: **TF**
Description: **Tap Factory**

Distance (ft): **126.5**
Structural Grade: **0**
O&M Grade: **0**
Clock Start/From: **10**
Clock To:
1st Value: **4.000**
2nd Value:
Value Percent:
Continuous Index:
Within 8" of Joint:
Remarks:

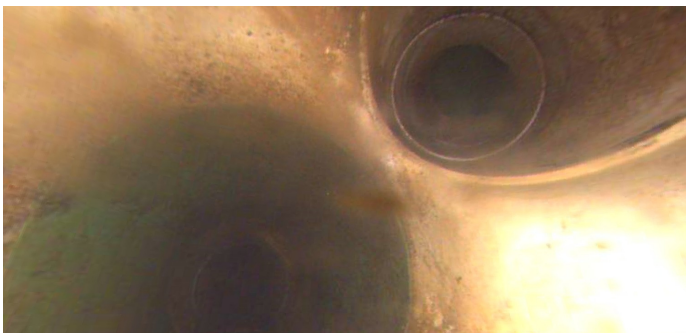
Code: **TF**
Description: **Tap Factory**

Distance (ft): **128.9**
Structural Grade: **0**
O&M Grade: **0**
Clock Start/From: **10**
Clock To:
1st Value: **4.000**
2nd Value:
Value Percent:
Continuous Index:
Within 8" of Joint:
Remarks:

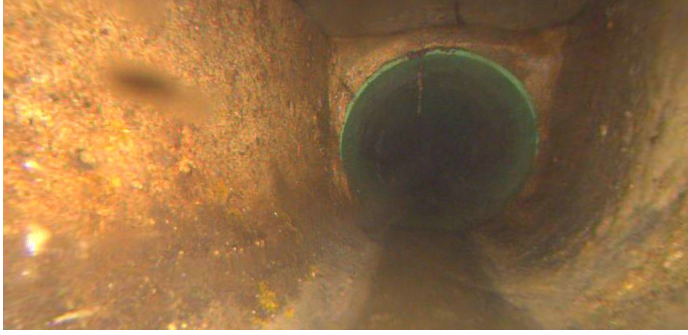
Code:	AMH
Description:	Manhole
Distance (ft):	158.5
Structural Grade:	0
O&M Grade:	0
Clock Start/From:	
Clock To:	
1st Value:	
2nd Value:	
Value Percent:	
Continuous Index:	
Within 8" of Joint:	NO
Remarks:	M-708-144
