Profile/Photo Observation Report

Date:	09/14/2023	Weather:		Coding:	PACP 7.0
Pipe Length (ft):	5.5	Owner:	City of Hobart	Pre Clean:	Light Cleaning
P.O.#:	YES502259	Surveyor:	S. Bucklin	PSR:	P-708-148.1-148
Customer:	City of Hobart	Clean Date:	09/07/2023	Shape:	C

Street:	South Lake Street	Flow Control:	Not Controlled
City:	Hobart, IN	Year Renewed:	
Location:	Easement/Right of Way	Tape/Media #:	
Purpose:	Routine Assessment	Dia/Height:	8"
Use:	Sanitary Sewage Pipe	Material:	PVC
Drain Area:		Lining:	None
Category:	NA		
Comment:			
Location Details:		Direction of Survey:	Upstream
US MH:	M-708-148.1	DS MH:	M-708-148
		Total Length Surveyed (ft):	5.5

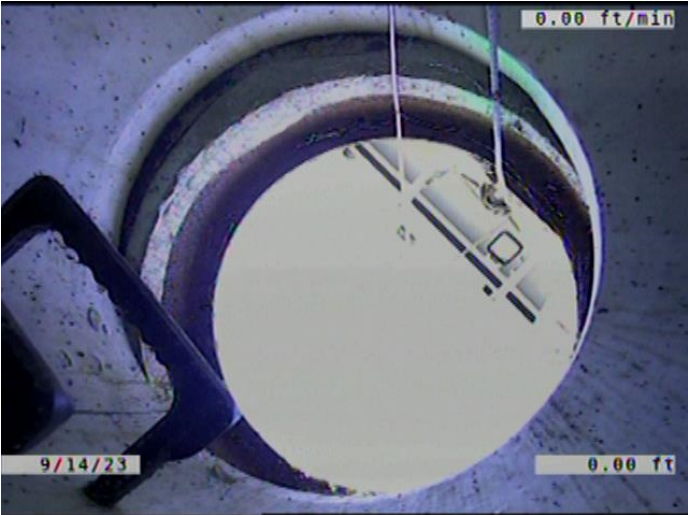
Code:	AMH
Description:	Manhole
Distance (ft):	.0
Structural Grade:	0
O&M Grade:	0
Clock Start/From:	
Clock To:	
1st Value:	
2nd Value:	
Value Percent:	
Continuous Index:	
Within 8" of Joint:	NO
Remarks:	M-708-148

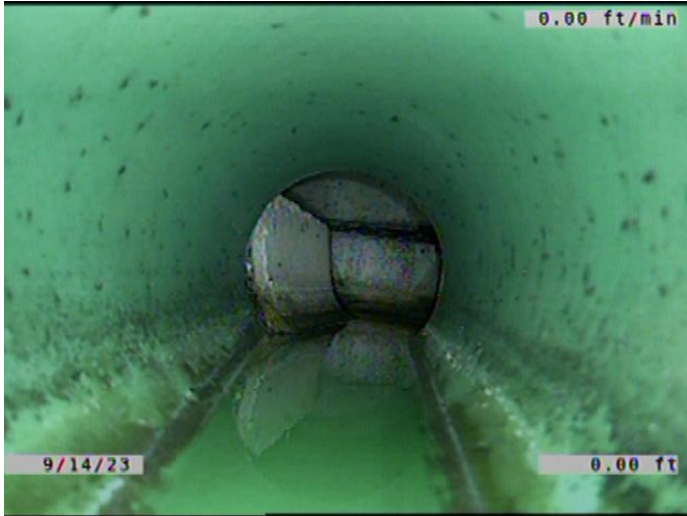
Code:	MWL
Description:	Miscellaneous Water Level
Distance (ft):	.0
Structural Grade:	0
O&M Grade:	0
Clock Start/From:	
Clock To:	
1st Value:	
2nd Value:	
Value Percent:	5.000
Continuous Index:	
Within 8" of Joint:	NO
Remarks:

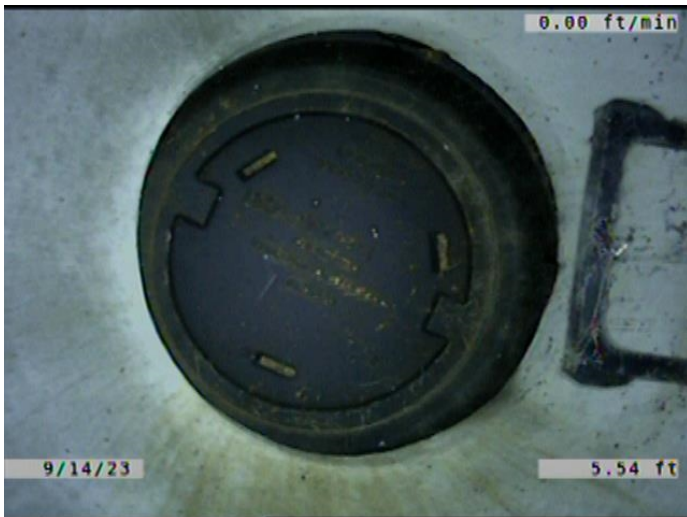
Code:	AMH
Description:	Manhole
Distance (ft):	5.5
Structural Grade:	0
O&M Grade:	0
Clock Start/From:	
Clock To:	
1st Value:	
2nd Value:	
Value Percent:	
Continuous Index:	
Within 8" of Joint:	NO
Remarks:	M-708-148.1
