Profile/Photo Observation Report

Date:	09/14/2023	Weather:		Coding:	PACP 7.0
Pipe Length (ft):	148.3	Owner:	City of Hobart	Pre Clean:	Light Cleaning
P.O.#:	YES502259	Surveyor:	S. Bucklin	PSR:	P-708-148.2-148.1
Customer:	City of Hobart	Clean Date:	09/07/2023	Shape:	C

Street:	South Lake Street	Flow Control:	Not Controlled
City:	Hobart, IN	Year Renewed:	
Location:	Easement/Right of Way	Tape/Media #:	
Purpose:	Routine Assessment	Dia/Height:	8"
Use:	Sanitary Sewage Pipe	Material:	PVC
Drain Area:		Lining:	None
Category:	NA		
Comment:			
Location Details:		Direction of Survey:	Upstream
US MH:	M-708-148.2	DS MH:	M-708-148.1
		Total Length Surveyed (ft):	148.3

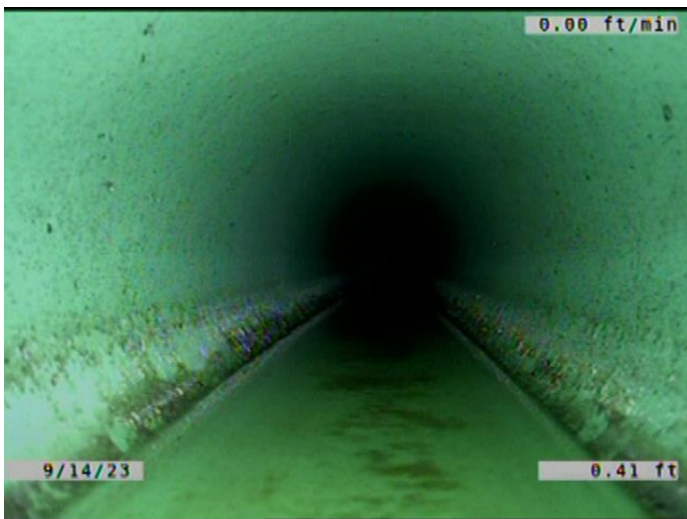
Code:	MWLS
Description:	Miscellaneous Water Level Sag
Distance (ft):	.4
Structural Grade:	2
O&M Grade:	0
Clock Start/From:	
Clock To:	
1st Value:	
2nd Value:	
Value Percent:	10.000
Continuous Index:	S01
Within 8" of Joint:	NO
Remarks:

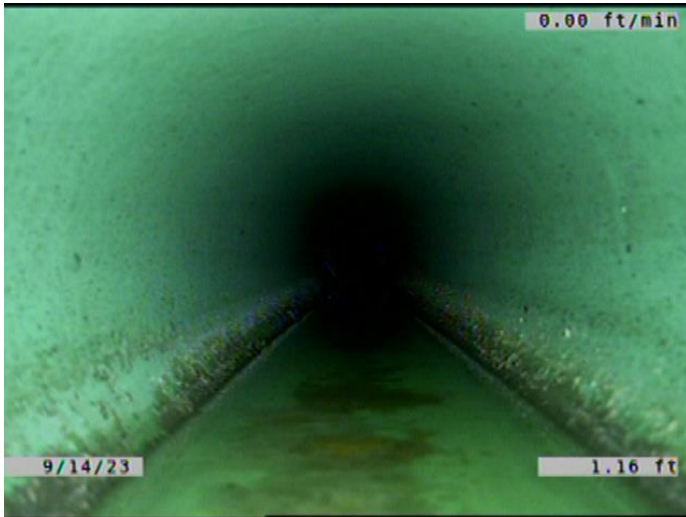
Code: **DSF**
Description: **Deposits Settled Fine**

Distance (ft): **1.2**
Structural Grade: **0**
O&M Grade: **2**
Clock Start/From: **5**
Clock To: **7**
1st Value:
2nd Value:
Value Percent: **5.000**
Continuous Index: **S02**
Within 8" of Joint: **YES**
Remarks:

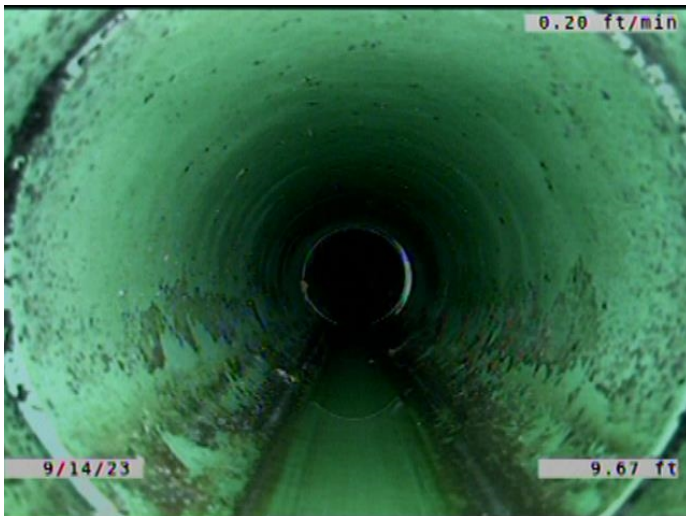
Code: **MWLS**
Description: **Miscellaneous Water Level Sag**

Distance (ft): **9.7**
Structural Grade: **2**
O&M Grade: **0**
Clock Start/From:
Clock To:
1st Value:
2nd Value:
Value Percent: **10.000**
Continuous Index: **F01**
Within 8" of Joint: **NO**
Remarks:

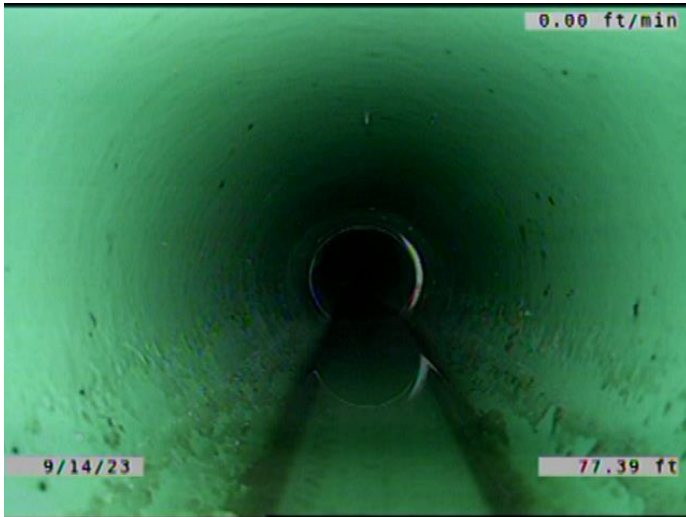
Code: **MWLS**
Description: **Miscellaneous Water Level Sag**

Distance (ft): **77.4**
Structural Grade: **2**
O&M Grade: **0**
Clock Start/From:
Clock To:
1st Value:
2nd Value:
Value Percent: **5.000**
Continuous Index: **S03**
Within 8" of Joint: **NO**
Remarks:

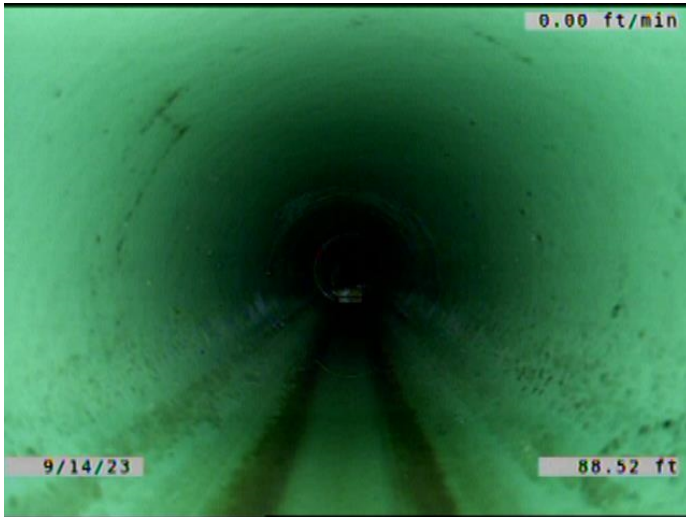
Code: **MWLS**
Description: **Miscellaneous Water Level Sag**

Distance (ft): **88.5**
Structural Grade: **2**
O&M Grade: **0**
Clock Start/From:
Clock To:
1st Value:
2nd Value:
Value Percent: **5.000**
Continuous Index: **F03**
Within 8" of Joint: **NO**
Remarks:
