## Profile/Photo Observation Report

Street:	<b>Lake</b>	Flow Control:	<b>Not Controlled</b>
City:	<b>Hobart, IN</b>	Year Renewed:	
Location:	<b>Sidewalk</b>	Tape/Media #:	
Purpose:	<b>Maintenance Related</b>	Dia/Height:	<b>12"</b>
Use:	<b>Sanitary</b>	Material:	<b>PVC</b>
Drain Area:	<b>NA</b>	Lining:	<b>Cured in Place</b>
Category:	<b>NA</b>		
Comment:

Location Details:		Direction of Survey:	<b>Downstream</b>
US MH:	<b>M-708-150</b>	DS MH:	<b>M-708-146</b>
		Total Length Surveyed (ft):	<b>143.6</b>

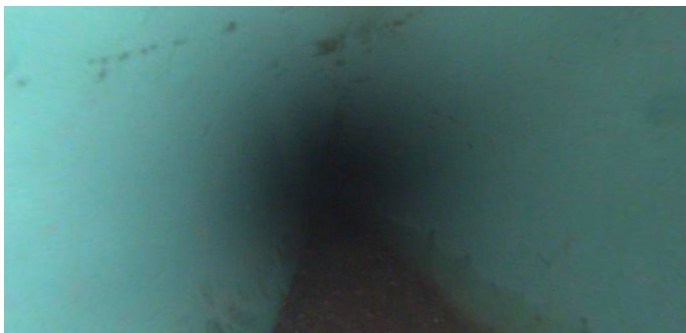
Code: **AMH**  
Description: **Manhole**

Distance (ft): **.0**  
Structural Grade: **0**  
O&M Grade: **0**  
Clock Start/From:  
Clock To:  
1st Value:  
2nd Value:  
Value Percent:  
Continuous Index:  
Within 8" of Joint: **NO**  
Remarks: **M-708-150**

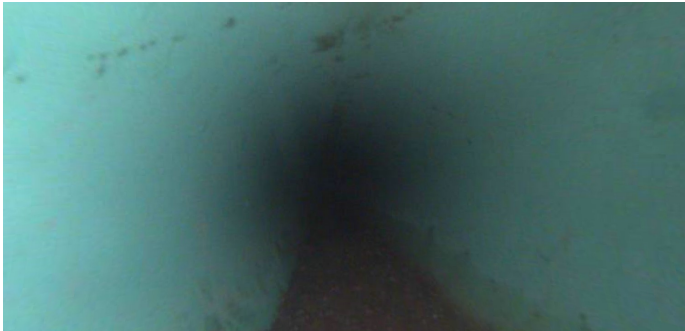
Code:	<b>MWL</b>
Description:	<b>Water Level</b>

Distance (ft):	<b>.0</b>
Structural Grade:	<b>0</b>
O&M Grade:	<b>0</b>
Clock Start/From:	
Clock To:	
1st Value:	
2nd Value:	
Value Percent:	<b>0.000</b>
Continuous Index:	
Within 8" of Joint:	<b>NO</b>
Remarks:

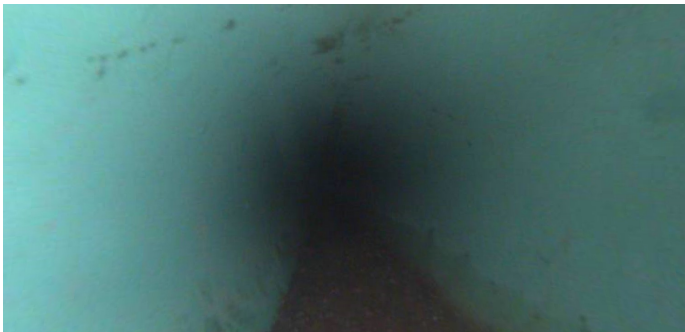
Code:	<b>DSF</b>
Description:	<b>Deposits Settled Fine</b>

Distance (ft):	<b>.0</b>
Structural Grade:	<b>0</b>
O&M Grade:	<b>2</b>
Clock Start/From:	<b>6</b>
Clock To:	
1st Value:	
2nd Value:	
Value Percent:	<b>5.000</b>
Continuous Index:	<b>S01</b>
Within 8" of Joint:	<b>NO</b>
Remarks:

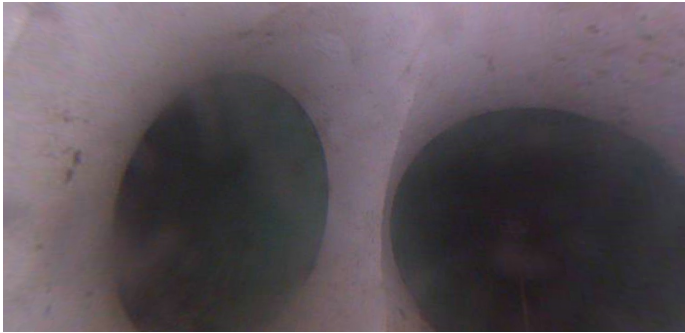
Code: **TF**  
Description: **Tap Factory**

Distance (ft): **8.8**  
Structural Grade: **0**  
O&M Grade: **0**  
Clock Start/From: **3**  
Clock To:  
1st Value: **4.000**  
2nd Value:  
Value Percent:  
Continuous Index:  
Within 8" of Joint:  
Remarks:

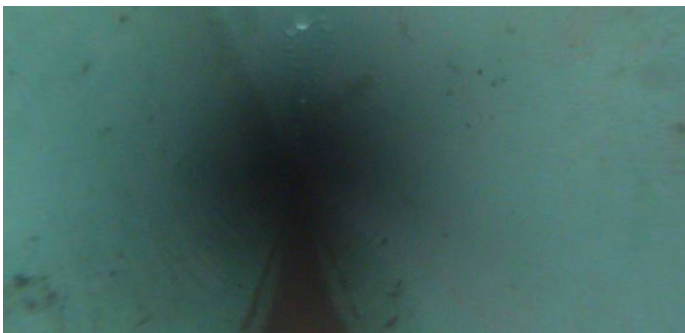
Code: **DSF**  
Description: **Deposits Settled Fine**

Distance (ft): **8.8**  
Structural Grade: **0**  
O&M Grade: **2**  
Clock Start/From: **6**  
Clock To:  
1st Value:  
2nd Value:  
Value Percent: **5.000**  
Continuous Index: **F01**  
Within 8" of Joint: **NO**  
Remarks:

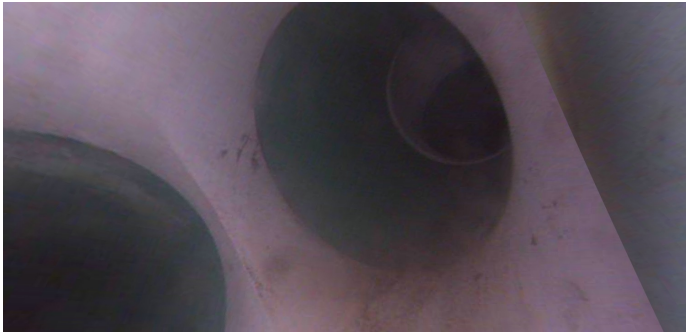
Code: **TF**  
Description: **Tap Factory**

Distance (ft): **43.0**  
Structural Grade: **0**  
O&M Grade: **0**  
Clock Start/From: **10**  
Clock To:  
1st Value: **4.000**  
2nd Value:  
Value Percent:  
Continuous Index:  
Within 8" of Joint:  
Remarks:

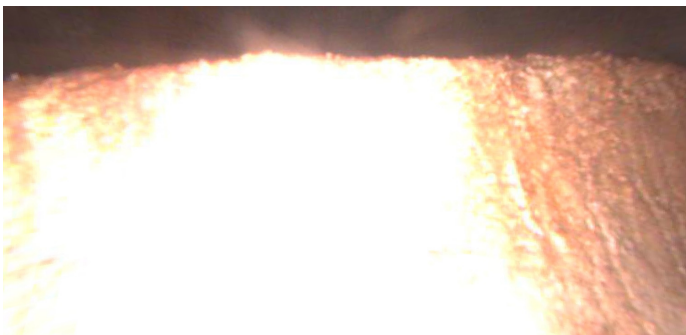
Code: **AMH**  
Description: **Manhole**

Distance (ft): **143.6**  
Structural Grade: **0**  
O&M Grade: **0**  
Clock Start/From:  
Clock To:  
1st Value:  
2nd Value:  
Value Percent:  
Continuous Index:  
Within 8" of Joint: **NO**  
Remarks: **M-708-146**
