## Profile/Photo Observation Report

Street:	<b>Hidden Oak Drive</b>	Flow Control:	
City:	<b>Hobart, IN</b>	Year Renewed:	
Location:	<b>Light Highway</b>	Tape/Media #:	<b>948</b>
Purpose:	<b>Routine Assessment</b>	Dia/Height:	<b>8"</b>
Use:	<b>Sanitary</b>	Material:	<b>PVC</b>
Drain Area:		Lining:	
Category:	<b>NA</b>		
Comment:

Location Details:		Direction of Survey:	<b>Upstream</b>
US MH:	<b>M-708-162</b>	DS MH:	<b>M-708-163</b>
		Total Length Surveyed (ft):	<b>97.1</b>

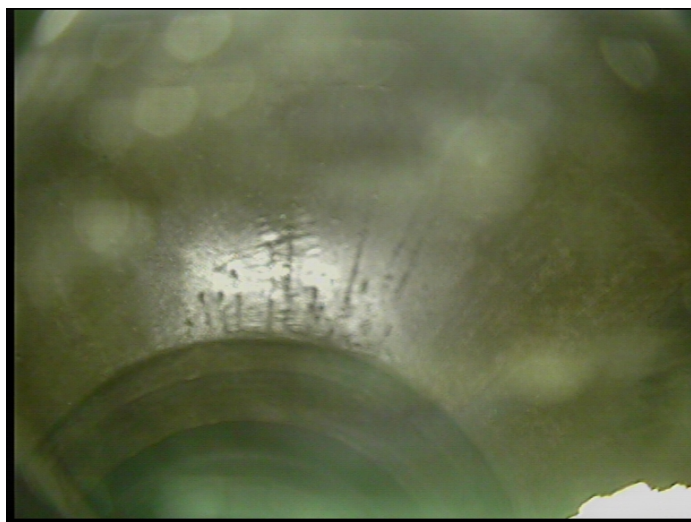
Code: **AMH**  
Description: **Manhole**

Distance (ft): **.0**  
Structural Grade: **0**  
O&M Grade: **0**  
Clock Start/From:  
Clock To:  
1st Value:  
2nd Value:  
Value Percent:  
Continuous Index:  
Within 8" of Joint: **NO**  
Remarks: **M-708-163**

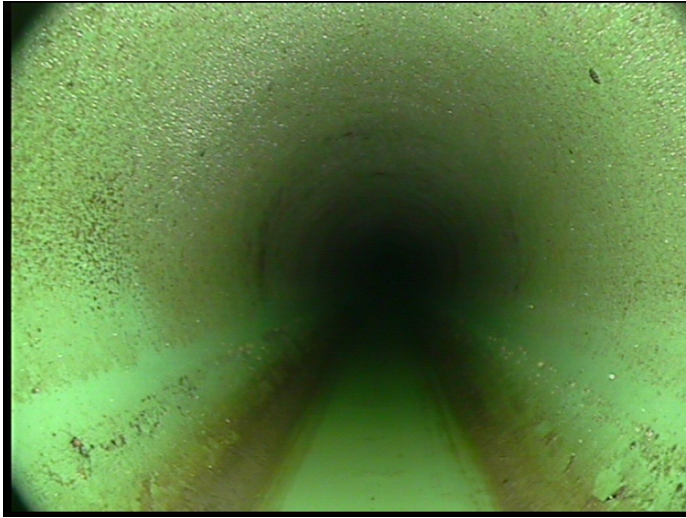
Code:	<b>MWL</b>
Description:	<b>Water Level</b>
Distance (ft):	<b>.0</b>
Structural Grade:	<b>0</b>
O&M Grade:	<b>0</b>
Clock Start/From:	
Clock To:	
1st Value:	
2nd Value:	
Value Percent:	<b>5.000</b>
Continuous Index:	
Within 8" of Joint:	<b>NO</b>
Remarks:

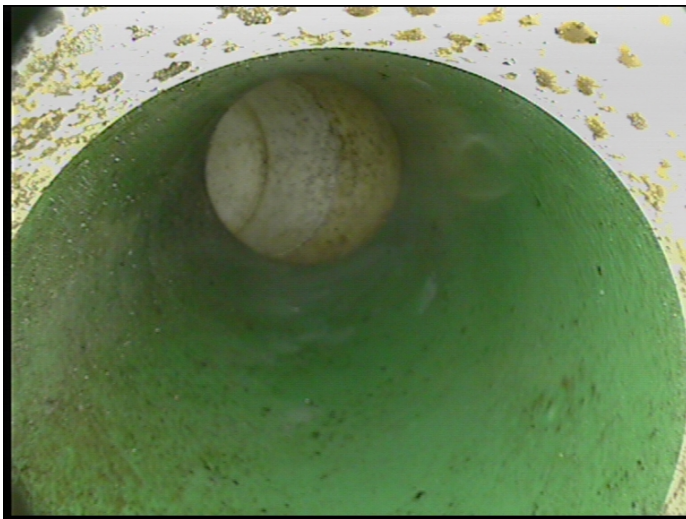
Code:	<b>TF</b>
Description:	<b>Tap Factory</b>
Distance (ft):	<b>45.3</b>
Structural Grade:	<b>0</b>
O&M Grade:	<b>0</b>
Clock Start/From:	<b>10</b>
Clock To:	
1st Value:	<b>4.000</b>
2nd Value:	
Value Percent:	
Continuous Index:	
Within 8" of Joint:	<b>NO</b>
Remarks:

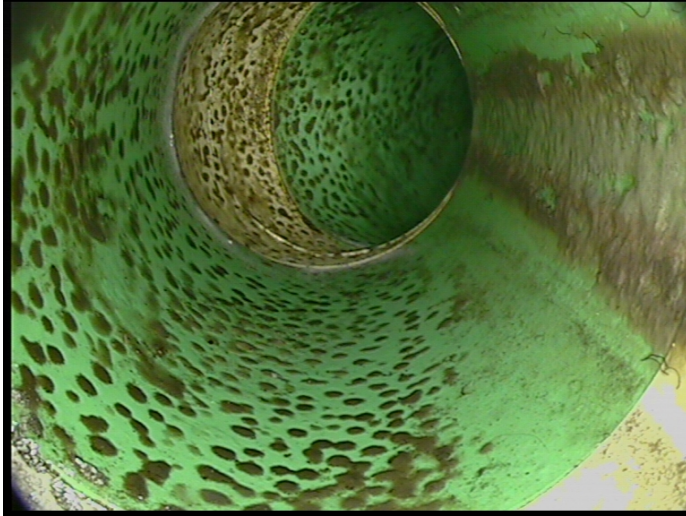
Code: **TF**  
Description: **Tap Factory**

Distance (ft): **47.1**  
Structural Grade: **0**  
O&M Grade: **0**  
Clock Start/From: **2**  
Clock To:  
1st Value: **4.000**  
2nd Value:  
Value Percent:  
Continuous Index:  
Within 8" of Joint: **NO**  
Remarks:

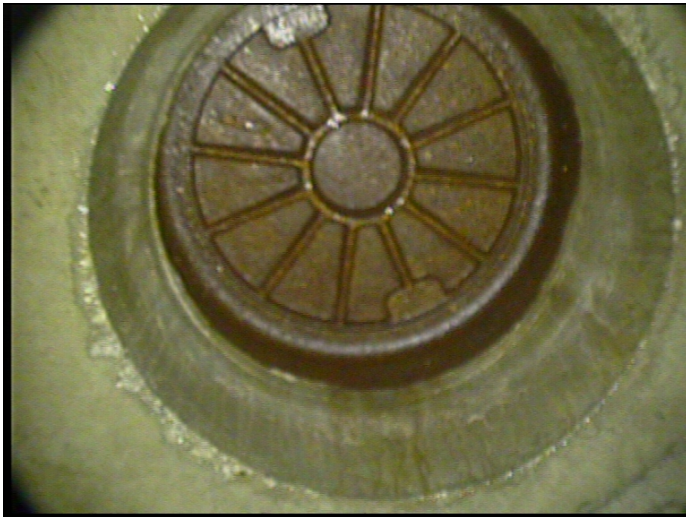
Code: **AMH**  
Description: **Manhole**

Distance (ft): **97.1**  
Structural Grade: **0**  
O&M Grade: **0**  
Clock Start/From:  
Clock To:  
1st Value:  
2nd Value:  
Value Percent:  
Continuous Index:  
Within 8" of Joint: **NO**  
Remarks: **M-708-162**
