## Profile/Photo Observation Report

Street:	<b>AZALEA DR</b>	Flow Control:	<b>Not Controlled</b>
City:	<b>Hobart, IN</b>	Year Renewed:	
Location:	<b>Sidewalk</b>	Tape/Media #:	
Purpose:	<b>Maintenance Related</b>	Dia/Height:	<b>8"</b>
Use:	<b>Sanitary</b>	Material:	<b>PVC</b>
Drain Area:	<b>NA</b>	Lining:	<b>Cured in Place</b>
Category:	<b>NA</b>		
Comment:

Location Details:		Direction of Survey:	<b>Upstream</b>
US MH:	<b>M-708-168</b>	DS MH:	<b>M-708-169</b>
		Total Length Surveyed (ft):	<b>256.1</b>

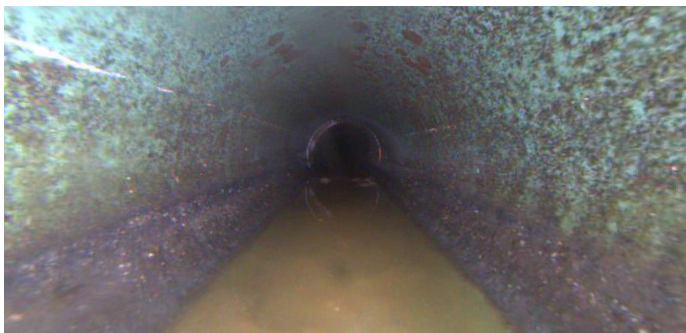
Code: **AMH**  
Description: **Manhole**

Distance (ft): **.0**  
Structural Grade: **0**  
O&M Grade: **0**  
Clock Start/From:  
Clock To:  
1st Value:  
2nd Value:  
Value Percent:  
Continuous Index:  
Within 8" of Joint: **NO**  
Remarks: **M-708-169**

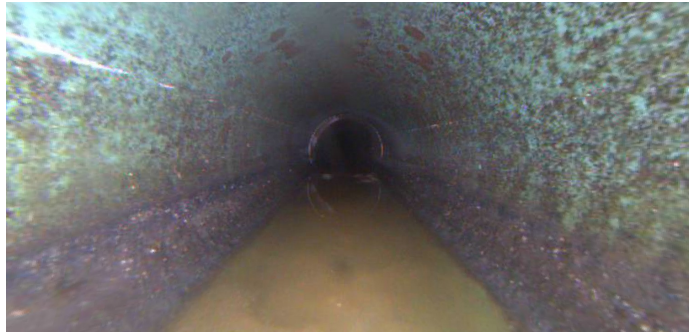
Code: **MWL**  
Description: **Water Level**

Distance (ft): **.0**  
Structural Grade: **0**  
O&M Grade: **0**  
Clock Start/From:  
Clock To:  
1st Value:  
2nd Value:  
Value Percent: **10.000**  
Continuous Index:  
Within 8" of Joint: **NO**  
Remarks:

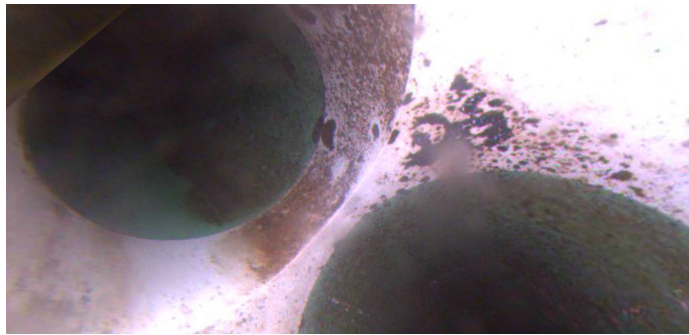
Code: **TF**  
Description: **Tap Factory**

Distance (ft): **3.2**  
Structural Grade: **0**  
O&M Grade: **0**  
Clock Start/From: **10**  
Clock To:  
1st Value: **4.000**  
2nd Value:  
Value Percent:  
Continuous Index:  
Within 8" of Joint:  
Remarks:

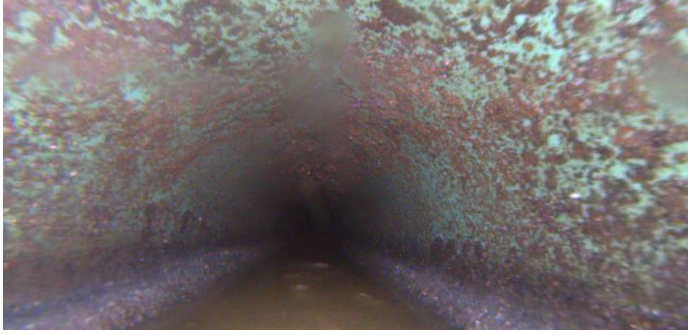
Code:	<b>DAGS</b>
Description:	<b>Deposits Attached Grease</b>
Distance (ft):	<b>4.5</b>
Structural Grade:	<b>0</b>
O&M Grade:	<b>2</b>
Clock Start/From:	<b>8</b>
Clock To:	<b>4</b>
1st Value:	
2nd Value:	
Value Percent:	<b>5.000</b>
Continuous Index:	<b>S01</b>
Within 8" of Joint:	<b>NO</b>
Remarks:

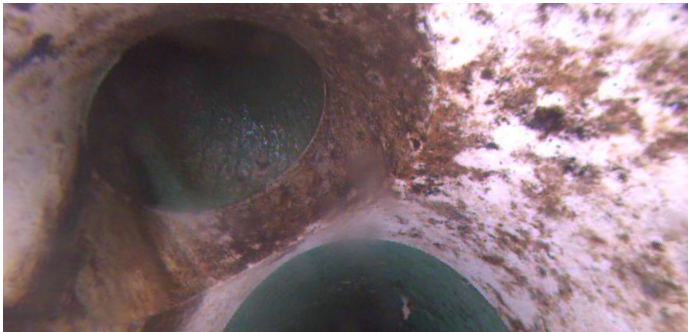
Code:	<b>TF</b>
Description:	<b>Tap Factory</b>
Distance (ft):	<b>23.3</b>
Structural Grade:	<b>0</b>
O&M Grade:	<b>0</b>
Clock Start/From:	<b>11</b>
Clock To:	
1st Value:	<b>4.000</b>
2nd Value:	
Value Percent:	
Continuous Index:	
Within 8" of Joint:	
Remarks:

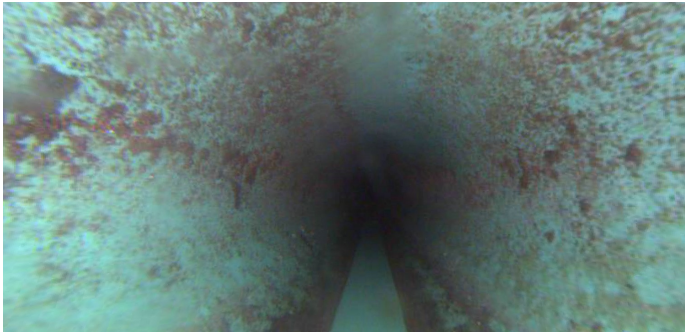
Code: **DAGS**  
Description: **Deposits Attached Grease**

Distance (ft): **25.5**  
Structural Grade: **0**  
O&M Grade: **2**  
Clock Start/From: **8**  
Clock To: **4**  
1st Value:  
2nd Value:  
Value Percent: **5.000**  
Continuous Index: **F01**  
Within 8" of Joint: **NO**  
Remarks:

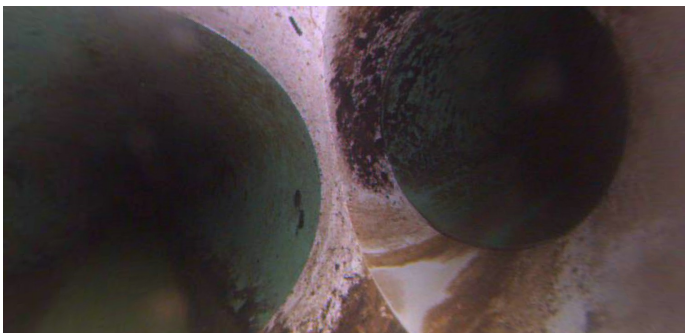
Code: **TF**  
Description: **Tap Factory**

Distance (ft): **56.7**  
Structural Grade: **0**  
O&M Grade: **0**  
Clock Start/From: **3**  
Clock To:  
1st Value: **4.000**  
2nd Value:  
Value Percent:  
Continuous Index:  
Within 8" of Joint:  
Remarks:

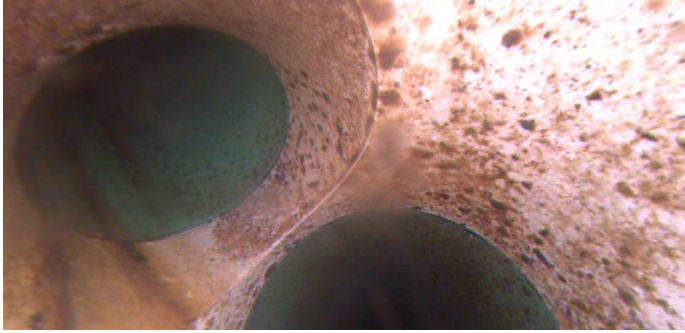
Code: **TF**  
Description: **Tap Factory**

Distance (ft): **76.8**  
Structural Grade: **0**  
O&M Grade: **0**  
Clock Start/From: **10**  
Clock To:  
1st Value: **4.000**  
2nd Value:  
Value Percent:  
Continuous Index:  
Within 8" of Joint:  
Remarks:

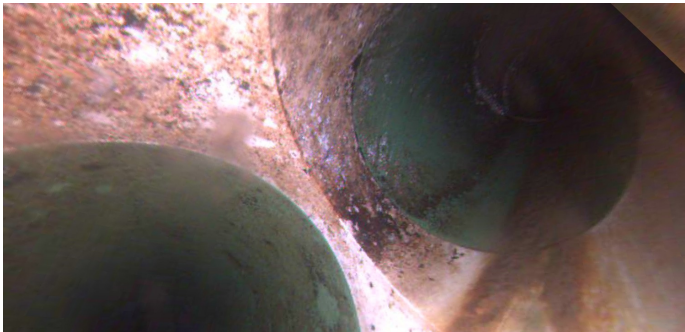
Code: **TF**  
Description: **Tap Factory**

Distance (ft): **110.2**  
Structural Grade: **0**  
O&M Grade: **0**  
Clock Start/From: **2**  
Clock To:  
1st Value: **4.000**  
2nd Value:  
Value Percent:  
Continuous Index:  
Within 8" of Joint:  
Remarks:

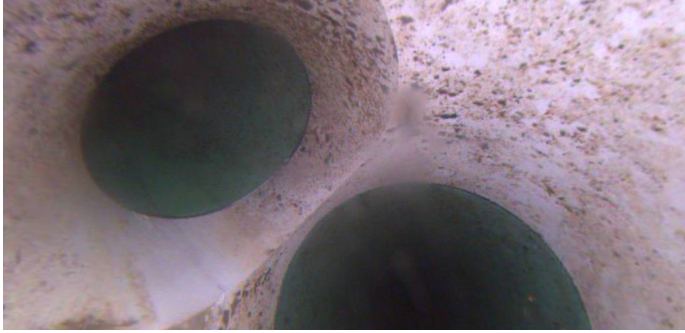
Code: **TF**  
Description: **Tap Factory**

Distance (ft): **130.6**  
Structural Grade: **0**  
O&M Grade: **0**  
Clock Start/From: **10**  
Clock To:  
1st Value: **4.000**  
2nd Value:  
Value Percent:  
Continuous Index:  
Within 8" of Joint:  
Remarks:

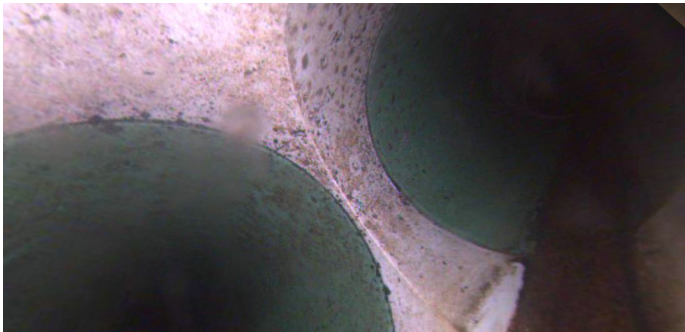
Code: **TFA**  
Description: **Tap Factory Active**

Distance (ft): **171.5**  
Structural Grade: **0**  
O&M Grade: **0**  
Clock Start/From: **2**  
Clock To:  
1st Value: **4.000**  
2nd Value:  
Value Percent:  
Continuous Index:  
Within 8" of Joint:  
Remarks:

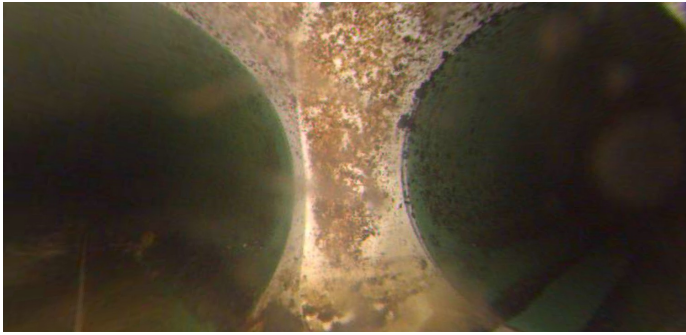
Code: **TFA**  
Description: **Tap Factory Active**

Distance (ft): **195.4**  
Structural Grade: **0**  
O&M Grade: **0**  
Clock Start/From: **9**  
Clock To:  
1st Value: **4.000**  
2nd Value:  
Value Percent:  
Continuous Index:  
Within 8" of Joint:  
Remarks:

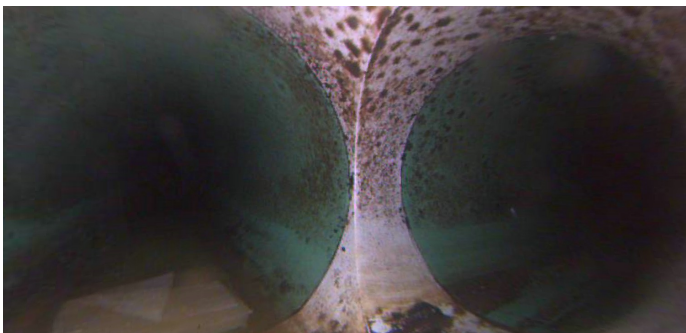
Code: **TF**  
Description: **Tap Factory**

Distance (ft): **224.5**  
Structural Grade: **0**  
O&M Grade: **0**  
Clock Start/From: **3**  
Clock To:  
1st Value: **4.000**  
2nd Value:  
Value Percent:  
Continuous Index:  
Within 8" of Joint:  
Remarks:

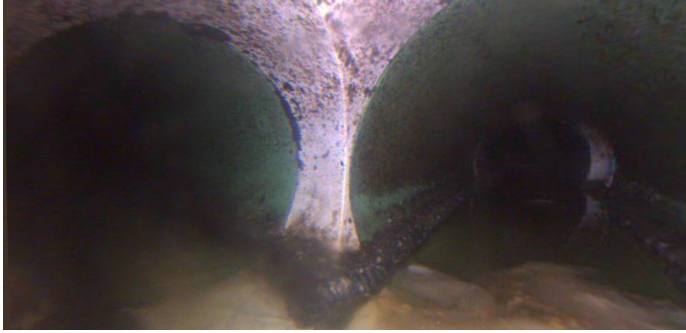
Code: **TFA**  
Description: **Tap Factory Active**

Distance (ft): **246.2**  
Structural Grade: **0**  
O&M Grade: **0**  
Clock Start/From: **9**  
Clock To:  
1st Value: **4.000**  
2nd Value:  
Value Percent:  
Continuous Index:  
Within 8" of Joint:  
Remarks:

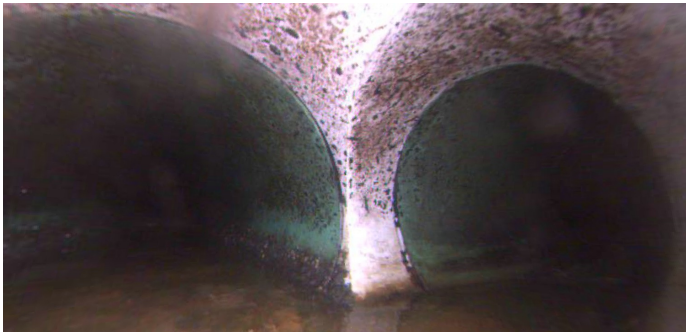
Code: **TFA**  
Description: **Tap Factory Active**

Distance (ft): **248.2**  
Structural Grade: **0**  
O&M Grade: **0**  
Clock Start/From: **3**  
Clock To:  
1st Value: **4.000**  
2nd Value:  
Value Percent:  
Continuous Index:  
Within 8" of Joint:  
Remarks:

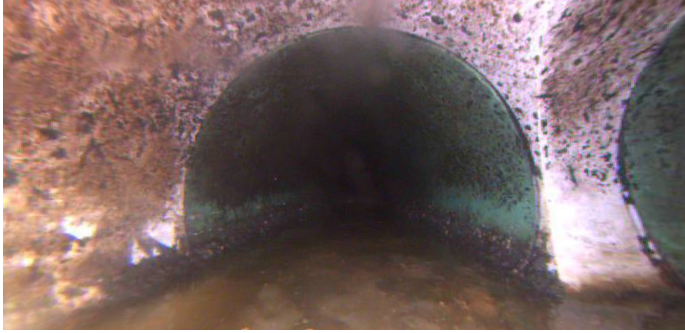
Code: **MWL**  
Description: **Water Level**

Distance (ft): **248.2**  
Structural Grade: **0**  
O&M Grade: **0**  
Clock Start/From:  
Clock To:  
1st Value:  
2nd Value:  
Value Percent: **30.000**  
Continuous Index:  
Within 8" of Joint: **NO**  
Remarks:

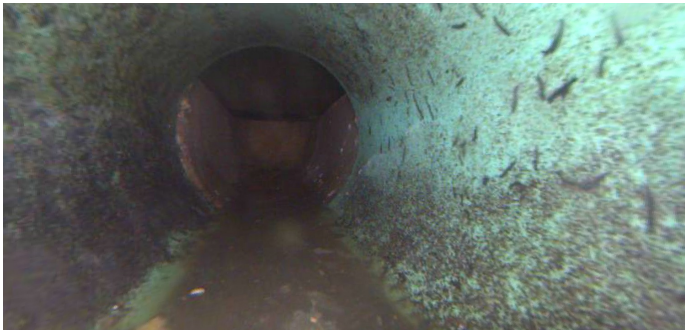
Code: **MWL**  
Description: **Water Level**

Distance (ft): **253.2**  
Structural Grade: **0**  
O&M Grade: **0**  
Clock Start/From:  
Clock To:  
1st Value:  
2nd Value:  
Value Percent: **5.000**  
Continuous Index:  
Within 8" of Joint: **NO**  
Remarks:

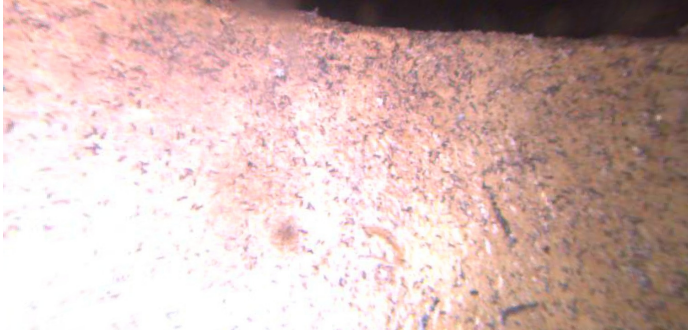
Code:	AMH
Description:	Manhole
Distance (ft):	256.1
Structural Grade:	0
O&M Grade:	0
Clock Start/From:	
Clock To:	
1st Value:	
2nd Value:	
Value Percent:	
Continuous Index:	
Within 8" of Joint:	NO
Remarks:	M-708-168
