## Profile/Photo Observation Report

Date:	<b>04/02/2018</b>	Weather:		Coding:	<b>PACP 6.0</b>
Pipe Length (ft):	<b>253.2</b>	Owner:	<b>NA</b>	Pre Clean:	<b>Not Known</b>
P.O.#:		Surveyor:	<b>Jen Costello</b>	PSR:	<b>P-708-168-169</b>
Customer:		Clean Date:	<b>01/01/1900</b>	Shape:	<b>C</b>

Street:	<b>Magnolia</b>	Flow Control:	<b>Not Controlled</b>
City:	<b>Hobart, IN</b>	Year Renewed:	
Location:	<b>Sidewalk</b>	Tape/Media #:	
Purpose:	<b>Maintenance Related</b>	Dia/Height:	<b>8"</b>
Use:	<b>Sanitary</b>	Material:	<b>PVC</b>
Drain Area:	<b>NA</b>	Lining:	<b>Cured in Place</b>
Category:	<b>NA</b>		
Comment:

Location Details:		Direction of Survey:	<b>Upstream</b>
US MH:	<b>M-708-168</b>	DS MH:	<b>M-708-169</b>
		Total Length Surveyed (ft):	<b>256.1</b>

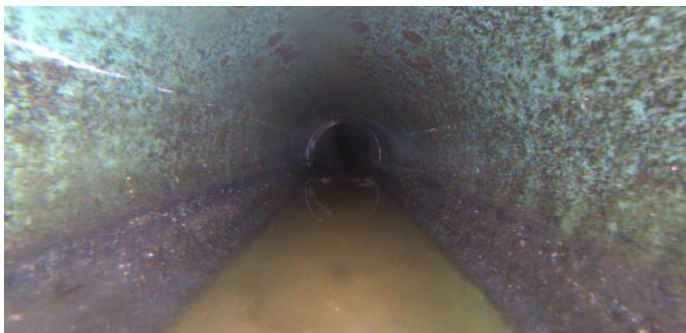
Code: **AMH**  
Description: **Manhole**

Distance (ft): **.0**  
Structural Grade: **0**  
O&M Grade: **0**  
Clock Start/From:  
Clock To:  
1st Value:  
2nd Value:  
Value Percent:  
Continuous Index:  
Within 8" of Joint: **NO**  
Remarks: **M-708-169**

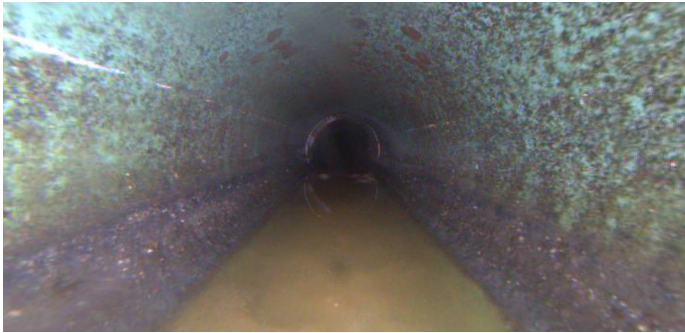
Code:	<b>MWL</b>
Description:	<b>Water Level</b>

Distance (ft):	<b>.0</b>
Structural Grade:	<b>0</b>
O&M Grade:	<b>0</b>
Clock Start/From:	
Clock To:	
1st Value:	
2nd Value:	
Value Percent:	<b>10.000</b>
Continuous Index:	
Within 8" of Joint:	<b>NO</b>
Remarks:

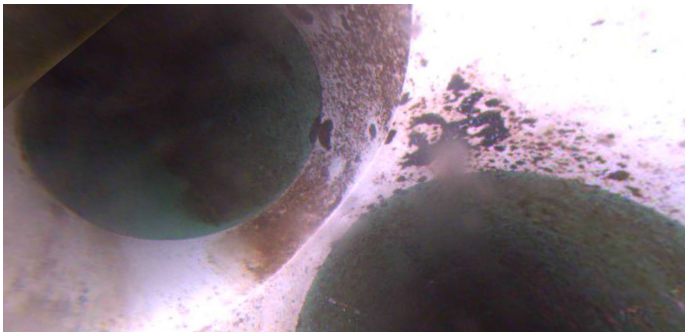
Code:	<b>TF</b>
Description:	<b>Tap Factory</b>

Distance (ft):	<b>3.2</b>
Structural Grade:	<b>0</b>
O&M Grade:	<b>0</b>
Clock Start/From:	<b>10</b>
Clock To:	
1st Value:	<b>4.000</b>
2nd Value:	
Value Percent:	
Continuous Index:	
Within 8" of Joint:	
Remarks:

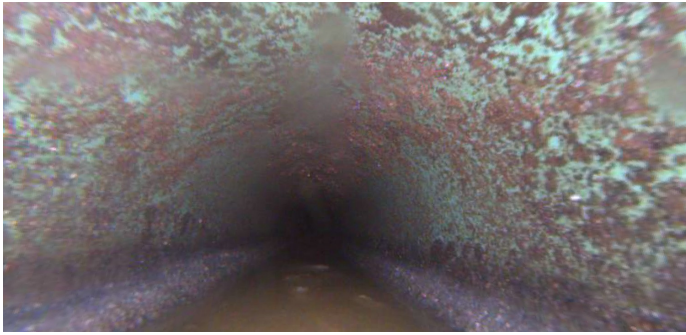
Code: **DAGS**  
Description: **Deposits Attached Grease**

Distance (ft): **4.5**  
Structural Grade: **0**  
O&M Grade: **2**  
Clock Start/From: **8**  
Clock To: **4**  
1st Value:  
2nd Value:  
Value Percent: **5.000**  
Continuous Index: **S01**  
Within 8" of Joint: **NO**  
Remarks:

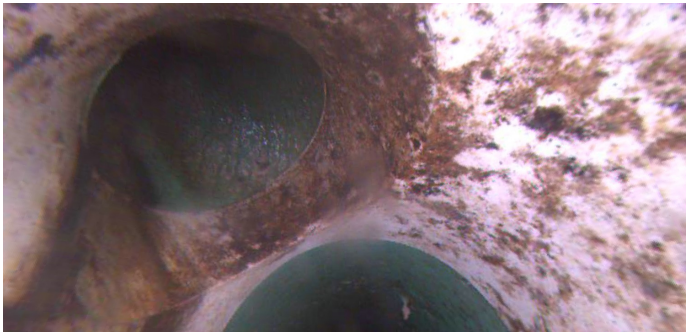
Code: **TF**  
Description: **Tap Factory**

Distance (ft): **23.3**  
Structural Grade: **0**  
O&M Grade: **0**  
Clock Start/From: **11**  
Clock To:  
1st Value: **4.000**  
2nd Value:  
Value Percent:  
Continuous Index:  
Within 8" of Joint:  
Remarks:

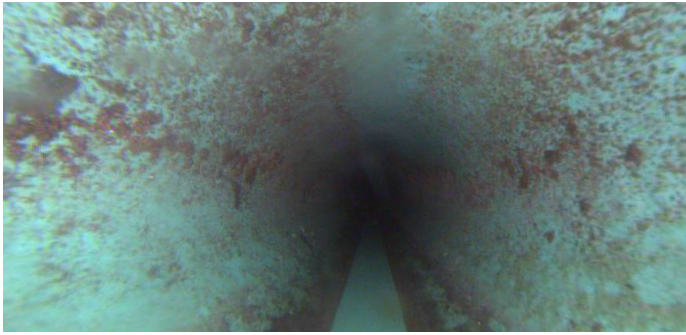
Code: **DAGS**  
Description: **Deposits Attached Grease**

Distance (ft): **25.5**  
Structural Grade: **0**  
O&M Grade: **2**  
Clock Start/From: **8**  
Clock To: **4**  
1st Value:  
2nd Value:  
Value Percent: **5.000**  
Continuous Index: **F01**  
Within 8" of Joint: **NO**  
Remarks:

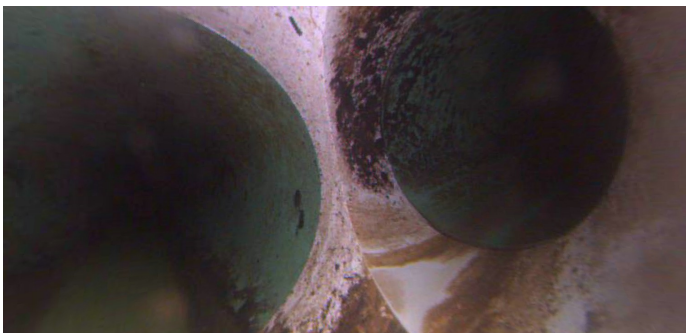
Code: **TF**  
Description: **Tap Factory**

Distance (ft): **56.7**  
Structural Grade: **0**  
O&M Grade: **0**  
Clock Start/From: **3**  
Clock To:  
1st Value: **4.000**  
2nd Value:  
Value Percent:  
Continuous Index:  
Within 8" of Joint:  
Remarks:

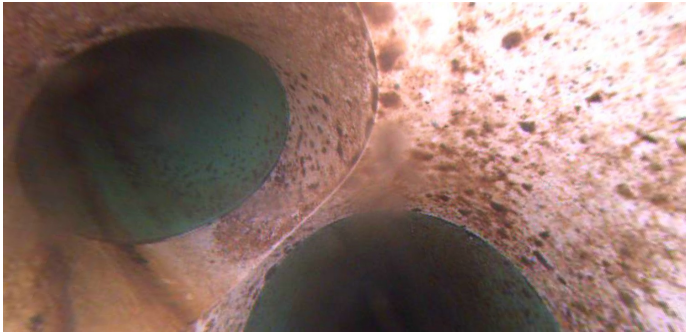
Code: **TF**  
Description: **Tap Factory**

Distance (ft): **76.8**  
Structural Grade: **0**  
O&M Grade: **0**  
Clock Start/From: **10**  
Clock To:  
1st Value: **4.000**  
2nd Value:  
Value Percent:  
Continuous Index:  
Within 8" of Joint:  
Remarks:

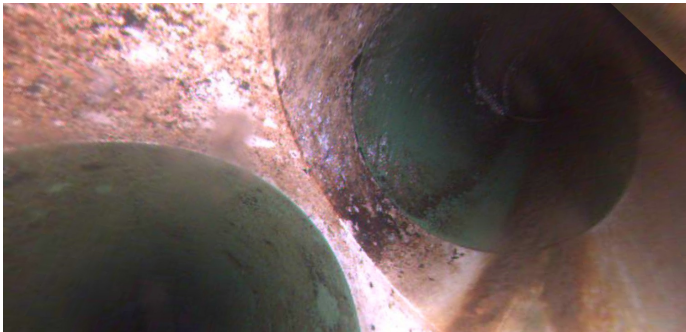
Code: **TF**  
Description: **Tap Factory**

Distance (ft): **110.2**  
Structural Grade: **0**  
O&M Grade: **0**  
Clock Start/From: **2**  
Clock To:  
1st Value: **4.000**  
2nd Value:  
Value Percent:  
Continuous Index:  
Within 8" of Joint:  
Remarks:

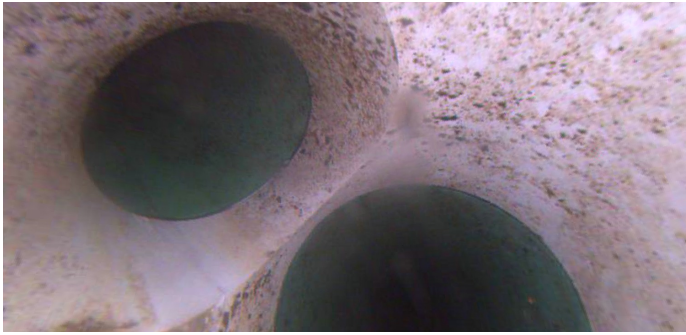
Code: **TF**  
Description: **Tap Factory**

Distance (ft): **130.6**  
Structural Grade: **0**  
O&M Grade: **0**  
Clock Start/From: **10**  
Clock To:  
1st Value: **4.000**  
2nd Value:  
Value Percent:  
Continuous Index:  
Within 8" of Joint:  
Remarks:

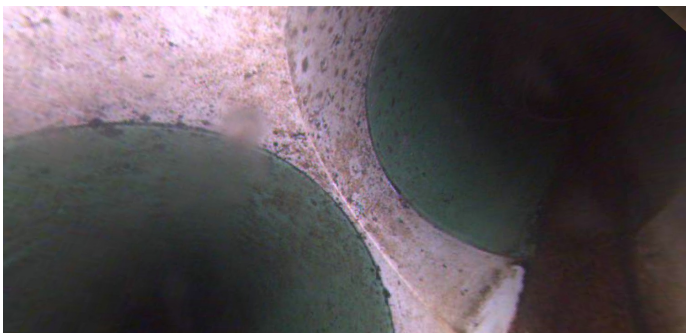
Code: **TFA**  
Description: **Tap Factory Active**

Distance (ft): **171.5**  
Structural Grade: **0**  
O&M Grade: **0**  
Clock Start/From: **2**  
Clock To:  
1st Value: **4.000**  
2nd Value:  
Value Percent:  
Continuous Index:  
Within 8" of Joint:  
Remarks:

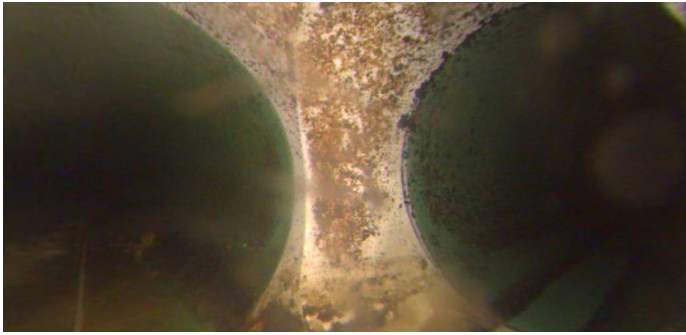
Code: **TFA**  
Description: **Tap Factory Active**

Distance (ft): **195.4**  
Structural Grade: **0**  
O&M Grade: **0**  
Clock Start/From: **9**  
Clock To:  
1st Value: **4.000**  
2nd Value:  
Value Percent:  
Continuous Index:  
Within 8" of Joint:  
Remarks:

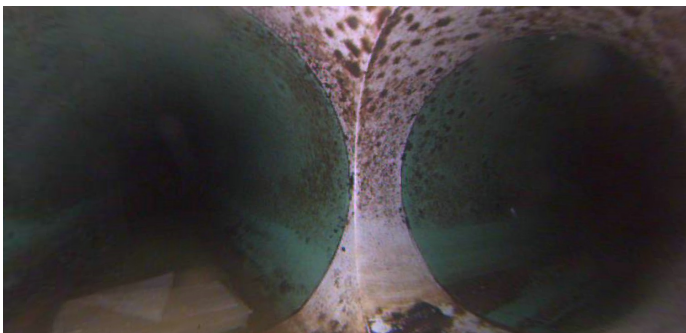
Code: **TF**  
Description: **Tap Factory**

Distance (ft): **224.5**  
Structural Grade: **0**  
O&M Grade: **0**  
Clock Start/From: **3**  
Clock To:  
1st Value: **4.000**  
2nd Value:  
Value Percent:  
Continuous Index:  
Within 8" of Joint:  
Remarks:

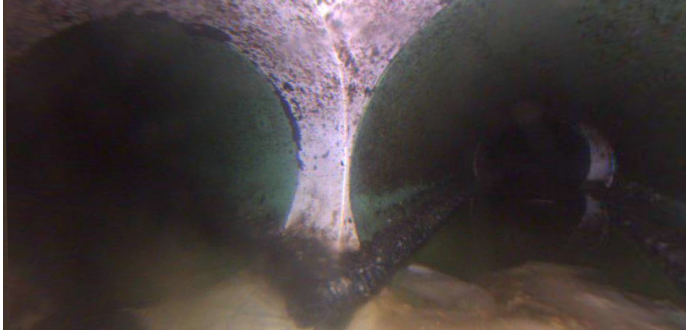
Code: **TFA**  
Description: **Tap Factory Active**

Distance (ft): **246.2**  
Structural Grade: **0**  
O&M Grade: **0**  
Clock Start/From: **9**  
Clock To:  
1st Value: **4.000**  
2nd Value:  
Value Percent:  
Continuous Index:  
Within 8" of Joint:  
Remarks:

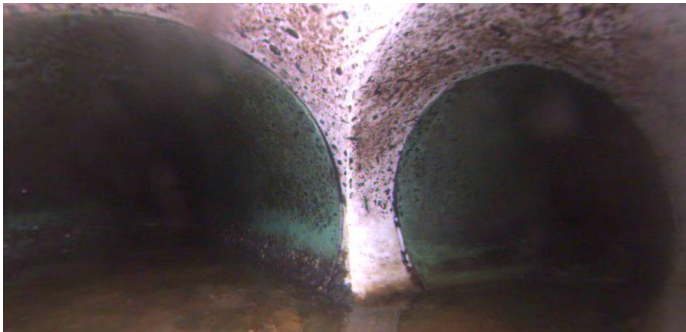
Code: **TFA**  
Description: **Tap Factory Active**

Distance (ft): **248.2**  
Structural Grade: **0**  
O&M Grade: **0**  
Clock Start/From: **3**  
Clock To:  
1st Value: **4.000**  
2nd Value:  
Value Percent:  
Continuous Index:  
Within 8" of Joint:  
Remarks:

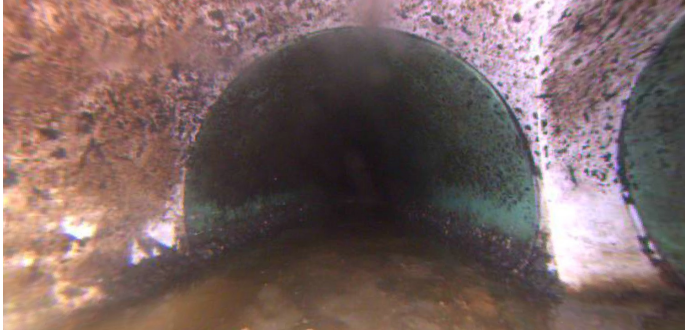
Code: **MWL**  
Description: **Water Level**

Distance (ft): **248.2**  
Structural Grade: **0**  
O&M Grade: **0**  
Clock Start/From:  
Clock To:  
1st Value:  
2nd Value:  
Value Percent: **30.000**  
Continuous Index:  
Within 8" of Joint: **NO**  
Remarks:

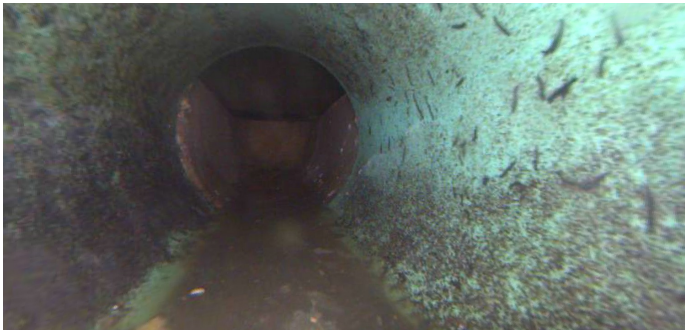
Code: **MWL**  
Description: **Water Level**

Distance (ft): **253.2**  
Structural Grade: **0**  
O&M Grade: **0**  
Clock Start/From:  
Clock To:  
1st Value:  
2nd Value:  
Value Percent: **5.000**  
Continuous Index:  
Within 8" of Joint: **NO**  
Remarks:

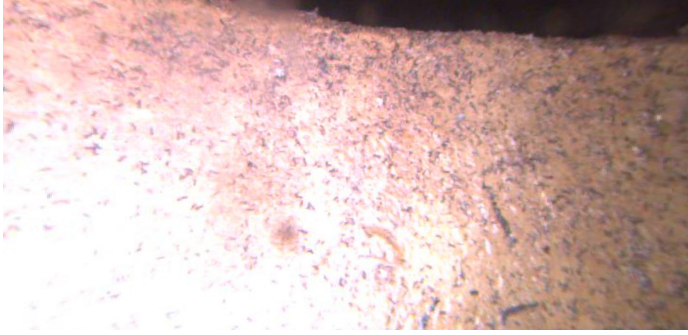
Code:	<b>AMH</b>
Description:	<b>Manhole</b>
Distance (ft):	<b>256.1</b>
Structural Grade:	<b>0</b>
O&M Grade:	<b>0</b>
Clock Start/From:	
Clock To:	
1st Value:	
2nd Value:	
Value Percent:	
Continuous Index:	
Within 8" of Joint:	<b>NO</b>
Remarks:	<b>M-708-168</b>
