Profile/Photo Observation Report

Date:	03/21/2018	Weather:		Coding:	PACP 6.0
Pipe Length (ft):	148.5	Owner:	NA	Pre Clean:	Not Known
P.O.#:		Surveyor:	Selasie Honu	PSR:	P-709-001-002
Customer:		Clean Date:	01/01/1900	Shape:	C

Location Details:		Direction of Survey:	Downstream
US MH:	M-709-001	DS MH:	M-709-002
		Total Length Surveyed (ft):	170.0

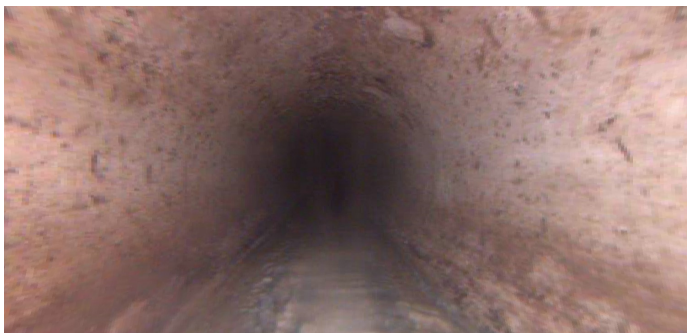
Code: **AMH**
 Description: **Manhole**

Distance (ft): **.0**
 Structural Grade: **0**
 O&M Grade: **0**
 Clock Start/From:
 Clock To:
 1st Value:
 2nd Value:
 Value Percent:
 Continuous Index:
 Within 8" of Joint: **NO**
 Remarks: **M-709-001**

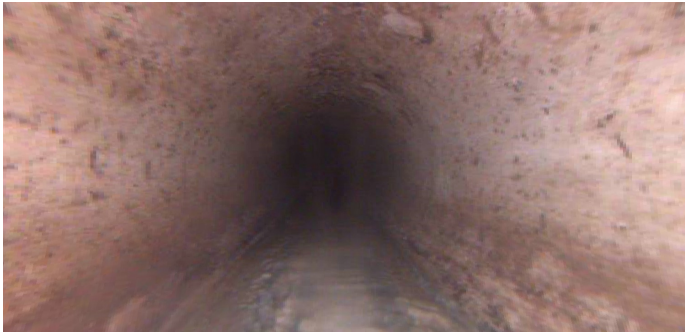
Code:	MWL
Description:	Water Level

Distance (ft):	.0
Structural Grade:	0
O&M Grade:	0
Clock Start/From:	
Clock To:	
1st Value:	
2nd Value:	
Value Percent:	5.000
Continuous Index:	
Within 8" of Joint:	NO
Remarks:

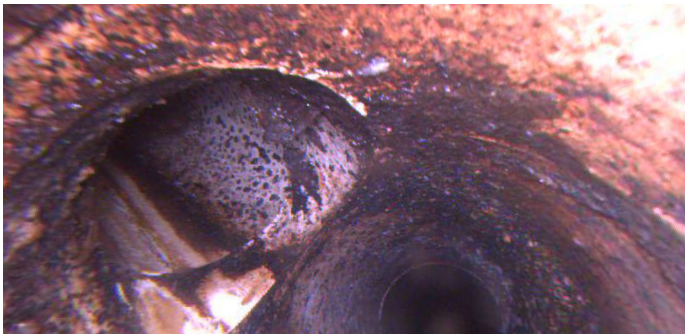
Code:	TF
Description:	Tap Factory

Distance (ft):	26.8
Structural Grade:	0
O&M Grade:	0
Clock Start/From:	1
Clock To:	
1st Value:	4.000
2nd Value:	
Value Percent:	
Continuous Index:	
Within 8" of Joint:	
Remarks:

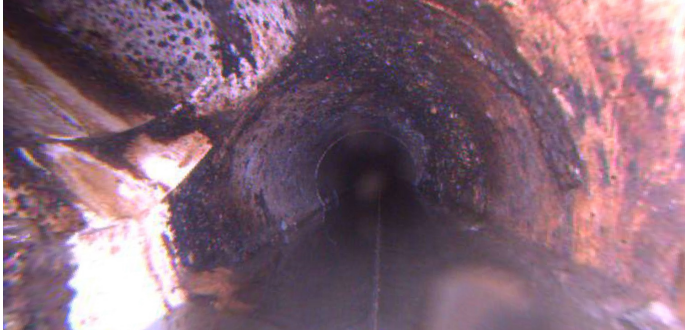
Code: **DAGS**
Description: **Deposits Attached Grease**

Distance (ft): **26.8**
Structural Grade: **0**
O&M Grade: **2**
Clock Start/From: **8**
Clock To: **4**
1st Value:
2nd Value:
Value Percent: **5.000**
Continuous Index:
Within 8" of Joint: **NO**
Remarks:

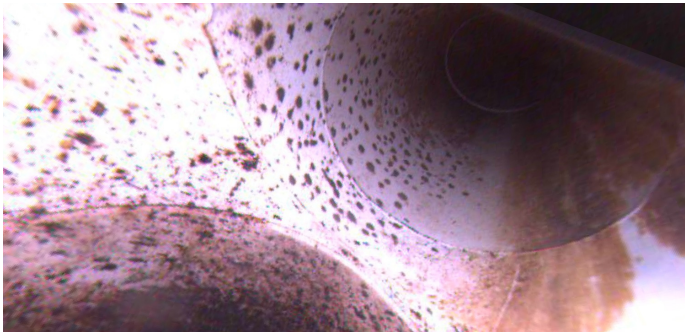
Code: **TF**
Description: **Tap Factory**

Distance (ft): **28.0**
Structural Grade: **0**
O&M Grade: **0**
Clock Start/From: **11**
Clock To:
1st Value: **4.000**
2nd Value:
Value Percent:
Continuous Index:
Within 8" of Joint:
Remarks:

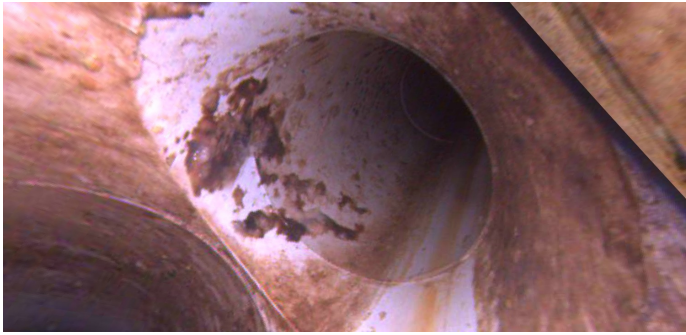
Code: **TF**
Description: **Tap Factory**

Distance (ft): **129.5**
Structural Grade: **0**
O&M Grade: **0**
Clock Start/From: **10**
Clock To:
1st Value: **4.000**
2nd Value:
Value Percent:
Continuous Index:
Within 8" of Joint:
Remarks:

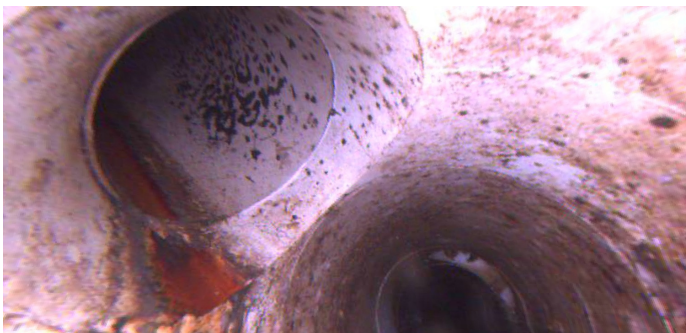
Code: **TF**
Description: **Tap Factory**

Distance (ft): **131.3**
Structural Grade: **0**
O&M Grade: **0**
Clock Start/From: **2**
Clock To:
1st Value: **4.000**
2nd Value:
Value Percent:
Continuous Index:
Within 8" of Joint:
Remarks:

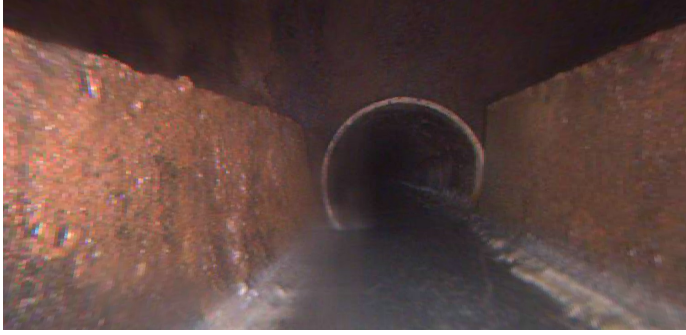
Code:	AMH
Description:	Manhole
Distance (ft):	170.0
Structural Grade:	0
O&M Grade:	0
Clock Start/From:	
Clock To:	
1st Value:	
2nd Value:	
Value Percent:	
Continuous Index:	
Within 8" of Joint:	NO
Remarks:	M-709-002
