## Profile/Photo Observation Report

Street:	<b>BRACKEN PKWY</b>	Flow Control:	<b>Not Controlled</b>
City:	<b>Hobart, IN</b>	Year Renewed:	
Location:	<b>Sidewalk</b>	Tape/Media #:	
Purpose:	<b>Maintenance Related</b>	Dia/Height:	<b>8"</b>
Use:	<b>Sanitary</b>	Material:	<b>PVC</b>
Drain Area:	<b>NA</b>	Lining:	
Category:	<b>NA</b>		
Comment:

Location Details:		Direction of Survey:	<b>Upstream</b>
US MH:	<b>M-709-003</b>	DS MH:	<b>M-709-004</b>
		Total Length Surveyed (ft):	<b>154.0</b>

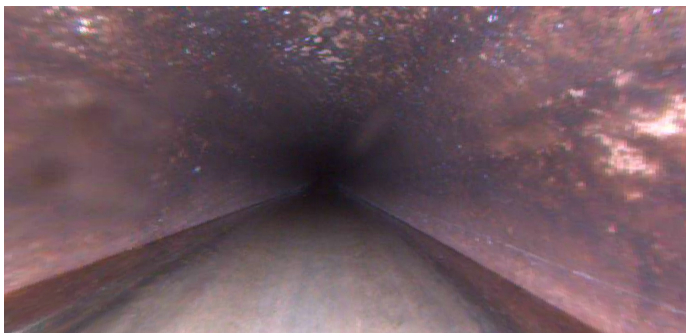
Code: **AMH**  
Description: **Manhole**

Distance (ft): **.0**  
Structural Grade: **0**  
O&M Grade: **0**  
Clock Start/From:  
Clock To:  
1st Value:  
2nd Value:  
Value Percent:  
Continuous Index:  
Within 8" of Joint: **NO**  
Remarks: **M-709-004**

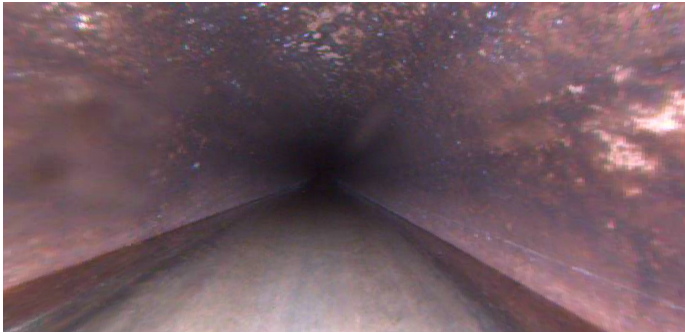
Code:	<b>MWL</b>
Description:	<b>Water Level</b>

Distance (ft):	<b>.0</b>
Structural Grade:	<b>0</b>
O&M Grade:	<b>0</b>
Clock Start/From:	
Clock To:	
1st Value:	
2nd Value:	
Value Percent:	<b>5.000</b>
Continuous Index:	
Within 8" of Joint:	<b>NO</b>
Remarks:

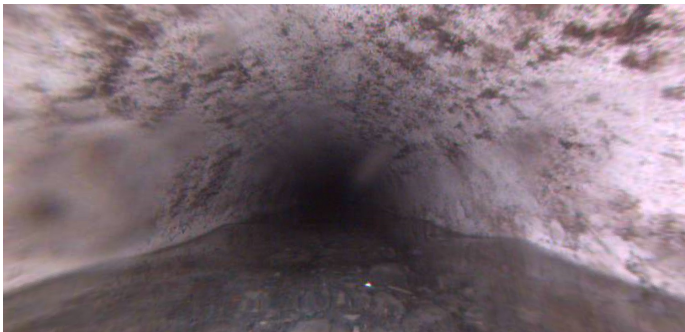
Code:	<b>MWL</b>
Description:	<b>Water Level</b>

Distance (ft):	<b>26.9</b>
Structural Grade:	<b>0</b>
O&M Grade:	<b>0</b>
Clock Start/From:	
Clock To:	
1st Value:	
2nd Value:	
Value Percent:	<b>40.000</b>
Continuous Index:	
Within 8" of Joint:	<b>NO</b>
Remarks:

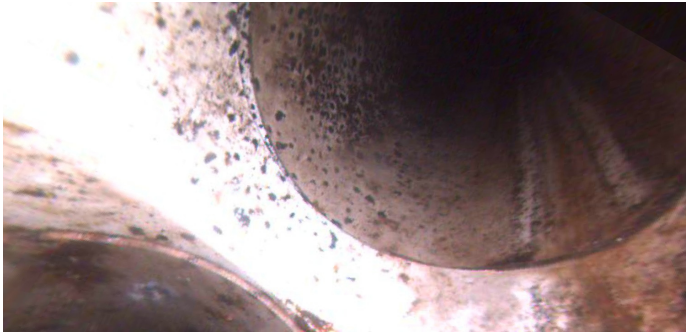
Code: **TF**  
Description: **Tap Factory**

Distance (ft): **36.9**  
Structural Grade: **0**  
O&M Grade: **0**  
Clock Start/From: **1**  
Clock To:  
1st Value: **4.000**  
2nd Value:  
Value Percent:  
Continuous Index:  
Within 8" of Joint:  
Remarks:

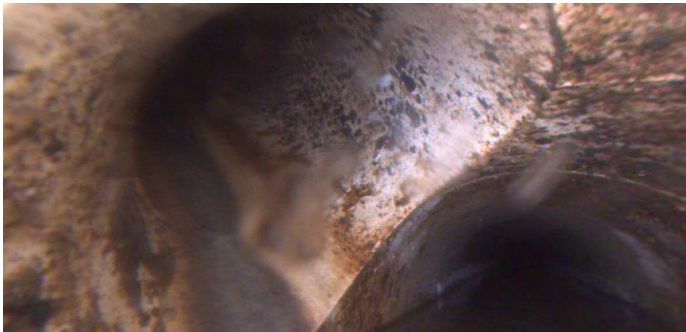
Code: **TF**  
Description: **Tap Factory**

Distance (ft): **38.3**  
Structural Grade: **0**  
O&M Grade: **0**  
Clock Start/From: **10**  
Clock To:  
1st Value: **4.000**  
2nd Value:  
Value Percent:  
Continuous Index:  
Within 8" of Joint:  
Remarks:

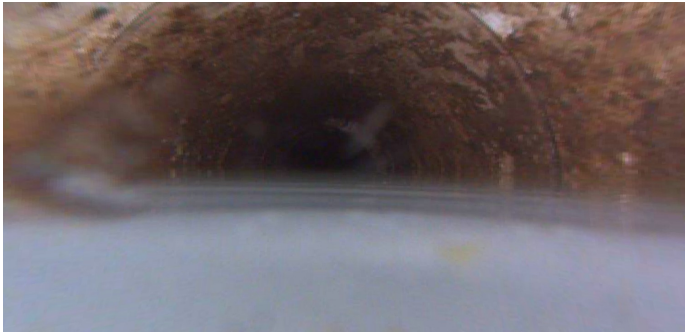
Code: **MWLS**  
Description: **Water Level Sag**

Distance (ft): **115.5**  
Structural Grade: **2**  
O&M Grade: **3**  
Clock Start/From:  
Clock To:  
1st Value:  
2nd Value:  
Value Percent: **10.000**  
Continuous Index: **S01**  
Within 8" of Joint: **NO**  
Remarks:

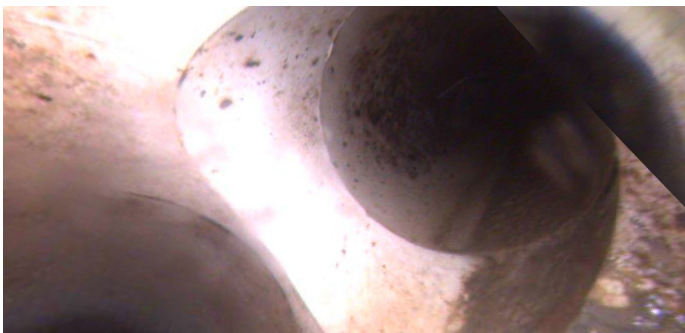
Code: **TF**  
Description: **Tap Factory**

Distance (ft): **115.7**  
Structural Grade: **0**  
O&M Grade: **0**  
Clock Start/From: **10**  
Clock To:  
1st Value: **4.000**  
2nd Value:  
Value Percent:  
Continuous Index:  
Within 8" of Joint:  
Remarks:

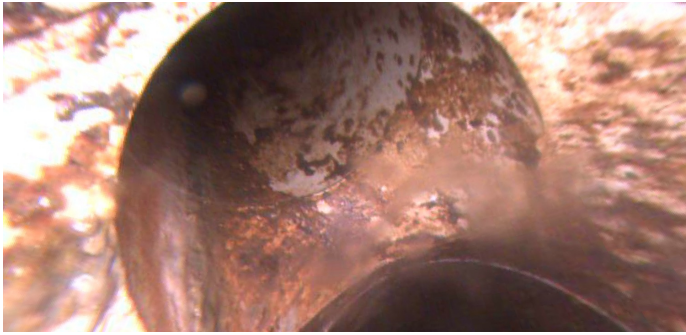
Code: **TF**  
Description: **Tap Factory**

Distance (ft): **117.4**  
Structural Grade: **0**  
O&M Grade: **0**  
Clock Start/From: **1**  
Clock To:  
1st Value: **4.000**  
2nd Value:  
Value Percent:  
Continuous Index:  
Within 8" of Joint:  
Remarks:

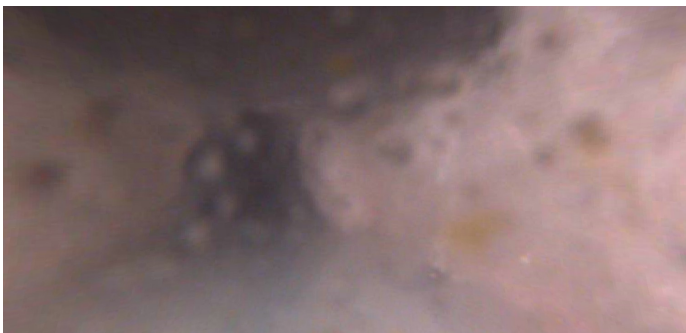
Code: **AMH**  
Description: **Manhole**

Distance (ft): **154.0**  
Structural Grade: **0**  
O&M Grade: **0**  
Clock Start/From:  
Clock To:  
1st Value:  
2nd Value:  
Value Percent:  
Continuous Index:  
Within 8" of Joint: **NO**  
Remarks: **M-709-003**

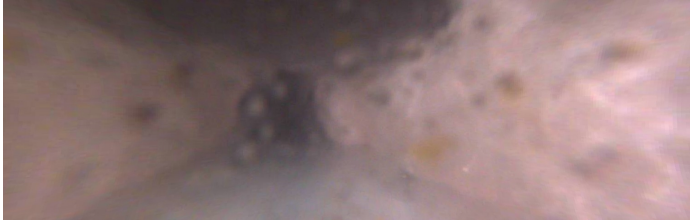
Code:	<b>MWLS</b>
Description:	<b>Water Level Sag</b>
Distance (ft):	<b>154.0</b>
Structural Grade:	<b>2</b>
O&M Grade:	<b>3</b>
Clock Start/From:	
Clock To:	
1st Value:	
2nd Value:	
Value Percent:	<b>10.000</b>
Continuous Index:	<b>F01</b>
Within 8" of Joint:	<b>NO</b>
Remarks:
