## Profile/Photo Observation Report

| Street: | <b>Oak</b> | Flow Control: | <b>Not Controlled</b> |
| City: | <b>Hobart, IN</b> | Year Renewed: | |

| US MH: | <b>M-709-003</b> | DS MH: | <b>M-709-004</b> |

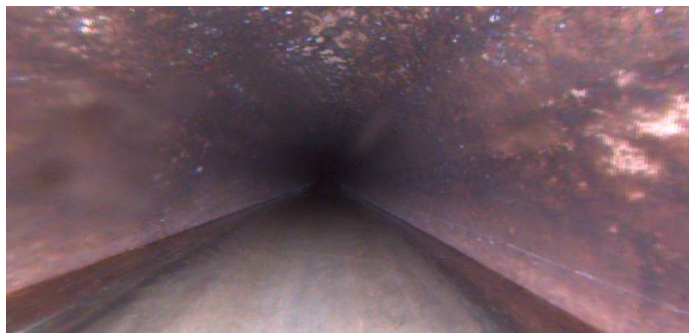
Code: **AMH**  
Description: **Manhole**

Distance (ft): **.0**  
Structural Grade: **0**  
O&M Grade: **0**  
Clock Start/From:  
Clock To:  
1st Value:  
2nd Value:  
Value Percent:  
Continuous Index:  
Within 8" of Joint: **NO**  
Remarks: **M-709-004**

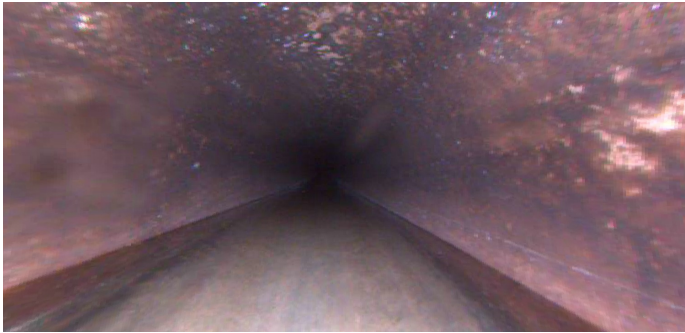
| Code: | <b>MWL</b> |
| Description: | <b>Water Level</b> |

| Distance (ft): | <b>.0</b> |
| Value Percent: | <b>5.000</b> |

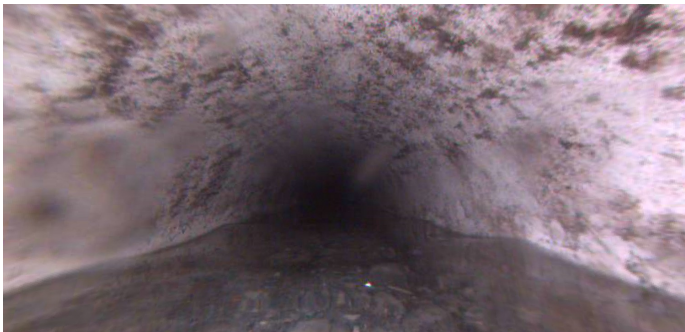
| Code: | <b>MWL</b> |
| Description: | <b>Water Level</b> |

| Distance (ft): | <b>26.9</b> |
| Value Percent: | <b>40.000</b> |

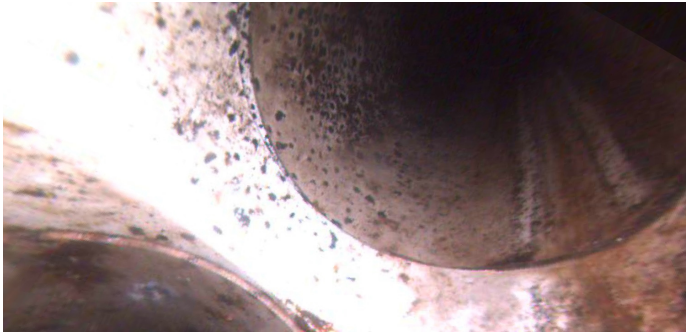
Code: **TF**  
Description: **Tap Factory**

Distance (ft): **36.9**  
Structural Grade: **0**  
O&M Grade: **0**  
Clock Start/From: **1**  
Clock To:  
1st Value: **4.000**  
2nd Value:  
Value Percent:  
Continuous Index:  
Within 8" of Joint:  
Remarks:

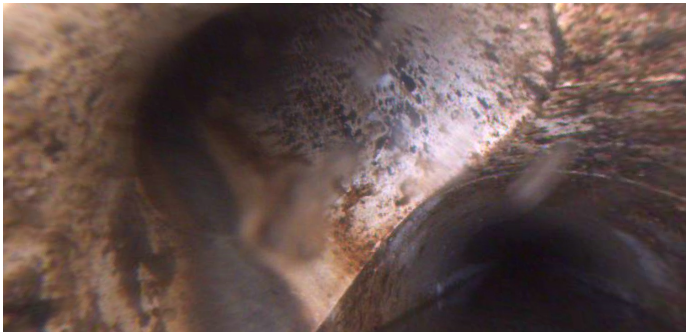
Code: **TF**  
Description: **Tap Factory**

Distance (ft): **38.3**  
Structural Grade: **0**  
O&M Grade: **0**  
Clock Start/From: **10**  
Clock To:  
1st Value: **4.000**  
2nd Value:  
Value Percent:  
Continuous Index:  
Within 8" of Joint:  
Remarks:

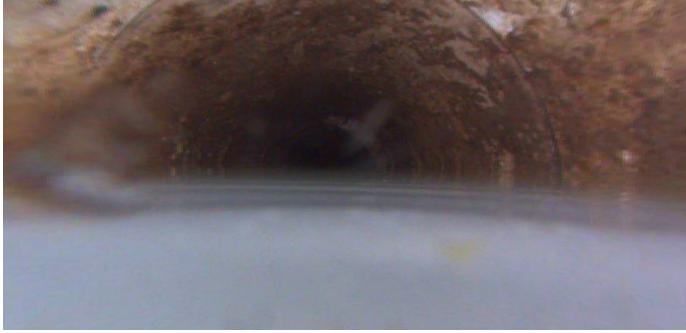
Code: **MWLS**  
Description: **Water Level Sag**

Distance (ft): **115.5**  
Structural Grade: **2**  
O&M Grade: **3**  
Clock Start/From:  
Clock To:  
1st Value:  
2nd Value:  
Value Percent: **10.000**  
Continuous Index: **S01**  
Within 8" of Joint: **NO**  
Remarks:

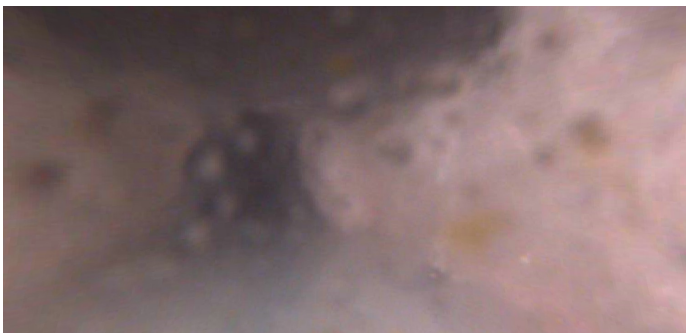
Code: **AMH**  
Description: **Manhole**

Distance (ft): **154.0**  
Structural Grade: **0**  
O&M Grade: **0**  
Clock Start/From:  
Clock To:  
1st Value:  
2nd Value:  
Value Percent:  
Continuous Index:  
Within 8" of Joint: **NO**  
Remarks: **M-709-003**
