Profile/Photo Observation Report

Date:	03/21/2018	Weather:		Coding:	PACP 6.0
Pipe Length (ft):	174.7	Owner:	NA	Pre Clean:	Not Known
P.O.#:		Surveyor:	Selasie Honu	PSR:	P-709-004-005
Customer:		Clean Date:	01/01/1900	Shape:	C

Street:	BRACKEN PKWY	Flow Control:	Not Controlled
City:	Hobart, IN	Year Renewed:	
Location:	Sidewalk	Tape/Media #:	
Purpose:	Maintenance Related	Dia/Height:	8"
Use:	Sanitary	Material:	PVC
Drain Area:	NA	Lining:	
Category:	NA		
Comment:			
Location Details:		Direction of Survey:	Downstream
US MH:	M-709-004	DS MH:	M-709-005
		Total Length Surveyed (ft):	175.9

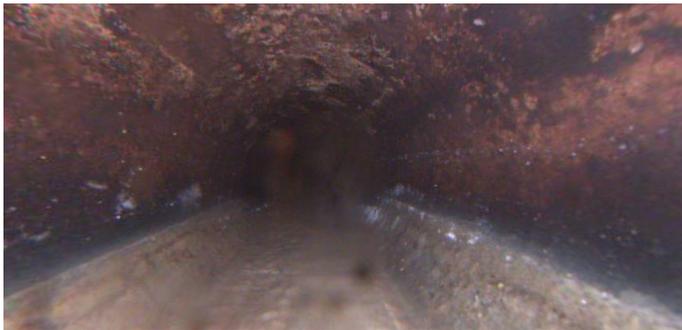
Code: **DAGS**
Description: **Deposits Attached Grease**

Distance (ft): **.0**
Structural Grade: **0**
O&M Grade: **2**
Clock Start/From: **8**
Clock To: **4**
1st Value:
2nd Value:
Value Percent: **5.000**
Continuous Index: **S01**
Within 8" of Joint: **NO**
Remarks:

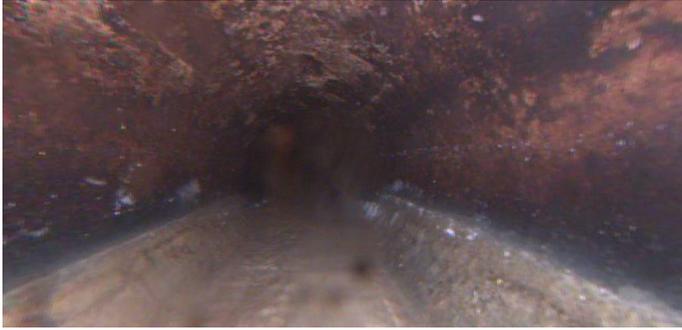
Code: **AMH**
Description: **Manhole**

Distance (ft): **.0**
Structural Grade: **0**
O&M Grade: **0**
Clock Start/From:
Clock To:
1st Value:
2nd Value:
Value Percent:
Continuous Index:
Within 8" of Joint: **NO**
Remarks: **M-709-004**

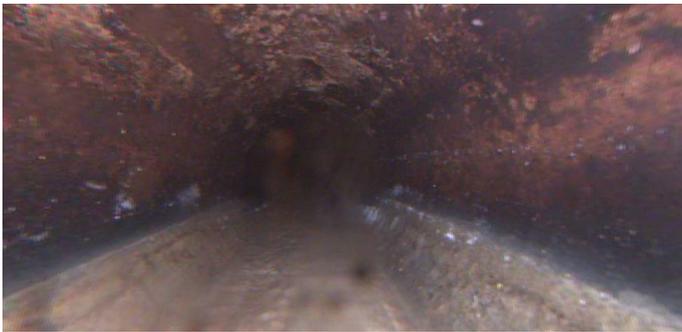
Code: **MWL**
Description: **Water Level**

Distance (ft): **.0**
Structural Grade: **0**
O&M Grade: **0**
Clock Start/From:
Clock To:
1st Value:
2nd Value:
Value Percent: **5.000**
Continuous Index:
Within 8" of Joint: **NO**
Remarks:

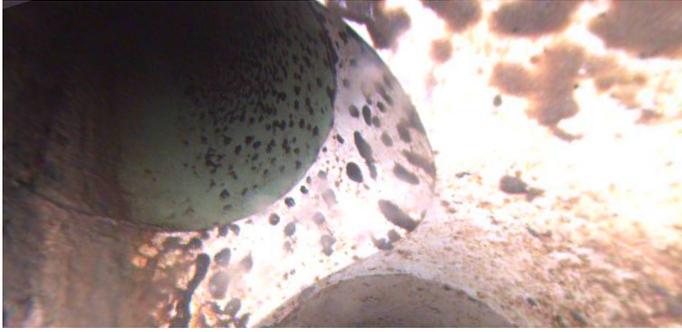
Code: **TF**
Description: **Tap Factory**

Distance (ft): **38.4**
Structural Grade: **0**
O&M Grade: **0**
Clock Start/From: **11**
Clock To:
1st Value: **4.000**
2nd Value:
Value Percent:
Continuous Index:
Within 8" of Joint:
Remarks:

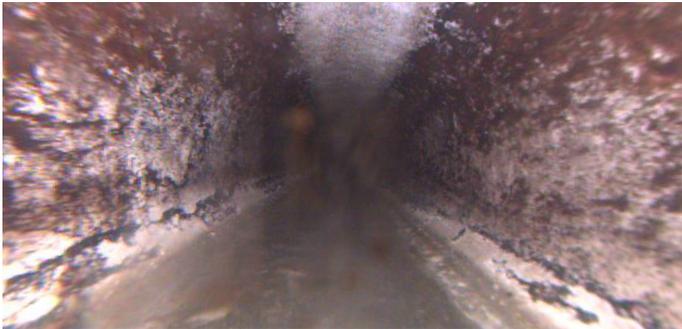
Code: **DAGS**
Description: **Deposits Attached Grease**

Distance (ft): **45.9**
Structural Grade: **0**
O&M Grade: **2**
Clock Start/From: **8**
Clock To: **4**
1st Value:
2nd Value:
Value Percent: **5.000**
Continuous Index: **F01**
Within 8" of Joint: **NO**
Remarks:

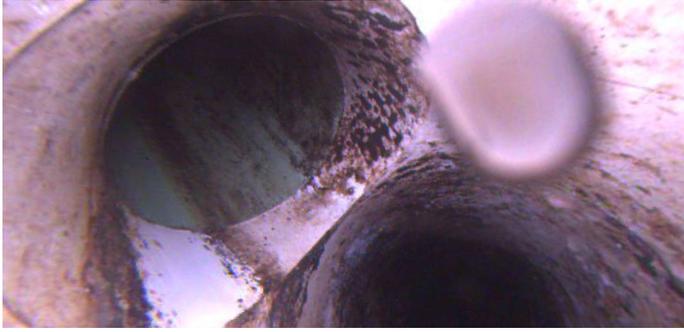
Code: **TF**
Description: **Tap Factory**

Distance (ft): **80.2**
Structural Grade: **0**
O&M Grade: **0**
Clock Start/From: **2**
Clock To:
1st Value: **4.000**
2nd Value:
Value Percent:
Continuous Index:
Within 8" of Joint:
Remarks:

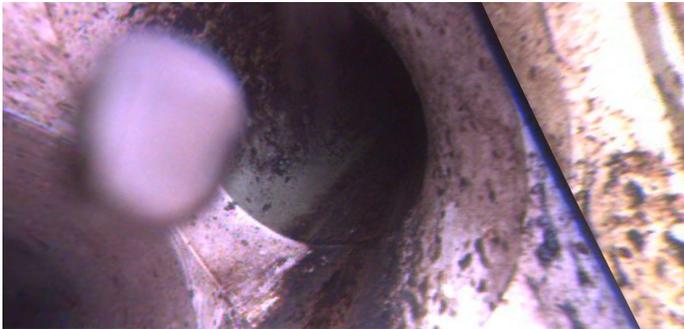
Code: **TF**
Description: **Tap Factory**

Distance (ft): **133.2**
Structural Grade: **0**
O&M Grade: **0**
Clock Start/From: **10**
Clock To:
1st Value: **4.000**
2nd Value:
Value Percent:
Continuous Index:
Within 8" of Joint:
Remarks:

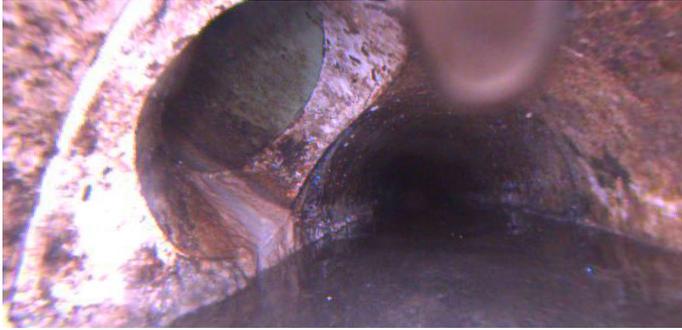
Code: **TF**
Description: **Tap Factory**

Distance (ft): **158.7**
Structural Grade: **0**
O&M Grade: **0**
Clock Start/From: **2**
Clock To:
1st Value: **4.000**
2nd Value:
Value Percent:
Continuous Index:
Within 8" of Joint:
Remarks:

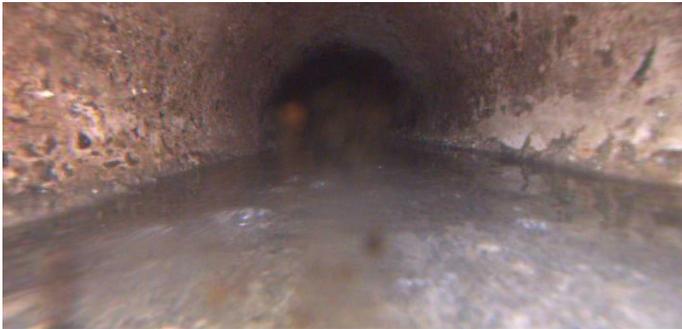
Code: **MWL**
Description: **Water Level**

Distance (ft): **158.7**
Structural Grade: **0**
O&M Grade: **0**
Clock Start/From:
Clock To:
1st Value:
2nd Value:
Value Percent: **30.000**
Continuous Index:
Within 8" of Joint: **NO**
Remarks:

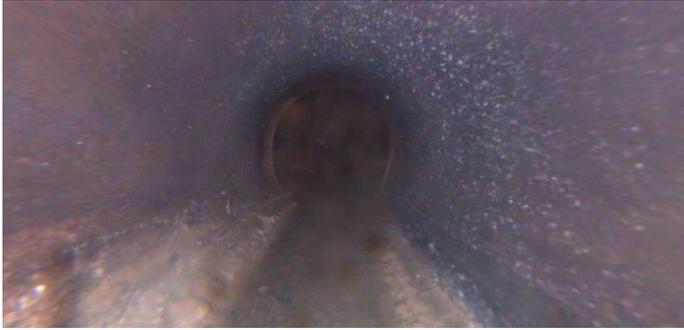
Code: **MWL**
Description: **Water Level**

Distance (ft): **172.6**
Structural Grade: **0**
O&M Grade: **0**
Clock Start/From:
Clock To:
1st Value:
2nd Value:
Value Percent: **5.000**
Continuous Index:
Within 8" of Joint: **NO**
Remarks:

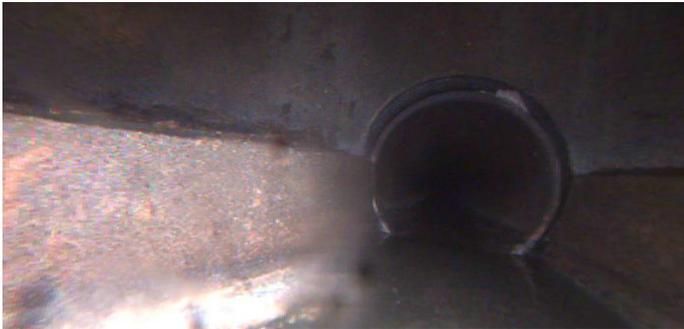
Code: **AMH**
Description: **Manhole**

Distance (ft): **175.9**
Structural Grade: **0**
O&M Grade: **0**
Clock Start/From:
Clock To:
1st Value:
2nd Value:
Value Percent:
Continuous Index:
Within 8" of Joint: **NO**
Remarks: **M-709-005**
