Profile/Photo Observation Report

Date:	03/20/2018	Weather:		Coding:	PACP 6.0
Pipe Length (ft):	201.0	Owner:	NA	Pre Clean:	Not Known
P.O.#:		Surveyor:	John Kuglmaier	PSR:	P-709-005-006
Customer:		Clean Date:	01/01/1900	Shape:	C

Street:	BRACKEN PKWY & DUNLIN CT	Flow Control:	Not Controlled
City:	Hobart, IN	Year Renewed:	
Location:	Yard	Tape/Media #:	
Purpose:	Maintenance Related	Dia/Height:	10"
Use:	Sanitary	Material:	PVC
Drain Area:	NA	Lining:	
Category:	NA		
Comment:

Location Details:		Direction of Survey:	Upstream
US MH:	M-709-005	DS MH:	M-709-006
		Total Length Surveyed (ft):	192.7

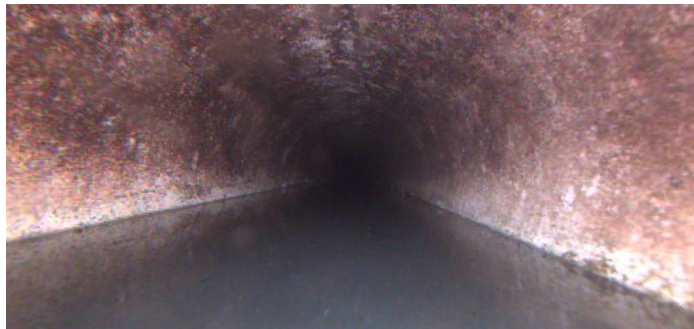
Code: **AMH**
Description: **Manhole**

Distance (ft): **.0**
Structural Grade: **0**
O&M Grade: **0**
Clock Start/From:
Clock To:
1st Value:
2nd Value:
Value Percent:
Continuous Index:
Within 8" of Joint: **NO**
Remarks: **M-709-006**

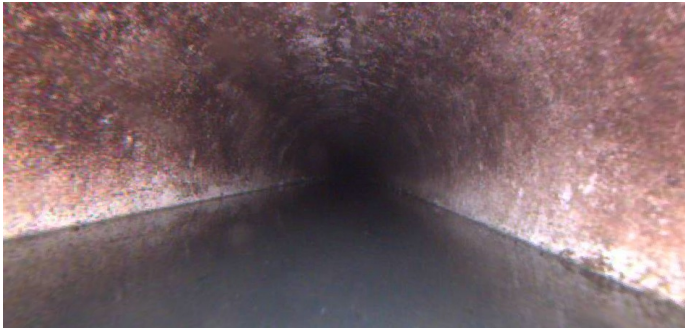
Code:	MWL
Description:	Water Level

Distance (ft):	.0
Structural Grade:	0
O&M Grade:	0
Clock Start/From:	
Clock To:	
1st Value:	
2nd Value:	
Value Percent:	35.000
Continuous Index:	
Within 8" of Joint:	NO
Remarks:

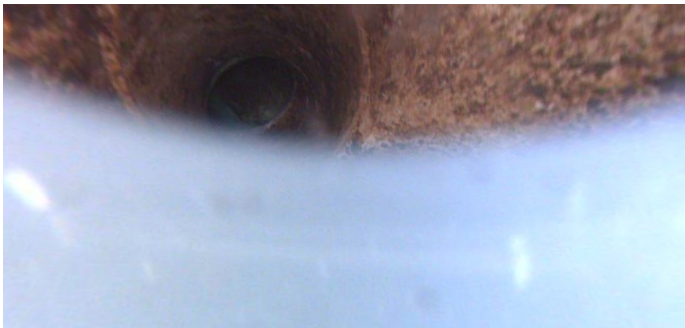
Code:	TF
Description:	Tap Factory

Distance (ft):	77.2
Structural Grade:	0
O&M Grade:	0
Clock Start/From:	10
Clock To:	
1st Value:	4.000
2nd Value:	
Value Percent:	
Continuous Index:	
Within 8" of Joint:	
Remarks:

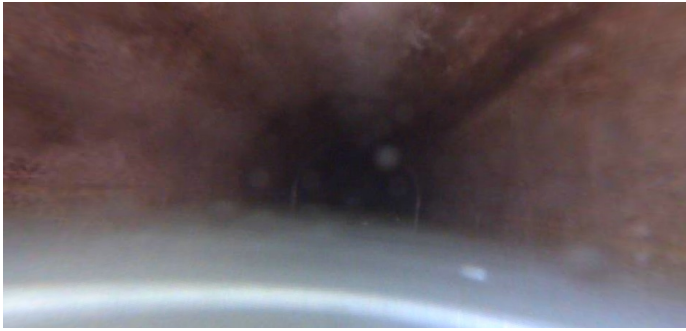
Code: **MWL**
Description: **Water Level**

Distance (ft): **162.9**
Structural Grade: **0**
O&M Grade: **0**
Clock Start/From:
Clock To:
1st Value:
2nd Value:
Value Percent: **50.000**
Continuous Index:
Within 8" of Joint: **NO**
Remarks:

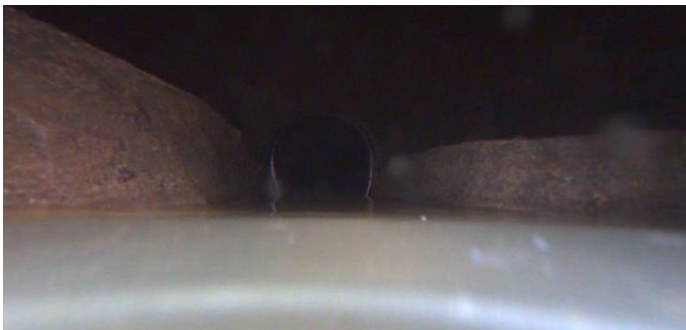
Code: **AMH**
Description: **Manhole**

Distance (ft): **192.7**
Structural Grade: **0**
O&M Grade: **0**
Clock Start/From:
Clock To:
1st Value:
2nd Value:
Value Percent:
Continuous Index:
Within 8" of Joint: **NO**
Remarks: **M-709-005**
