Profile/Photo Observation Report

Date:	03/19/2018	Weather:		Coding:	PACP 6.0
Pipe Length (ft):	60.1	Owner:	NA	Pre Clean:	Not Known
P.O.#:		Surveyor:	John Kuglmaier	PSR:	P-709-012-011
Customer:		Clean Date:	01/01/1900	Shape:	C

Street:	Oak	Flow Control:	Not Controlled
City:	Hobart, IN	Year Renewed:	
Location:	Light Highway	Tape/Media #:	
Purpose:	Maintenance Related	Dia/Height:	8"
Use:	Sanitary	Material:	PVC
Drain Area:	NA	Lining:	
Category:	NA		
Comment:

Location Details:		Direction of Survey:	Upstream
US MH:	M-709-011	DS MH:	M-709-012
		Total Length Surveyed (ft):	56.7

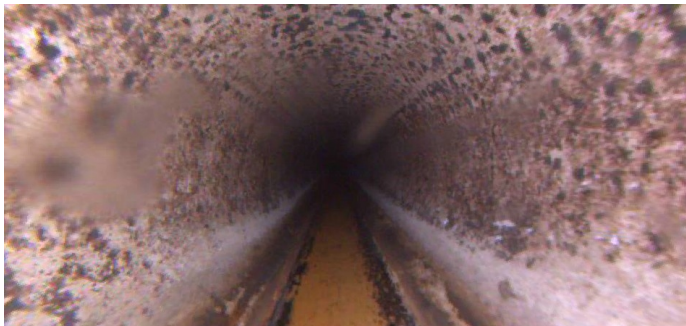
Code: **AMH**
Description: **Manhole**

Distance (ft): **.0**
Structural Grade: **0**
O&M Grade: **0**
Clock Start/From:
Clock To:
1st Value:
2nd Value:
Value Percent:
Continuous Index:
Within 8" of Joint: **NO**
Remarks: **M-709-012**

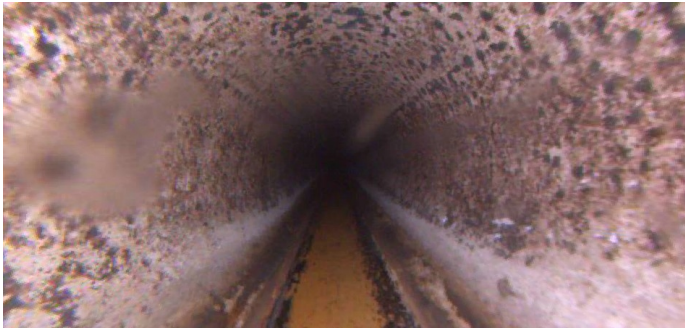
Code:	MWL
Description:	Water Level

Distance (ft):	.0
Structural Grade:	0
O&M Grade:	0
Clock Start/From:	
Clock To:	
1st Value:	
2nd Value:	
Value Percent:	5.000
Continuous Index:	
Within 8" of Joint:	NO
Remarks:

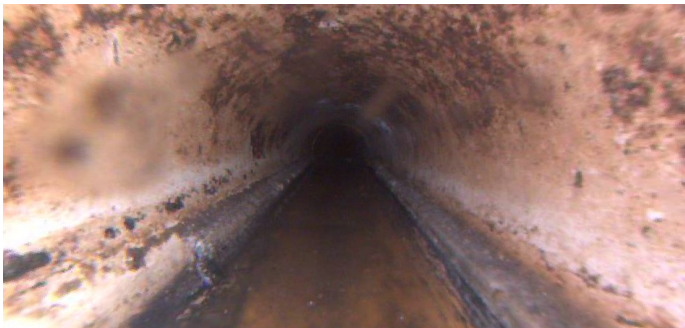
Code:	DAGS
Description:	Deposits Attached Grease

Distance (ft):	31.9
Structural Grade:	0
O&M Grade:	2
Clock Start/From:	4
Clock To:	8
1st Value:	
2nd Value:	
Value Percent:	10.000
Continuous Index:	S01
Within 8" of Joint:	NO
Remarks:

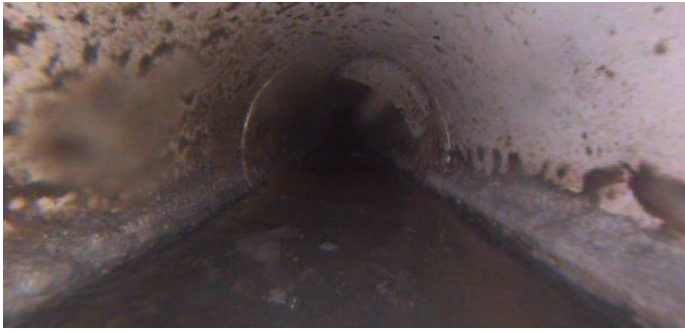
Code: **MWL**
Description: **Water Level**

Distance (ft): **34.0**
Structural Grade: **0**
O&M Grade: **0**
Clock Start/From:
Clock To:
1st Value:
2nd Value:
Value Percent: **25.000**
Continuous Index:
Within 8" of Joint: **NO**
Remarks:

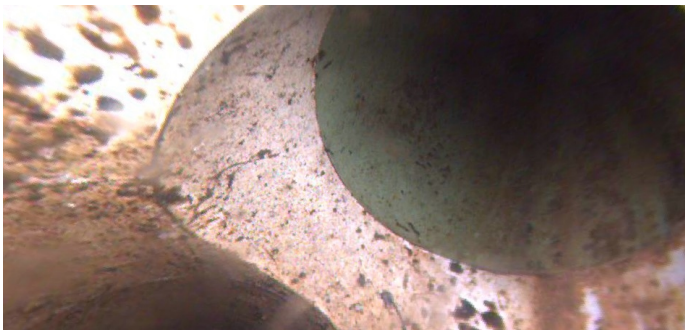
Code: **TF**
Description: **Tap Factory**

Distance (ft): **35.0**
Structural Grade: **0**
O&M Grade: **0**
Clock Start/From: **2**
Clock To:
1st Value: **4.000**
2nd Value:
Value Percent:
Continuous Index:
Within 8" of Joint:
Remarks:

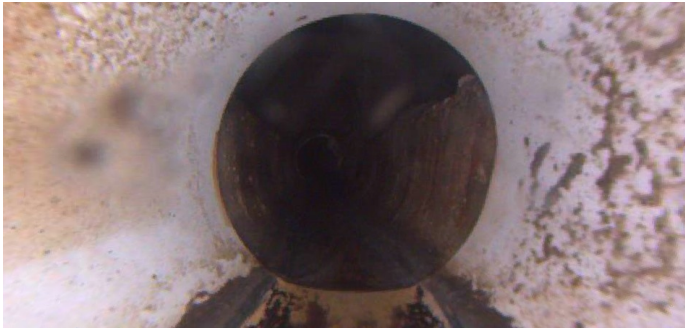
Code: **DAGS**
Description: **Deposits Attached Grease**

Distance (ft): **54.2**
Structural Grade: **0**
O&M Grade: **2**
Clock Start/From: **4**
Clock To: **8**
1st Value:
2nd Value:
Value Percent: **10.000**
Continuous Index: **F01**
Within 8" of Joint: **NO**
Remarks: **Clock positions vary**

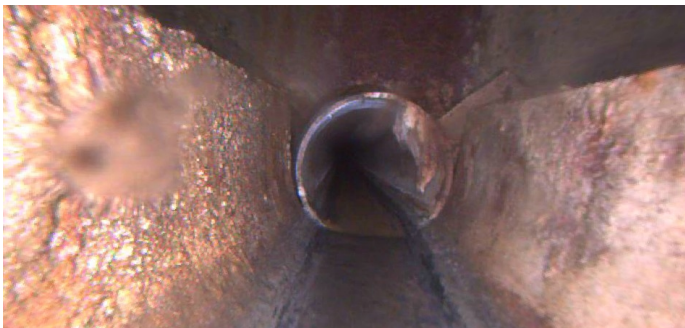
Code: **AMH**
Description: **Manhole**

Distance (ft): **56.7**
Structural Grade: **0**
O&M Grade: **0**
Clock Start/From:
Clock To:
1st Value:
2nd Value:
Value Percent:
Continuous Index:
Within 8" of Joint: **NO**
Remarks: **M-709-011**
