## Profile/Photo Observation Report

Street:	<b>Oak</b>	Flow Control:	<b>Not Controlled</b>
City:	<b>Hobart, IN</b>	Year Renewed:	
Location:	<b>Yard</b>	Tape/Media #:	
Purpose:	<b>Maintenance Related</b>	Dia/Height:	<b>8"</b>
Use:	<b>Sanitary</b>	Material:	<b>PVC</b>
Drain Area:	<b>NA</b>	Lining:	
Category:	<b>NA</b>		
Comment:

Location Details:		Direction of Survey:	<b>Upstream</b>
US MH:	<b>M-709-012</b>	DS MH:	<b>M-709-013</b>
		Total Length Surveyed (ft):	<b>163.8</b>

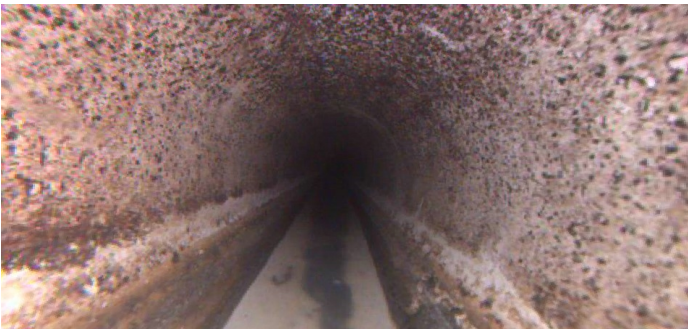
Code: **AMH**  
Description: **Manhole**

Distance (ft): **.0**  
Structural Grade: **0**  
O&M Grade: **0**  
Clock Start/From:  
Clock To:  
1st Value:  
2nd Value:  
Value Percent:  
Continuous Index:  
Within 8" of Joint: **NO**  
Remarks: **M-709-013**

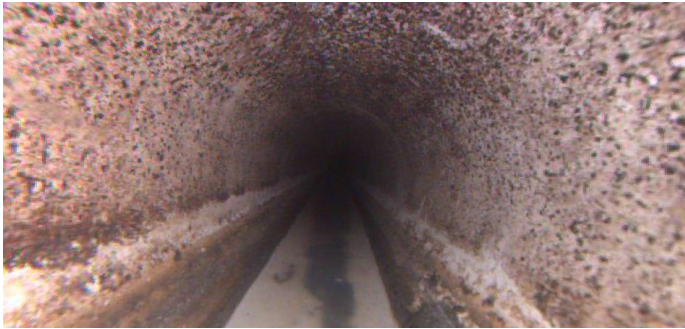
Code:	<b>MWL</b>
Description:	<b>Water Level</b>

Distance (ft):	<b>.0</b>
Structural Grade:	<b>0</b>
O&M Grade:	<b>0</b>
Clock Start/From:	
Clock To:	
1st Value:	
2nd Value:	
Value Percent:	<b>10.000</b>
Continuous Index:	
Within 8" of Joint:	<b>NO</b>
Remarks:

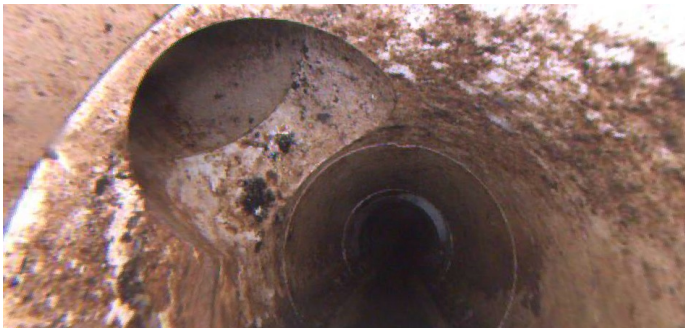
Code:	<b>TF</b>
Description:	<b>Tap Factory</b>

Distance (ft):	<b>30.3</b>
Structural Grade:	<b>0</b>
O&M Grade:	<b>0</b>
Clock Start/From:	<b>10</b>
Clock To:	
1st Value:	<b>4.000</b>
2nd Value:	
Value Percent:	
Continuous Index:	
Within 8" of Joint:	
Remarks:

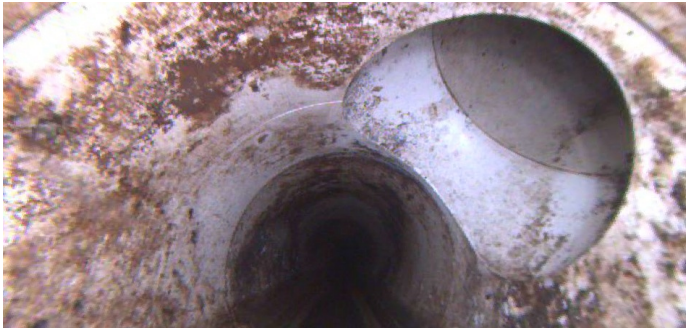
Code: **TF**  
Description: **Tap Factory**

Distance (ft): **31.9**  
Structural Grade: **0**  
O&M Grade: **0**  
Clock Start/From: **2**  
Clock To:  
1st Value: **4.000**  
2nd Value:  
Value Percent:  
Continuous Index:  
Within 8" of Joint:  
Remarks:

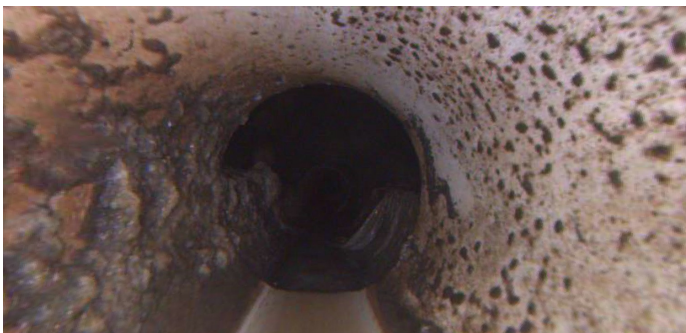
Code: **DAGS**  
Description: **Deposits Attached Grease**

Distance (ft): **161.0**  
Structural Grade: **0**  
O&M Grade: **2**  
Clock Start/From: **8**  
Clock To: **4**  
1st Value:  
2nd Value:  
Value Percent: **5.000**  
Continuous Index:  
Within 8" of Joint: **NO**  
Remarks:

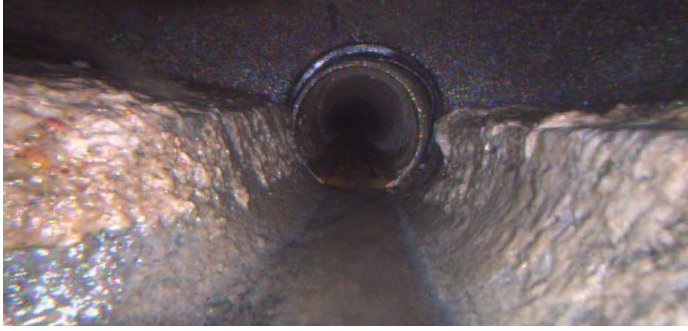
Code:	<b>AMH</b>
Description:	<b>Manhole</b>
Distance (ft):	<b>163.8</b>
Structural Grade:	<b>0</b>
O&M Grade:	<b>0</b>
Clock Start/From:	
Clock To:	
1st Value:	
2nd Value:	
Value Percent:	
Continuous Index:	
Within 8" of Joint:	<b>NO</b>
Remarks:	<b>M-709-012</b>
