Profile/Photo Observation Report

Date:	03/20/2018	Weather:		Coding:	PACP 6.0
Pipe Length (ft):	170.8	Owner:	NA	Pre Clean:	Not Known
P.O.#:		Surveyor:	John Kuglmaier	PSR:	P-709-029-012
Customer:		Clean Date:	01/01/1900	Shape:	C

Street:	Oak	Flow Control:	Not Controlled
City:	Hobart, IN	Year Renewed:	
Location:	Yard	Tape/Media #:	
Purpose:	Maintenance Related	Dia/Height:	8"
Use:	Sanitary	Material:	PVC
Drain Area:	NA	Lining:	
Category:	NA		
Comment:	2nd attempt. mh at 168', broke up clay mound.		
Location Details:		Direction of Survey:	Upstream
US MH:	M-709-012	DS MH:	M-709-029
		Total Length Surveyed (ft):	169.7

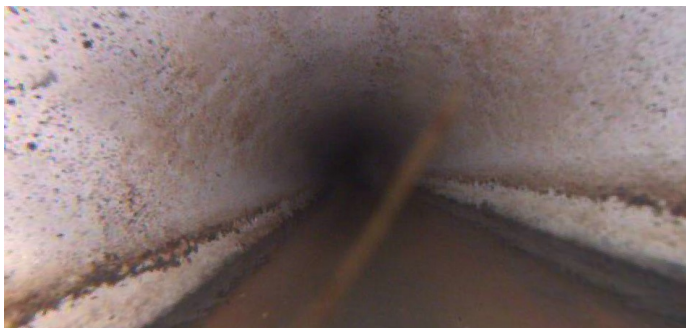
Code: **AMH**
Description: **Manhole**

Distance (ft): **.0**
Structural Grade: **0**
O&M Grade: **0**
Clock Start/From:
Clock To:
1st Value:
2nd Value:
Value Percent:
Continuous Index:
Within 8" of Joint: **NO**
Remarks: **M-709-029**

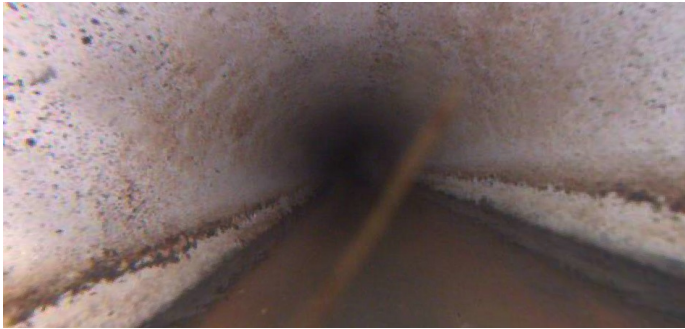
Code:	MWL
Description:	Water Level

Distance (ft):	.0
Structural Grade:	0
O&M Grade:	0
Clock Start/From:	
Clock To:	
1st Value:	
2nd Value:	
Value Percent:	20.000
Continuous Index:	
Within 8" of Joint:	NO
Remarks:

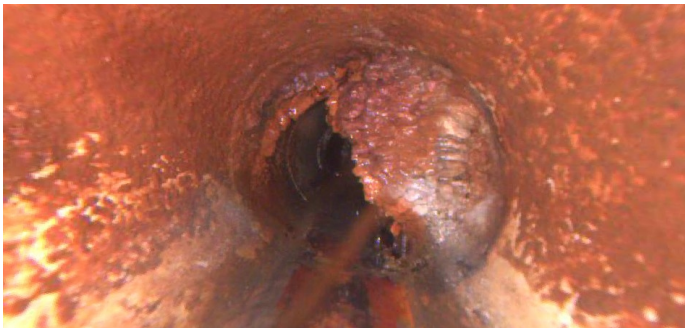
Code:	DAE
Description:	Deposits Attached Encrustation

Distance (ft):	68.3
Structural Grade:	0
O&M Grade:	5
Clock Start/From:	9
Clock To:	5
1st Value:	
2nd Value:	
Value Percent:	50.000
Continuous Index:	
Within 8" of Joint:	YES
Remarks:

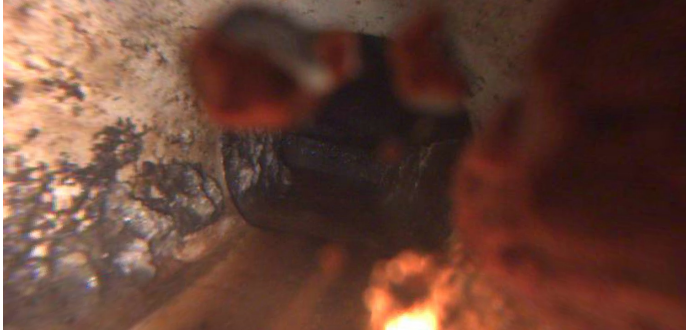
Code: **DAGS**
Description: **Deposits Attached Grease**

Distance (ft): **167.0**
Structural Grade: **0**
O&M Grade: **2**
Clock Start/From: **8**
Clock To: **4**
1st Value:
2nd Value:
Value Percent: **5.000**
Continuous Index:
Within 8" of Joint: **NO**
Remarks:
