Profile/Photo Observation Report

Date:	03/19/2018	Weather:		Coding:	PACP 6.0
Pipe Length (ft):	170.8	Owner:	NA	Pre Clean:	Not Known
P.O.#:		Surveyor:	John Kuglmaier	PSR:	P-709-030-012
Customer:		Clean Date:	01/01/1900	Shape:	C

Street:	WAXWING CIR	Flow Control:	Not Controlled
City:	Hobart, IN	Year Renewed:	
Location:	Yard	Tape/Media #:	
Purpose:	Maintenance Related	Dia/Height:	8"
Use:	Sanitary	Material:	PVC
Drain Area:	NA	Lining:	
Category:	NA		
Comment:

Location Details:		Direction of Survey:	Upstream
US MH:	M-709-012	DS MH:	M-709-030
		Total Length Surveyed (ft):	169.5

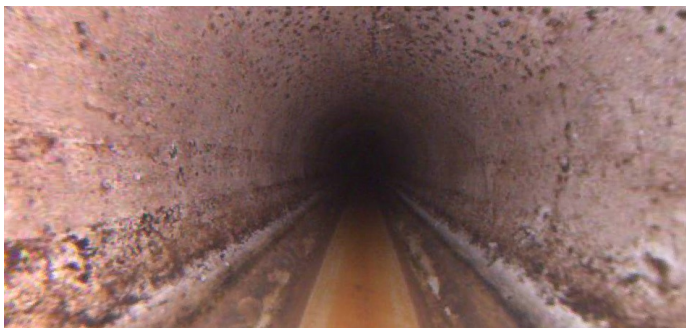
Code: **AMH**
Description: **Manhole**

Distance (ft): **.0**
Structural Grade: **0**
O&M Grade: **0**
Clock Start/From:
Clock To:
1st Value:
2nd Value:
Value Percent:
Continuous Index:
Within 8" of Joint: **NO**
Remarks: **M-709-030**

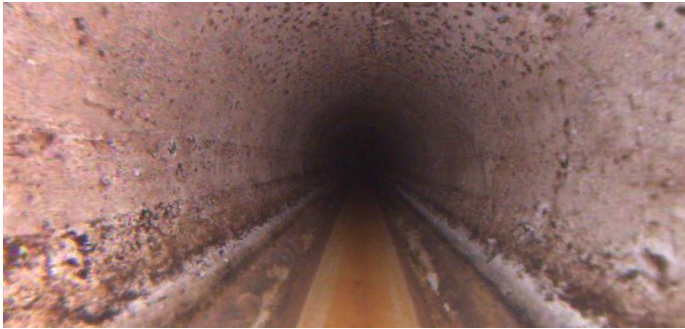
Code:	MWL
Description:	Water Level

Distance (ft):	.0
Structural Grade:	0
O&M Grade:	0
Clock Start/From:	
Clock To:	
1st Value:	
2nd Value:	
Value Percent:	5.000
Continuous Index:	
Within 8" of Joint:	NO
Remarks:

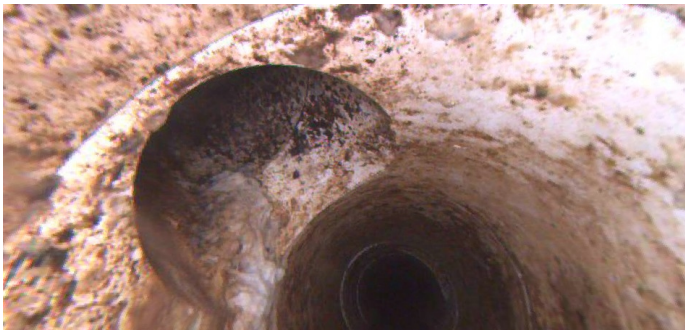
Code:	TF
Description:	Tap Factory

Distance (ft):	8.4
Structural Grade:	0
O&M Grade:	0
Clock Start/From:	10
Clock To:	
1st Value:	4.000
2nd Value:	
Value Percent:	
Continuous Index:	
Within 8" of Joint:	
Remarks:

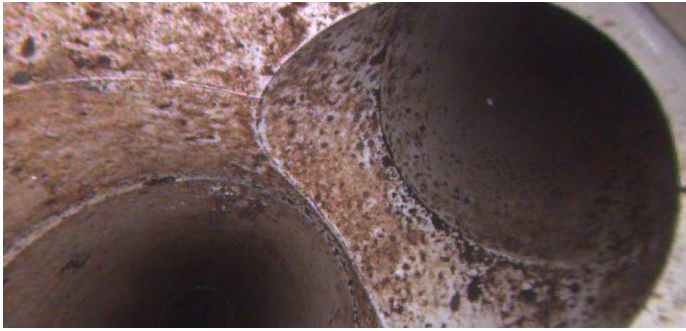
Code: **TF**
Description: **Tap Factory**

Distance (ft): **10.2**
Structural Grade: **0**
O&M Grade: **0**
Clock Start/From: **2**
Clock To:
1st Value: **4.000**
2nd Value:
Value Percent:
Continuous Index:
Within 8" of Joint:
Remarks:

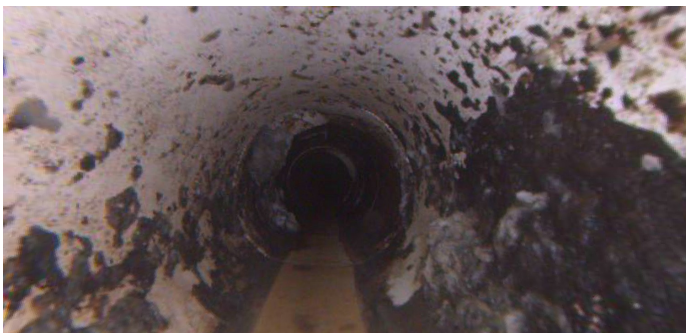
Code: **DAGS**
Description: **Deposits Attached Grease**

Distance (ft): **64.8**
Structural Grade: **0**
O&M Grade: **2**
Clock Start/From: **3**
Clock To: **5**
1st Value:
2nd Value:
Value Percent: **5.000**
Continuous Index:
Within 8" of Joint: **NO**
Remarks:

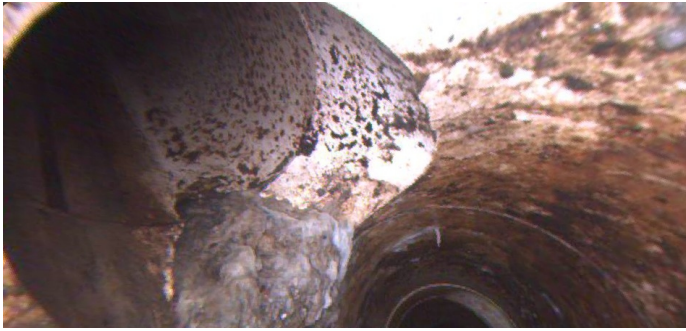
Code: **TF**
Description: **Tap Factory**

Distance (ft): **65.9**
Structural Grade: **0**
O&M Grade: **0**
Clock Start/From: **10**
Clock To:
1st Value: **4.000**
2nd Value:
Value Percent:
Continuous Index:
Within 8" of Joint:
Remarks:

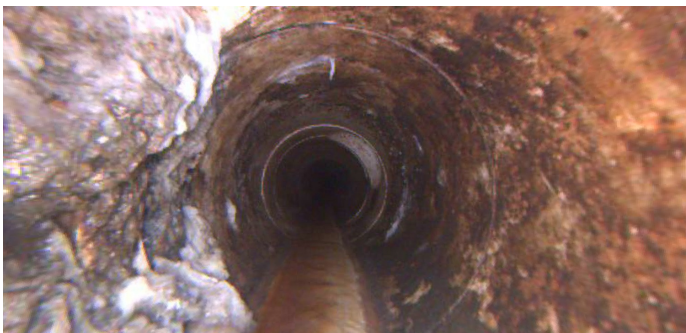
Code: **DAGS**
Description: **Deposits Attached Grease**

Distance (ft): **66.0**
Structural Grade: **0**
O&M Grade: **2**
Clock Start/From: **7**
Clock To: **9**
1st Value:
2nd Value:
Value Percent: **5.000**
Continuous Index:
Within 8" of Joint: **NO**
Remarks:

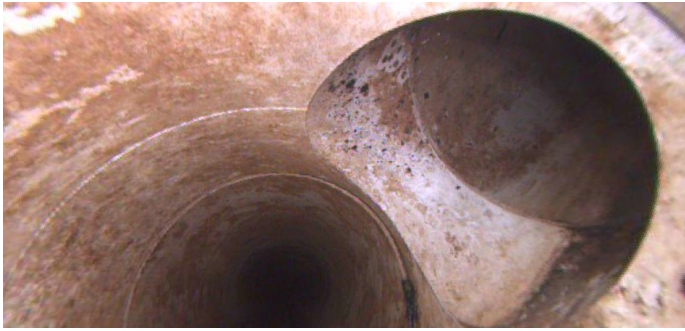
Code: **TF**
Description: **Tap Factory**

Distance (ft): **67.5**
Structural Grade: **0**
O&M Grade: **0**
Clock Start/From: **2**
Clock To:
1st Value: **4.000**
2nd Value:
Value Percent:
Continuous Index:
Within 8" of Joint:
Remarks:

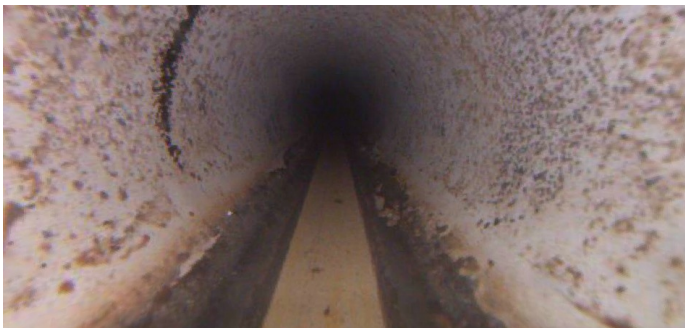
Code: **DAZ**
Description: **Deposits Attached Other**

Distance (ft): **118.4**
Structural Grade: **0**
O&M Grade: **2**
Clock Start/From: **4**
Clock To: **8**
1st Value:
2nd Value:
Value Percent: **5.000**
Continuous Index: **S01**
Within 8" of Joint: **NO**
Remarks: **Mixed materials**

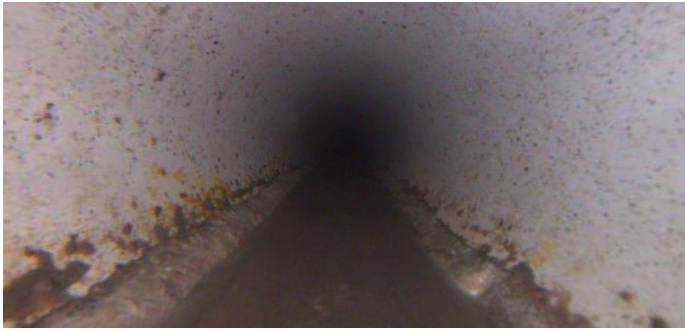
Code: **MWL**
Description: **Water Level**

Distance (ft): **130.5**
Structural Grade: **0**
O&M Grade: **0**
Clock Start/From:
Clock To:
1st Value:
2nd Value:
Value Percent: **15.000**
Continuous Index:
Within 8" of Joint: **NO**
Remarks:

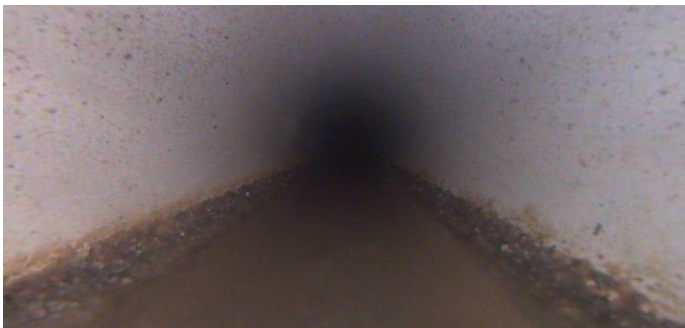
Code: **MWL**
Description: **Water Level**

Distance (ft): **137.7**
Structural Grade: **0**
O&M Grade: **0**
Clock Start/From:
Clock To:
1st Value:
2nd Value:
Value Percent: **25.000**
Continuous Index:
Within 8" of Joint: **NO**
Remarks:

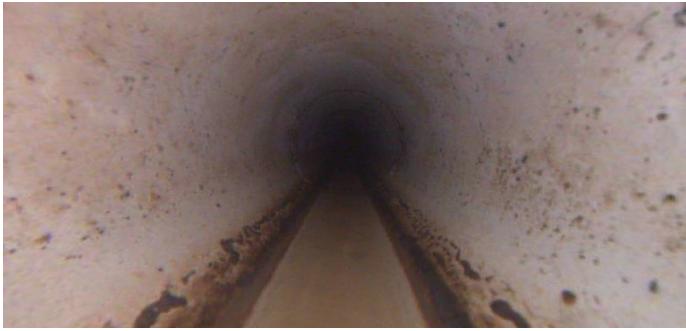
Code: **DAZ**
Description: **Deposits Attached Other**

Distance (ft): **152.1**
Structural Grade: **0**
O&M Grade: **2**
Clock Start/From: **4**
Clock To: **8**
1st Value:
2nd Value:
Value Percent: **5.000**
Continuous Index: **F01**
Within 8" of Joint: **NO**
Remarks: **Mixed materials / Clock positions vary**

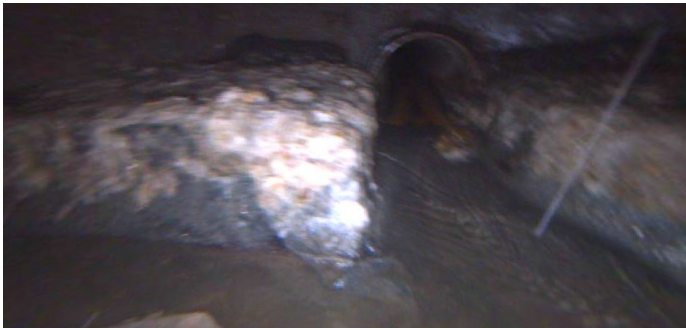
Code: **AMH**
Description: **Manhole**

Distance (ft): **169.5**
Structural Grade: **0**
O&M Grade: **0**
Clock Start/From:
Clock To:
1st Value:
2nd Value:
Value Percent:
Continuous Index:
Within 8" of Joint: **NO**
Remarks: **M-709-012**
