Profile/Photo Observation Report

Date:	03/19/2018	Weather:		Coding:	PACP 6.0
Pipe Length (ft):	170.8	Owner:	NA	Pre Clean:	Not Known
P.O.#:		Surveyor:	John Kuglmaier	PSR:	P-709-030-012
Customer:		Clean Date:	01/01/1900	Shape:	C

Street:	Oak	Flow Control:	Not Controlled
City:	Hobart, IN	Year Renewed:	
Location:	Yard	Tape/Media #:	
Purpose:	Maintenance Related	Dia/Height:	8"
Use:	Sanitary	Material:	PVC
Drain Area:	NA	Lining:	
Category:	NA		
Comment:

Location Details:		Direction of Survey:	Upstream
US MH:	M-709-012	DS MH:	M-709-030
		Total Length Surveyed (ft):	169.5

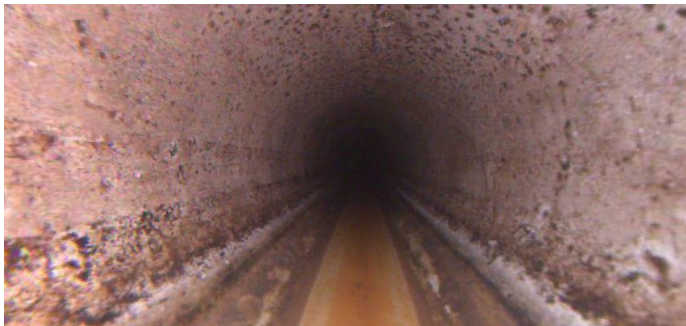
Code: **AMH**
Description: **Manhole**

Distance (ft): **.0**
Structural Grade: **0**
O&M Grade: **0**
Clock Start/From:
Clock To:
1st Value:
2nd Value:
Value Percent:
Continuous Index:
Within 8" of Joint: **NO**
Remarks: **M-709-030**

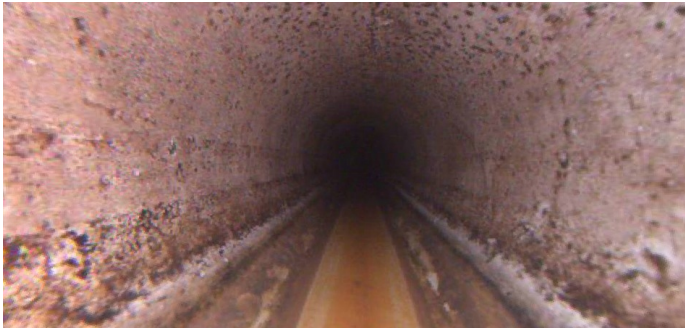
Code:	MWL
Description:	Water Level

Distance (ft):	.0
Structural Grade:	0
O&M Grade:	0
Clock Start/From:	
Clock To:	
1st Value:	
2nd Value:	
Value Percent:	5.000
Continuous Index:	
Within 8" of Joint:	NO
Remarks:

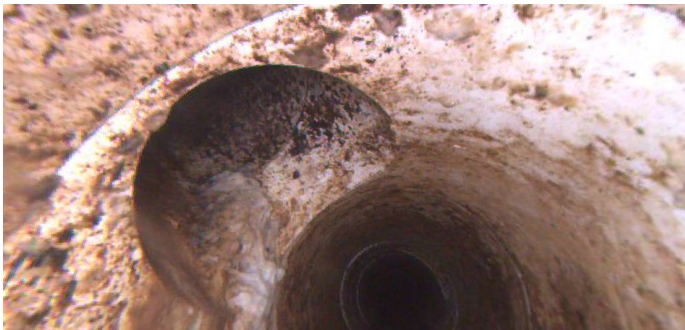
Code:	TF
Description:	Tap Factory

Distance (ft):	8.4
Structural Grade:	0
O&M Grade:	0
Clock Start/From:	10
Clock To:	
1st Value:	4.000
2nd Value:	
Value Percent:	
Continuous Index:	
Within 8" of Joint:	
Remarks:

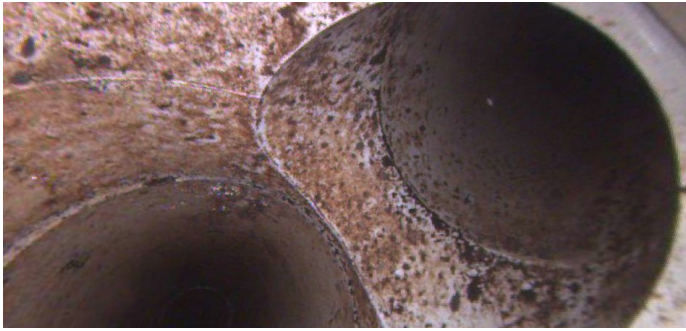
Code: **TF**
Description: **Tap Factory**

Distance (ft): **10.2**
Structural Grade: **0**
O&M Grade: **0**
Clock Start/From: **2**
Clock To:
1st Value: **4.000**
2nd Value:
Value Percent:
Continuous Index:
Within 8" of Joint:
Remarks:

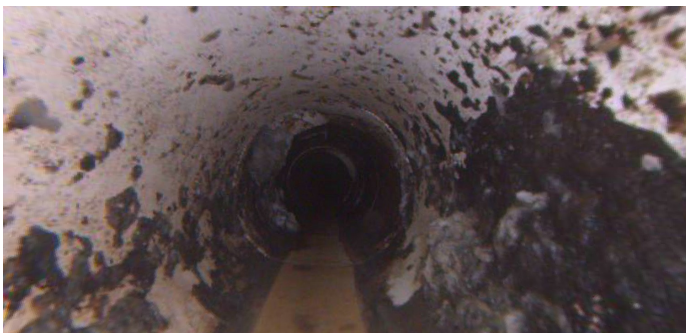
Code: **DAGS**
Description: **Deposits Attached Grease**

Distance (ft): **64.8**
Structural Grade: **0**
O&M Grade: **2**
Clock Start/From: **3**
Clock To: **5**
1st Value:
2nd Value:
Value Percent: **5.000**
Continuous Index:
Within 8" of Joint: **NO**
Remarks:

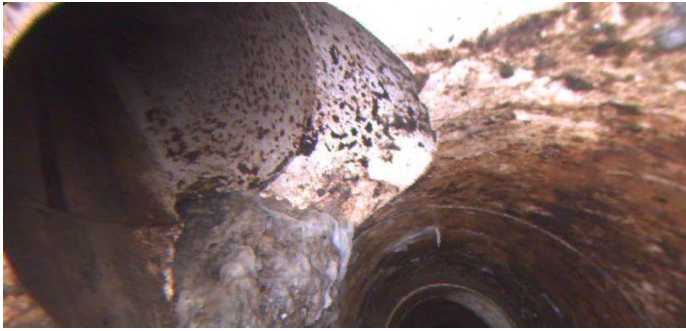
Code: **TF**
Description: **Tap Factory**

Distance (ft): **65.9**
Structural Grade: **0**
O&M Grade: **0**
Clock Start/From: **10**
Clock To:
1st Value: **4.000**
2nd Value:
Value Percent:
Continuous Index:
Within 8" of Joint:
Remarks:

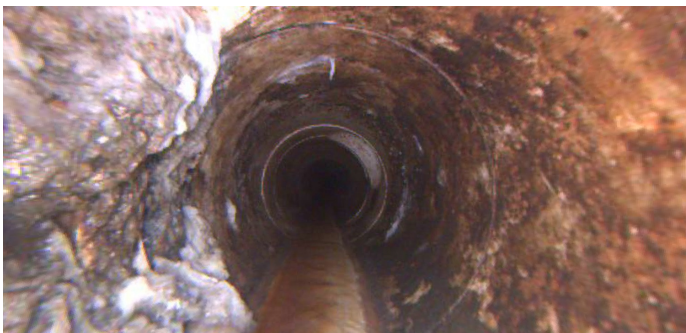
Code: **DAGS**
Description: **Deposits Attached Grease**

Distance (ft): **66.0**
Structural Grade: **0**
O&M Grade: **2**
Clock Start/From: **7**
Clock To: **9**
1st Value:
2nd Value:
Value Percent: **5.000**
Continuous Index:
Within 8" of Joint: **NO**
Remarks:

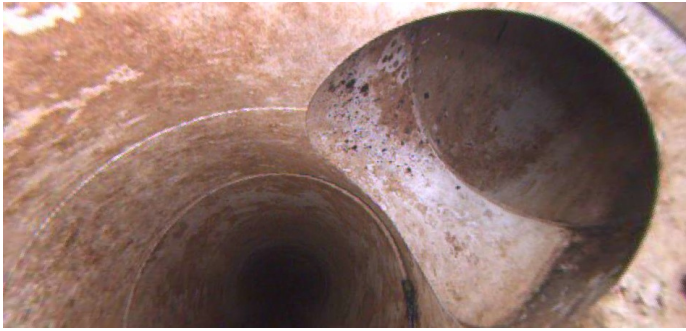
Code: **TF**
Description: **Tap Factory**

Distance (ft): **67.5**
Structural Grade: **0**
O&M Grade: **0**
Clock Start/From: **2**
Clock To:
1st Value: **4.000**
2nd Value:
Value Percent:
Continuous Index:
Within 8" of Joint:
Remarks:

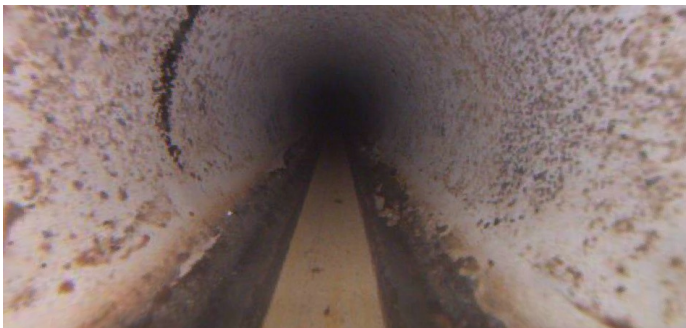
Code: **DAZ**
Description: **Deposits Attached Other**

Distance (ft): **118.4**
Structural Grade: **0**
O&M Grade: **2**
Clock Start/From: **4**
Clock To: **8**
1st Value:
2nd Value:
Value Percent: **5.000**
Continuous Index: **S01**
Within 8" of Joint: **NO**
Remarks: **Mixed materials**

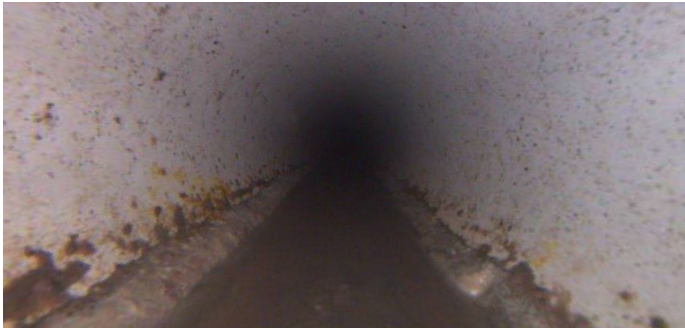
Code: **MWL**
Description: **Water Level**

Distance (ft): **130.5**
Structural Grade: **0**
O&M Grade: **0**
Clock Start/From:
Clock To:
1st Value:
2nd Value:
Value Percent: **15.000**
Continuous Index:
Within 8" of Joint: **NO**
Remarks:

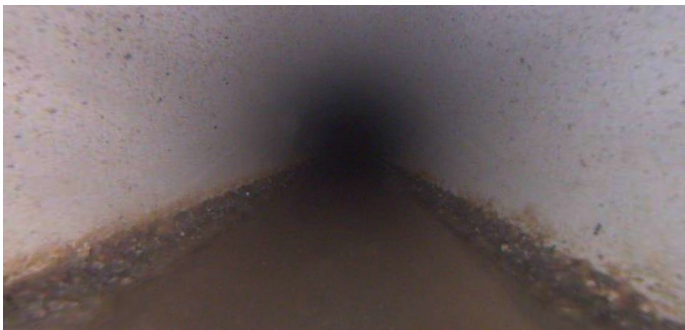
Code: **MWL**
Description: **Water Level**

Distance (ft): **137.7**
Structural Grade: **0**
O&M Grade: **0**
Clock Start/From:
Clock To:
1st Value:
2nd Value:
Value Percent: **25.000**
Continuous Index:
Within 8" of Joint: **NO**
Remarks:

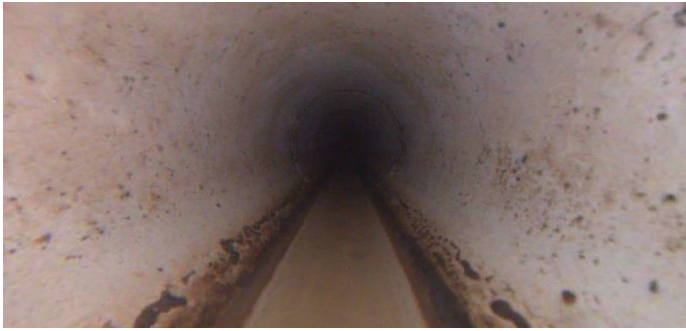
Code: **DAZ**
Description: **Deposits Attached Other**

Distance (ft): **152.1**
Structural Grade: **0**
O&M Grade: **2**
Clock Start/From: **4**
Clock To: **8**
1st Value:
2nd Value:
Value Percent: **5.000**
Continuous Index: **F01**
Within 8" of Joint: **NO**
Remarks: **Mixed materials / Clock positions vary**

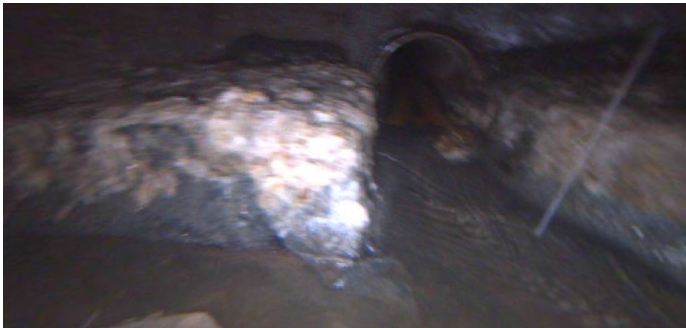
Code: **AMH**
Description: **Manhole**

Distance (ft): **169.5**
Structural Grade: **0**
O&M Grade: **0**
Clock Start/From:
Clock To:
1st Value:
2nd Value:
Value Percent:
Continuous Index:
Within 8" of Joint: **NO**
Remarks: **M-709-012**
