Profile/Photo Observation Report

Date:	03/19/2018	Weather:		Coding:	PACP 6.0
Pipe Length (ft):	166.8	Owner:	NA	Pre Clean:	Not Known
P.O.#:		Surveyor:	John Kuglmaier	PSR:	P-709-014-013
Customer:		Clean Date:	01/01/1900	Shape:	C

Street:	DUNLIN CT & WAXWING CIR	Flow Control:	Not Controlled
City:	Hobart, IN	Year Renewed:	
Location:	Yard	Tape/Media #:	
Purpose:	Maintenance Related	Dia/Height:	8"
Use:	Sanitary	Material:	PVC
Drain Area:	NA	Lining:	
Category:	NA		
Comment:	Reverse setup.

Location Details:		Direction of Survey:	Downstream
US MH:	M-709-013	DS MH:	M-709-014
		Total Length Surveyed (ft):	166.8

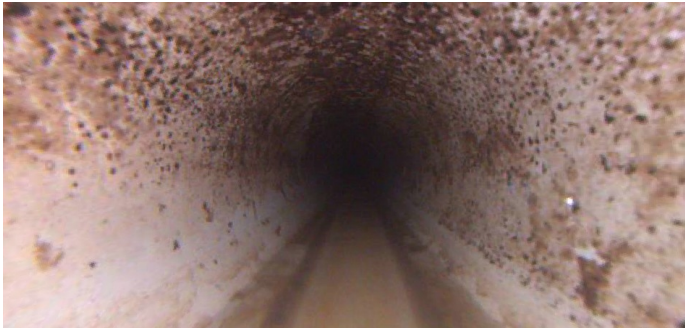
Code:	MWL
Description:	Water Level

Distance (ft):	.0
Structural Grade:	0
O&M Grade:	0
Clock Start/From:	
Clock To:	
1st Value:	
2nd Value:	
Value Percent:	5.000
Continuous Index:	
Within 8" of Joint:	NO
Remarks:

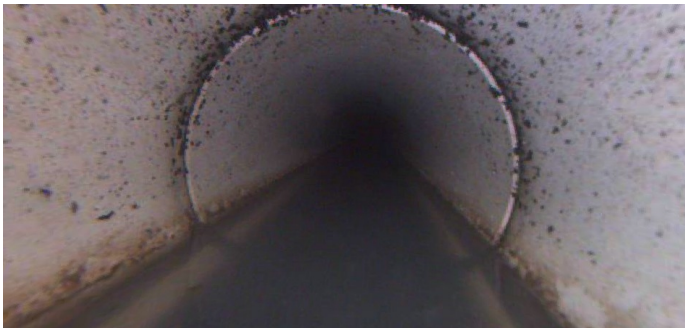
Code:	MWL
Description:	Water Level

Distance (ft):	24.9
Structural Grade:	0
O&M Grade:	0
Clock Start/From:	
Clock To:	
1st Value:	
2nd Value:	
Value Percent:	20.000
Continuous Index:	
Within 8" of Joint:	NO
Remarks:

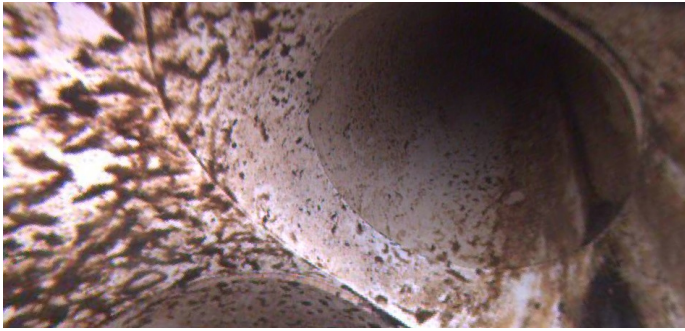
Code: **TF**
Description: **Tap Factory**

Distance (ft): **36.7**
Structural Grade: **0**
O&M Grade: **0**
Clock Start/From: **1**
Clock To:
1st Value: **4.000**
2nd Value:
Value Percent:
Continuous Index:
Within 8" of Joint:
Remarks:

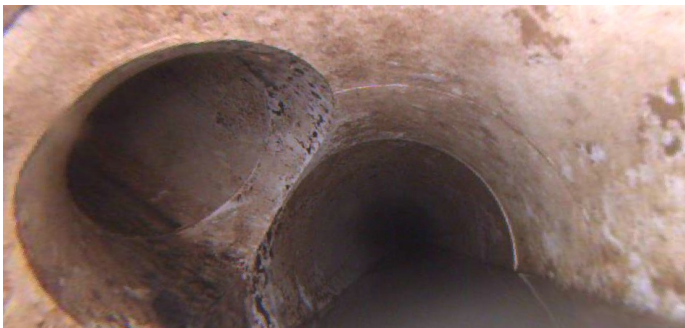
Code: **TF**
Description: **Tap Factory**

Distance (ft): **38.1**
Structural Grade: **0**
O&M Grade: **0**
Clock Start/From: **10**
Clock To:
1st Value: **4.000**
2nd Value:
Value Percent:
Continuous Index:
Within 8" of Joint:
Remarks:

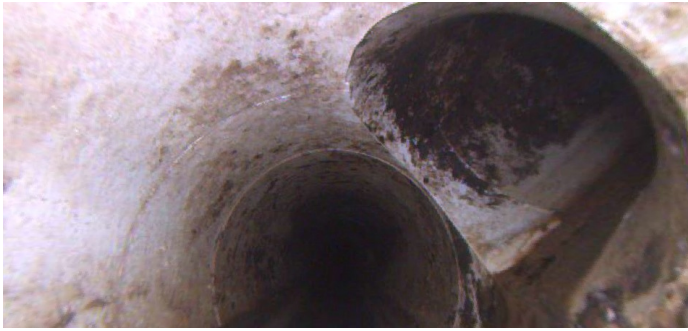
Code: **TF**
Description: **Tap Factory**

Distance (ft): **95.7**
Structural Grade: **0**
O&M Grade: **0**
Clock Start/From: **2**
Clock To:
1st Value: **4.000**
2nd Value:
Value Percent:
Continuous Index:
Within 8" of Joint:
Remarks:

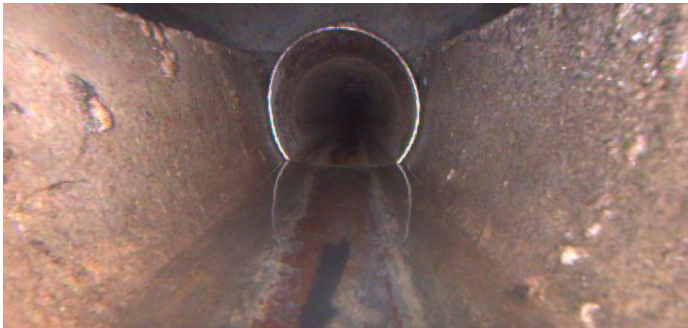
Code: **AMH**
Description: **Manhole**

Distance (ft): **166.8**
Structural Grade: **0**
O&M Grade: **0**
Clock Start/From:
Clock To:
1st Value:
2nd Value:
Value Percent:
Continuous Index:
Within 8" of Joint: **NO**
Remarks: **M-709-014**
