Profile/Photo Observation Report

Date:	03/19/2018	Weather:		Coding:	PACP 6.0
Pipe Length (ft):	166.8	Owner:	NA	Pre Clean:	Not Known
P.O.#:		Surveyor:	John Kuglmaier	PSR:	P-709-014-013
Customer:		Clean Date:	01/01/1900	Shape:	C

Street:	Oak	Flow Control:	Not Controlled
City:	Hobart, IN	Year Renewed:	
Location:	Yard	Tape/Media #:	
Purpose:	Maintenance Related	Dia/Height:	8"
Use:	Sanitary	Material:	PVC
Drain Area:	NA	Lining:	
Category:	NA		
Comment:	Reverse setup.

Location Details:		Direction of Survey:	Downstream
US MH:	M-709-013	DS MH:	M-709-014
		Total Length Surveyed (ft):	166.8

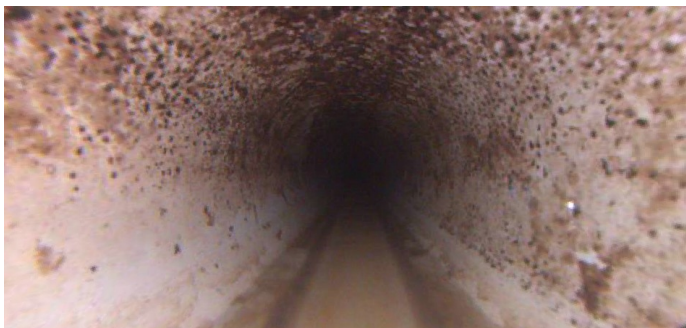
Code: **AMH**
Description: **Manhole**

Distance (ft): **.0**
Structural Grade: **0**
O&M Grade: **0**
Clock Start/From:
Clock To:
1st Value:
2nd Value:
Value Percent:
Continuous Index:
Within 8" of Joint: **NO**
Remarks: **M-709-013**

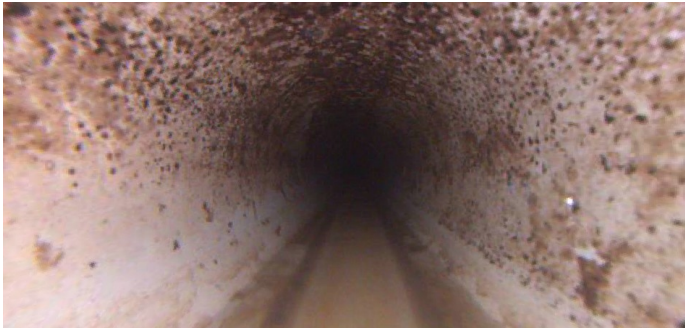
Code:	MWL
Description:	Water Level

Distance (ft):	.0
Structural Grade:	0
O&M Grade:	0
Clock Start/From:	
Clock To:	
1st Value:	
2nd Value:	
Value Percent:	5.000
Continuous Index:	
Within 8" of Joint:	NO
Remarks:

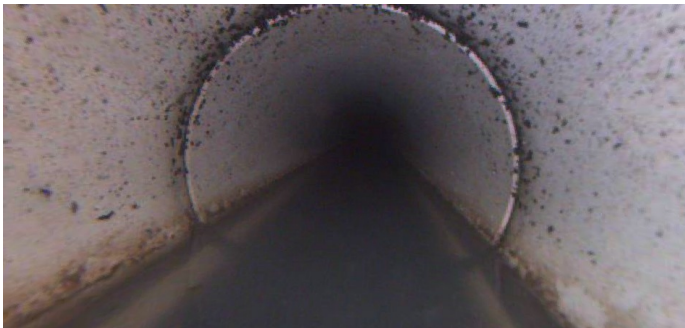
Code:	MWL
Description:	Water Level

Distance (ft):	24.9
Structural Grade:	0
O&M Grade:	0
Clock Start/From:	
Clock To:	
1st Value:	
2nd Value:	
Value Percent:	20.000
Continuous Index:	
Within 8" of Joint:	NO
Remarks:

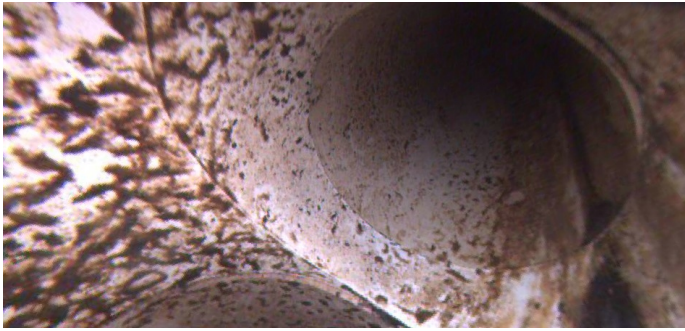
Code: **TF**
Description: **Tap Factory**

Distance (ft): **36.7**
Structural Grade: **0**
O&M Grade: **0**
Clock Start/From: **1**
Clock To:
1st Value: **4.000**
2nd Value:
Value Percent:
Continuous Index:
Within 8" of Joint:
Remarks:

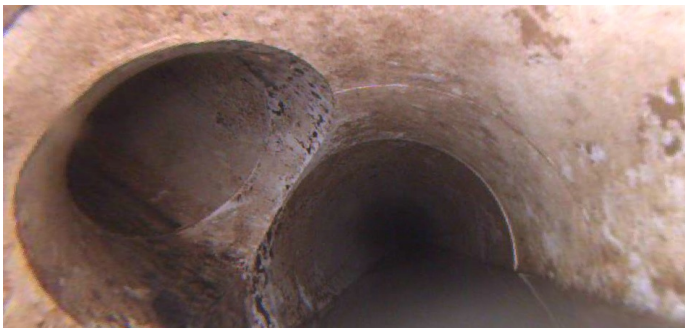
Code: **TF**
Description: **Tap Factory**

Distance (ft): **38.1**
Structural Grade: **0**
O&M Grade: **0**
Clock Start/From: **10**
Clock To:
1st Value: **4.000**
2nd Value:
Value Percent:
Continuous Index:
Within 8" of Joint:
Remarks:

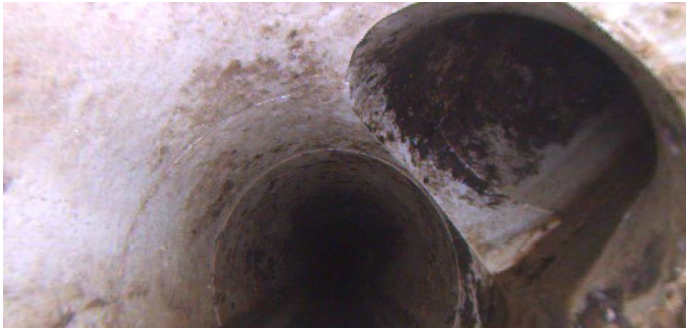
Code: **TF**
Description: **Tap Factory**

Distance (ft): **95.7**
Structural Grade: **0**
O&M Grade: **0**
Clock Start/From: **2**
Clock To:
1st Value: **4.000**
2nd Value:
Value Percent:
Continuous Index:
Within 8" of Joint:
Remarks:

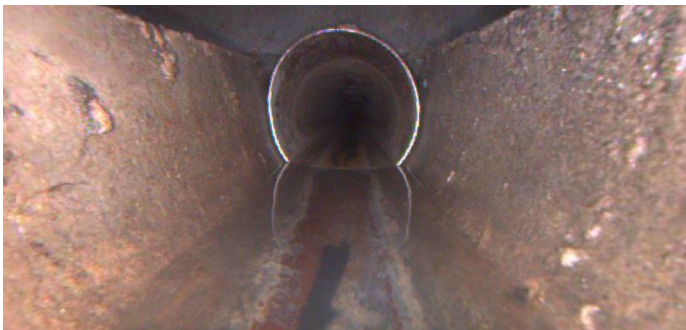
Code: **AMH**
Description: **Manhole**

Distance (ft): **166.8**
Structural Grade: **0**
O&M Grade: **0**
Clock Start/From:
Clock To:
1st Value:
2nd Value:
Value Percent:
Continuous Index:
Within 8" of Joint: **NO**
Remarks: **M-709-014**
