Profile/Photo Observation Report

Street:	DUNLIN CT & WAXWING CIR	Flow Control:	Not Controlled
City:	Hobart, IN	Year Renewed:	
Location:	Yard	Tape/Media #:	
Purpose:	Maintenance Related	Dia/Height:	8"
Use:	Sanitary	Material:	PVC
Drain Area:	NA	Lining:	
Category:	NA		
Comment:	blk silt rollover at 127'.

Location Details:		Direction of Survey:	Upstream
US MH:	M-709-013	DS MH:	M-709-014
		Total Length Surveyed (ft):	128.5

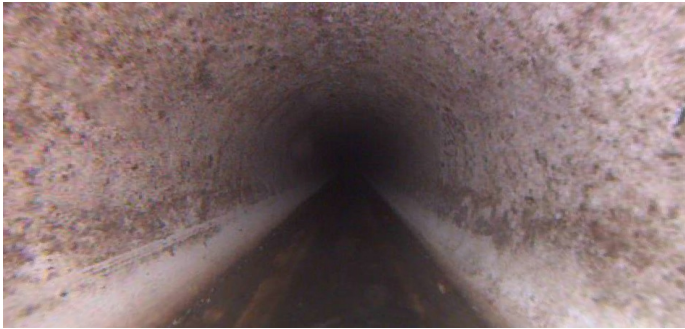
Code:	MWL
Description:	Water Level

Distance (ft):	.0
Structural Grade:	0
O&M Grade:	0
Clock Start/From:	
Clock To:	
1st Value:	
2nd Value:	
Value Percent:	10.000
Continuous Index:	
Within 8" of Joint:	NO
Remarks:

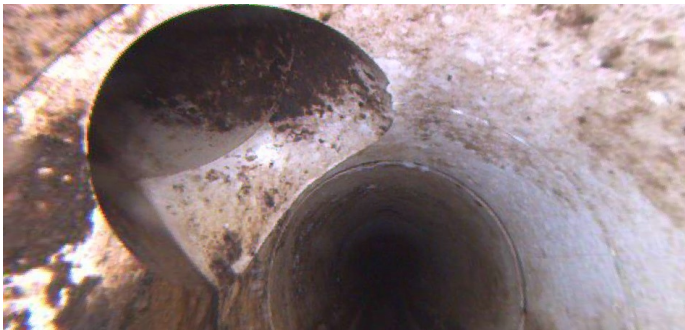
Code:	TF
Description:	Tap Factory

Distance (ft):	67.5
Structural Grade:	0
O&M Grade:	0
Clock Start/From:	10
Clock To:	
1st Value:	4.000
2nd Value:	
Value Percent:	
Continuous Index:	
Within 8" of Joint:	
Remarks:

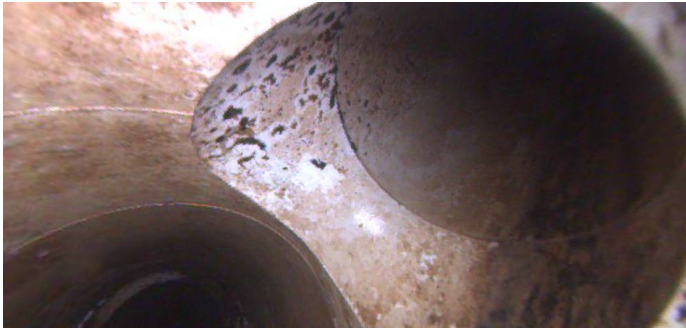
Code: **TF**
Description: **Tap Factory**

Distance (ft): **125.1**
Structural Grade: **0**
O&M Grade: **0**
Clock Start/From: **2**
Clock To:
1st Value: **4.000**
2nd Value:
Value Percent:
Continuous Index:
Within 8" of Joint:
Remarks:

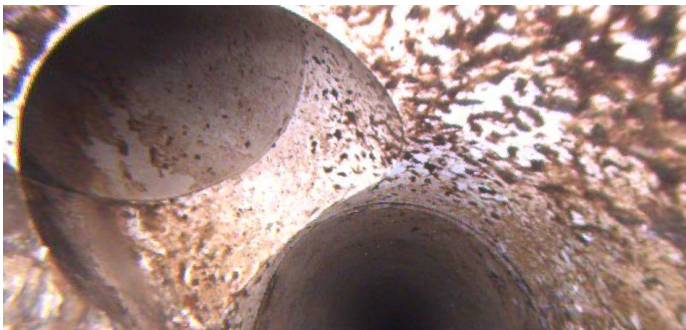
Code: **TF**
Description: **Tap Factory**

Distance (ft): **126.7**
Structural Grade: **0**
O&M Grade: **0**
Clock Start/From: **10**
Clock To:
1st Value: **4.000**
2nd Value:
Value Percent:
Continuous Index:
Within 8" of Joint:
Remarks:

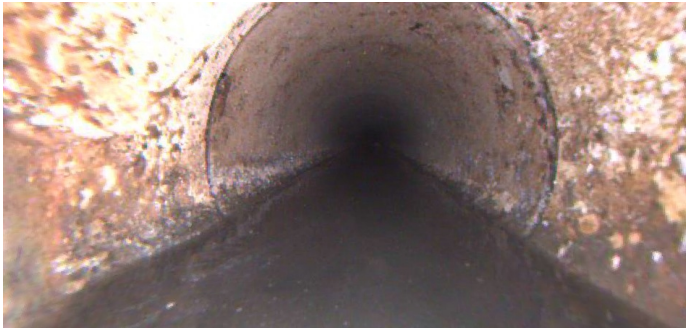
Code: **MWL**
Description: **Water Level**

Distance (ft): **126.9**
Structural Grade: **0**
O&M Grade: **0**
Clock Start/From:
Clock To:
1st Value:
2nd Value:
Value Percent: **20.000**
Continuous Index:
Within 8" of Joint: **NO**
Remarks:

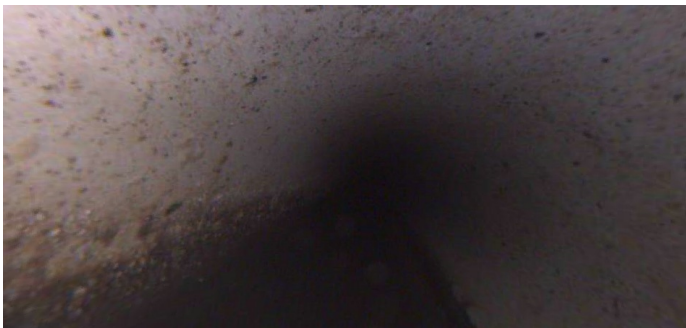
Code: **MSA**
Description: **Abandoned Survey**

Distance (ft): **128.5**
Structural Grade: **0**
O&M Grade: **0**
Clock Start/From:
Clock To:
1st Value:
2nd Value:
Value Percent:
Continuous Index:
Within 8" of Joint: **NO**
Remarks: **Unknown**
