## Profile/Photo Observation Report

Street:	<b>DUNLIN CT</b>	Flow Control:	<b>Not Controlled</b>
City:	<b>Hobart, IN</b>	Year Renewed:	
Location:	<b>Sidewalk</b>	Tape/Media #:	
Purpose:	<b>Maintenance Related</b>	Dia/Height:	<b>8"</b>
Use:	<b>Sanitary</b>	Material:	<b>PVC</b>
Drain Area:	<b>NA</b>	Lining:	
Category:	<b>NA</b>		
Comment:

Location Details:		Direction of Survey:	<b>Upstream</b>
US MH:	<b>M-709-015</b>	DS MH:	<b>M-709-016</b>
		Total Length Surveyed (ft):	<b>110.1</b>

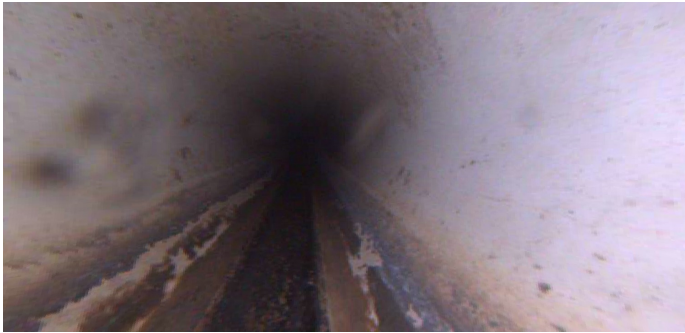
Code:	<b>MWL</b>
Description:	<b>Water Level</b>

Distance (ft):	<b>.0</b>
Structural Grade:	<b>0</b>
O&M Grade:	<b>0</b>
Clock Start/From:	
Clock To:	
1st Value:	
2nd Value:	
Value Percent:	<b>5.000</b>
Continuous Index:	
Within 8" of Joint:	<b>NO</b>
Remarks:

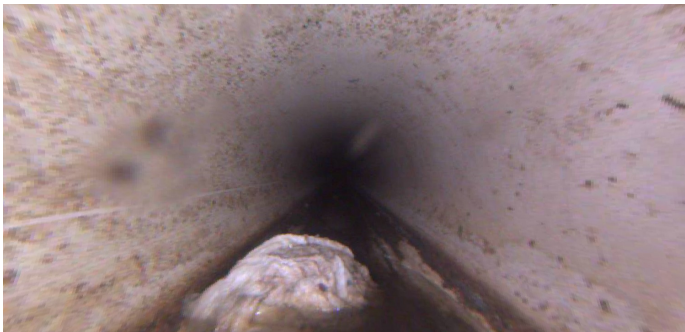
Code:	<b>DSZ</b>
Description:	<b>Deposits Settled Other</b>

Distance (ft):	<b>15.7</b>
Structural Grade:	<b>0</b>
O&M Grade:	<b>2</b>
Clock Start/From:	<b>6</b>
Clock To:	
1st Value:	
2nd Value:	
Value Percent:	<b>5.000</b>
Continuous Index:	
Within 8" of Joint:	<b>NO</b>
Remarks:	<b>wad of tissue</b>

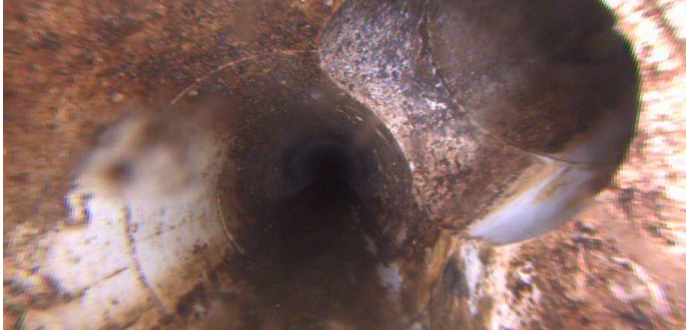
Code: **TF**  
Description: **Tap Factory**

Distance (ft): **26.8**  
Structural Grade: **0**  
O&M Grade: **0**  
Clock Start/From: **2**  
Clock To:  
1st Value: **4.000**  
2nd Value:  
Value Percent:  
Continuous Index:  
Within 8" of Joint: **YES**  
Remarks:

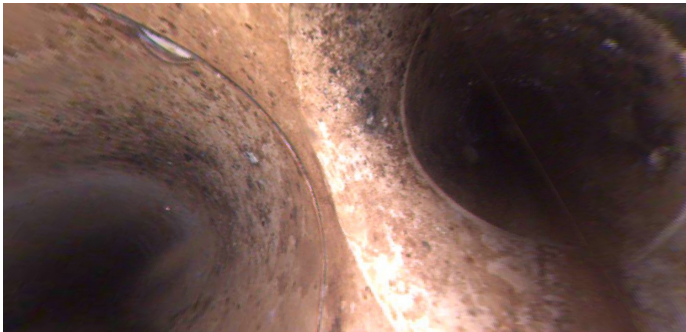
Code: **TF**  
Description: **Tap Factory**

Distance (ft): **85.9**  
Structural Grade: **0**  
O&M Grade: **0**  
Clock Start/From: **2**  
Clock To:  
1st Value: **4.000**  
2nd Value:  
Value Percent:  
Continuous Index:  
Within 8" of Joint: **YES**  
Remarks:

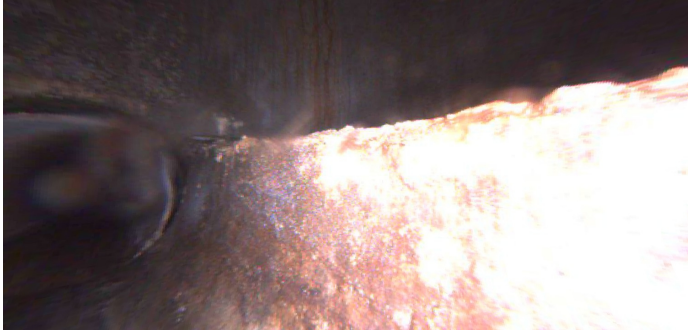
Code:	<b>AMH</b>
Description:	<b>Manhole</b>
Distance (ft):	<b>110.1</b>
Structural Grade:	<b>0</b>
O&M Grade:	<b>0</b>
Clock Start/From:	
Clock To:	
1st Value:	
2nd Value:	
Value Percent:	
Continuous Index:	
Within 8" of Joint:	<b>NO</b>
Remarks:	<b>M-709-015</b>
