Profile/Photo Observation Report

Street:	Oak	Flow Control:	Not Controlled
City:	Hobart, IN	Year Renewed:	
Location:	Sidewalk	Tape/Media #:	
Purpose:	Maintenance Related	Dia/Height:	8"
Use:	Sanitary	Material:	PVC
Drain Area:	NA	Lining:	
Category:	NA		
Comment:

Location Details:		Direction of Survey:	Upstream
US MH:	M-709-015	DS MH:	M-709-016
		Total Length Surveyed (ft):	110.1

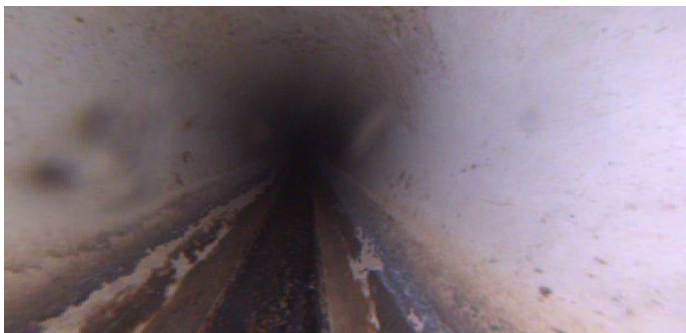
Code: **AMH**
Description: **Manhole**

Distance (ft): **.0**
Structural Grade: **0**
O&M Grade: **0**
Clock Start/From:
Clock To:
1st Value:
2nd Value:
Value Percent:
Continuous Index:
Within 8" of Joint: **NO**
Remarks: **M-709-016**

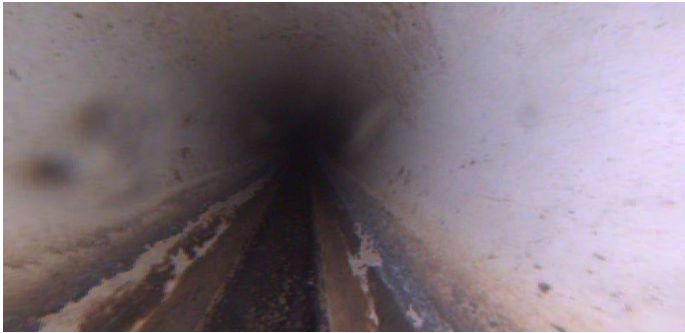
Code:	MWL
Description:	Water Level

Distance (ft):	.0
Structural Grade:	0
O&M Grade:	0
Clock Start/From:	
Clock To:	
1st Value:	
2nd Value:	
Value Percent:	5.000
Continuous Index:	
Within 8" of Joint:	NO
Remarks:

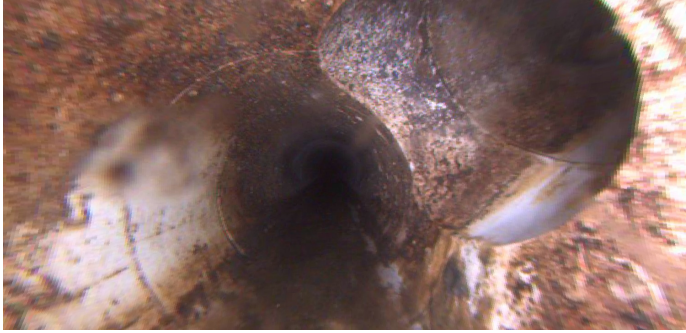
Code: **TF**
Description: **Tap Factory**

Distance (ft): **26.8**
Structural Grade: **0**
O&M Grade: **0**
Clock Start/From: **2**
Clock To:
1st Value: **4.000**
2nd Value:
Value Percent:
Continuous Index:
Within 8" of Joint: **YES**
Remarks:

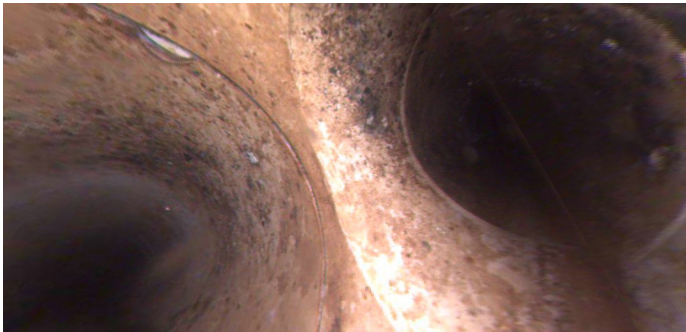
Code: **TF**
Description: **Tap Factory**

Distance (ft): **85.9**
Structural Grade: **0**
O&M Grade: **0**
Clock Start/From: **2**
Clock To:
1st Value: **4.000**
2nd Value:
Value Percent:
Continuous Index:
Within 8" of Joint: **YES**
Remarks:

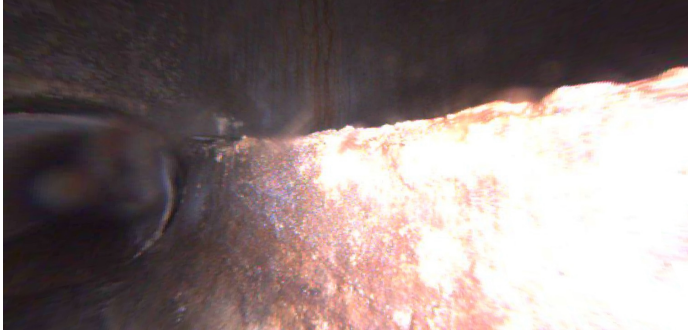
Code:	AMH
Description:	Manhole
Distance (ft):	110.1
Structural Grade:	0
O&M Grade:	0
Clock Start/From:	
Clock To:	
1st Value:	
2nd Value:	
Value Percent:	
Continuous Index:	
Within 8" of Joint:	NO
Remarks:	M-709-015
