## Profile/Photo Observation Report

Street:	<b>Oak</b>	Flow Control:	<b>Not Controlled</b>
City:	<b>Hobart, IN</b>	Year Renewed:	
Location:	<b>Sidewalk</b>	Tape/Media #:	
Purpose:	<b>Maintenance Related</b>	Dia/Height:	<b>8"</b>
Use:	<b>Sanitary</b>	Material:	<b>PVC</b>
Drain Area:	<b>NA</b>	Lining:	
Category:	<b>NA</b>		
Comment:

Location Details:		Direction of Survey:	<b>Downstream</b>
US MH:	<b>M-709-016</b>	DS MH:	<b>M-709-017</b>
		Total Length Surveyed (ft):	<b>97.2</b>

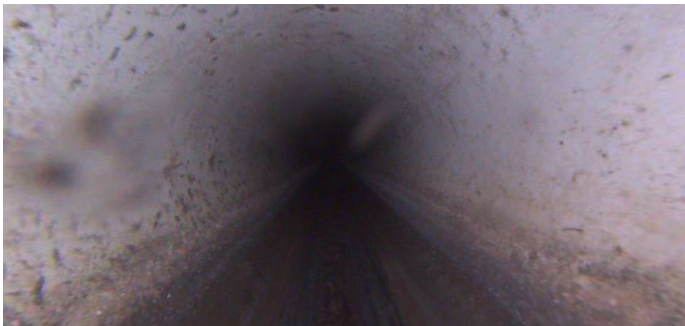
Code: **AMH**  
Description: **Manhole**

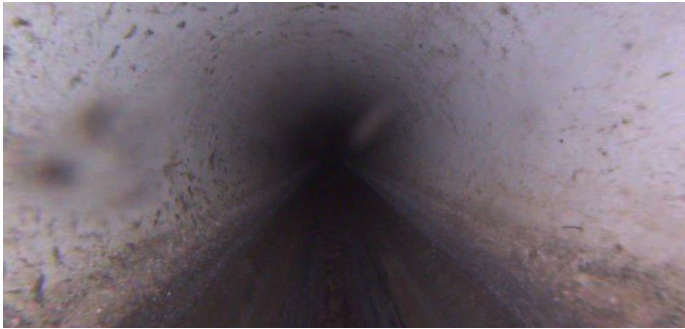
Code:	<b>MWL</b>
Description:	<b>Water Level</b>

Distance (ft):	<b>.0</b>
Structural Grade:	<b>0</b>
O&M Grade:	<b>0</b>
Clock Start/From:	
Clock To:	
1st Value:	
2nd Value:	
Value Percent:	<b>5.000</b>
Continuous Index:	
Within 8" of Joint:	<b>NO</b>
Remarks:

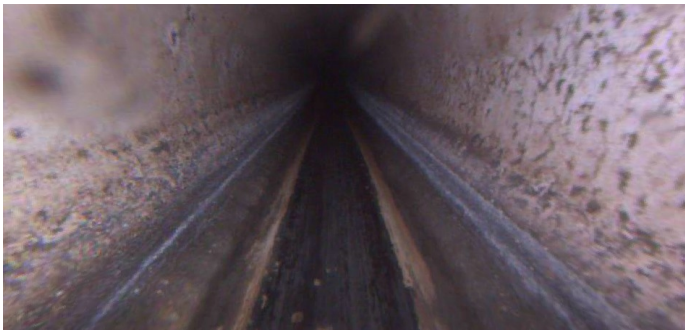
Code:	<b>DAGS</b>
Description:	<b>Deposits Attached Grease</b>

Distance (ft):	<b>4.9</b>
Structural Grade:	<b>0</b>
O&M Grade:	<b>2</b>
Clock Start/From:	<b>4</b>
Clock To:	<b>8</b>
1st Value:	
2nd Value:	
Value Percent:	<b>10.000</b>
Continuous Index:	<b>S01</b>
Within 8" of Joint:	<b>NO</b>
Remarks:

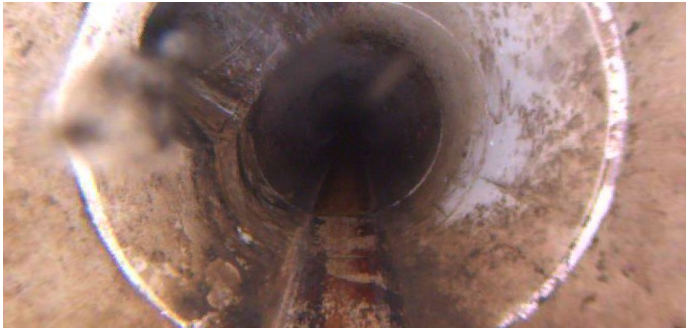
Code: **DAGS**  
Description: **Deposits Attached Grease**

Distance (ft): **12.3**  
Structural Grade: **0**  
O&M Grade: **2**  
Clock Start/From: **4**  
Clock To: **8**  
1st Value:  
2nd Value:  
Value Percent: **10.000**  
Continuous Index: **F01**  
Within 8" of Joint: **NO**  
Remarks: **Clock positions vary**

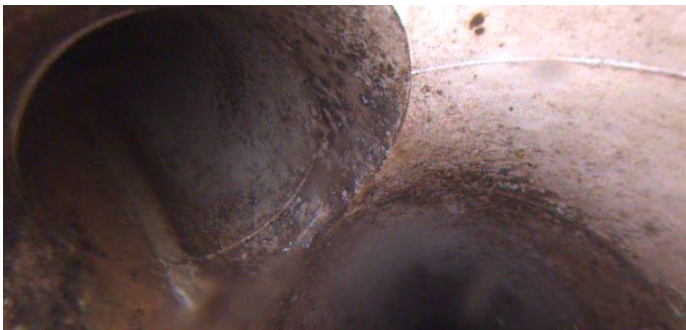
Code: **TF**  
Description: **Tap Factory**

Distance (ft): **12.8**  
Structural Grade: **0**  
O&M Grade: **0**  
Clock Start/From: **10**  
Clock To:  
1st Value: **4.000**  
2nd Value:  
Value Percent:  
Continuous Index:  
Within 8" of Joint:  
Remarks:

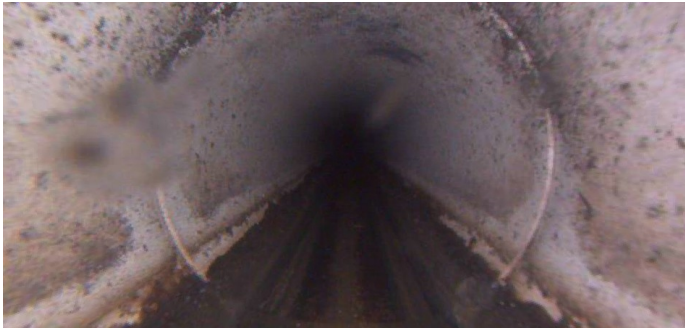
Code: **DAGS**  
Description: **Deposits Attached Grease**

Distance (ft): **26.9**  
Structural Grade: **0**  
O&M Grade: **2**  
Clock Start/From: **4**  
Clock To: **8**  
1st Value:  
2nd Value:  
Value Percent: **10.000**  
Continuous Index: **S02**  
Within 8" of Joint: **NO**  
Remarks:

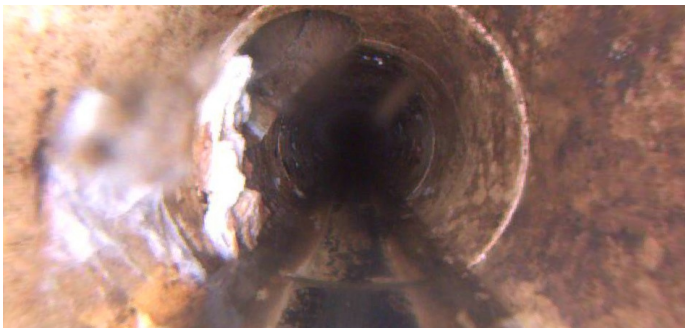
Code: **DAGS**  
Description: **Deposits Attached Grease**

Distance (ft): **50.5**  
Structural Grade: **0**  
O&M Grade: **2**  
Clock Start/From: **4**  
Clock To: **8**  
1st Value:  
2nd Value:  
Value Percent: **10.000**  
Continuous Index: **F02**  
Within 8" of Joint: **NO**  
Remarks: **Clock positions vary**

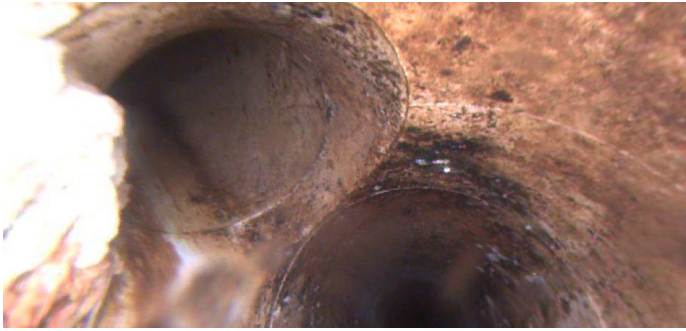
Code: **TF**  
Description: **Tap Factory**

Distance (ft): **51.0**  
Structural Grade: **0**  
O&M Grade: **0**  
Clock Start/From: **10**  
Clock To:  
1st Value: **4.000**  
2nd Value:  
Value Percent:  
Continuous Index:  
Within 8" of Joint:  
Remarks:

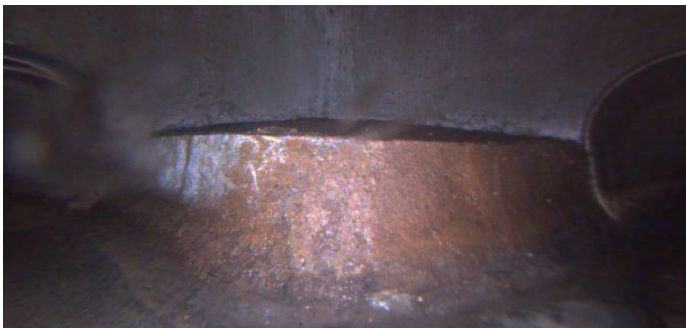
Code: **AMH**  
Description: **Manhole**

Distance (ft): **97.2**  
Structural Grade: **0**  
O&M Grade: **0**  
Clock Start/From:  
Clock To:  
1st Value:  
2nd Value:  
Value Percent:  
Continuous Index:  
Within 8" of Joint: **NO**  
Remarks: **M-709-017**
