## Profile/Photo Observation Report

Street:	<b>DUNLIN CT &amp; AVOCET CIR</b>	Flow Control:	<b>Not Controlled</b>
City:	<b>Hobart, IN</b>	Year Renewed:	
Location:	<b>Yard</b>	Tape/Media #:	
Purpose:	<b>Maintenance Related</b>	Dia/Height:	<b>8"</b>
Use:	<b>Sanitary</b>	Material:	<b>PVC</b>
Drain Area:	<b>NA</b>	Lining:	
Category:	<b>NA</b>		
Comment:

Location Details:		Direction of Survey:	<b>Upstream</b>
US MH:	<b>M-709-017</b>	DS MH:	<b>M-709-018</b>
		Total Length Surveyed (ft):	<b>119.5</b>

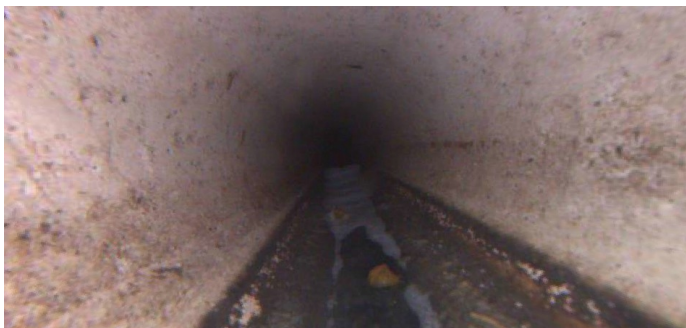
Code: **AMH**  
Description: **Manhole**

Distance (ft): **.0**  
Structural Grade: **0**  
O&M Grade: **0**  
Clock Start/From:  
Clock To:  
1st Value:  
2nd Value:  
Value Percent:  
Continuous Index:  
Within 8" of Joint: **NO**  
Remarks: **M-709-018**

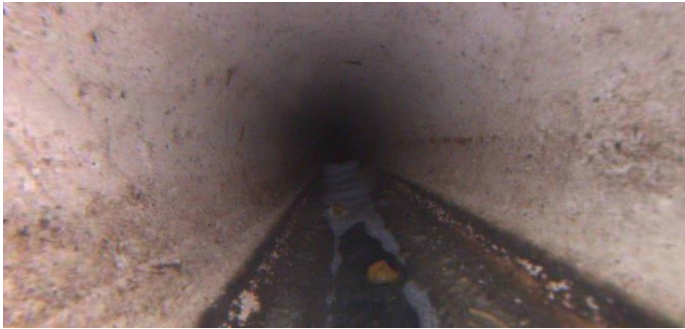
Code:	<b>MWL</b>
Description:	<b>Water Level</b>

Distance (ft):	<b>.0</b>
Structural Grade:	<b>0</b>
O&M Grade:	<b>0</b>
Clock Start/From:	
Clock To:	
1st Value:	
2nd Value:	
Value Percent:	<b>5.000</b>
Continuous Index:	
Within 8" of Joint:	<b>NO</b>
Remarks:

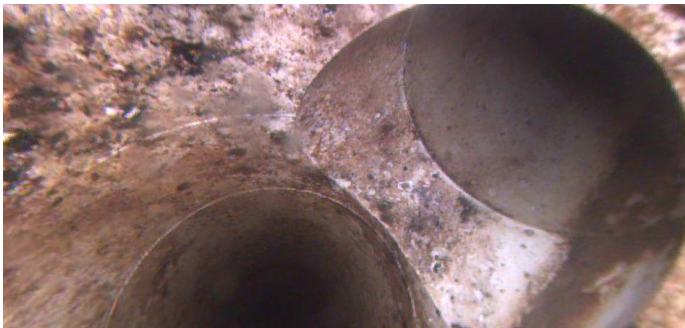
Code:	<b>TF</b>
Description:	<b>Tap Factory</b>

Distance (ft):	<b>8.2</b>
Structural Grade:	<b>0</b>
O&M Grade:	<b>0</b>
Clock Start/From:	<b>2</b>
Clock To:	
1st Value:	<b>4.000</b>
2nd Value:	
Value Percent:	
Continuous Index:	
Within 8" of Joint:	
Remarks:

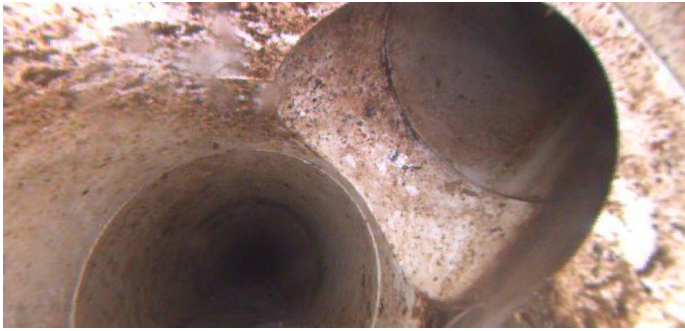
Code: **TFA**  
Description: **Tap Factory Active**

Distance (ft): **68.9**  
Structural Grade: **0**  
O&M Grade: **0**  
Clock Start/From: **2**  
Clock To:  
1st Value: **4.000**  
2nd Value:  
Value Percent:  
Continuous Index:  
Within 8" of Joint:  
Remarks:

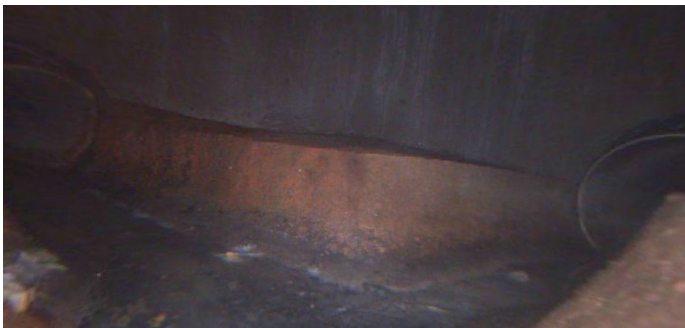
Code: **AMH**  
Description: **Manhole**

Distance (ft): **119.5**  
Structural Grade: **0**  
O&M Grade: **0**  
Clock Start/From:  
Clock To:  
1st Value:  
2nd Value:  
Value Percent:  
Continuous Index:  
Within 8" of Joint: **NO**  
Remarks: **M-709-017**
