Profile/Photo Observation Report

Street:	AVOCET CIR	Flow Control:	Not Controlled
City:	Hobart, IN	Year Renewed:	
Location:	Sidewalk	Tape/Media #:	
Purpose:	Maintenance Related	Dia/Height:	8"
Use:	Sanitary	Material:	PVC
Drain Area:	NA	Lining:	
Category:	NA		
Comment:	Flow direction wrong.

Location Details:		Direction of Survey:	Downstream
US MH:	M-709-020	DS MH:	M-709-021
		Total Length Surveyed (ft):	355.3

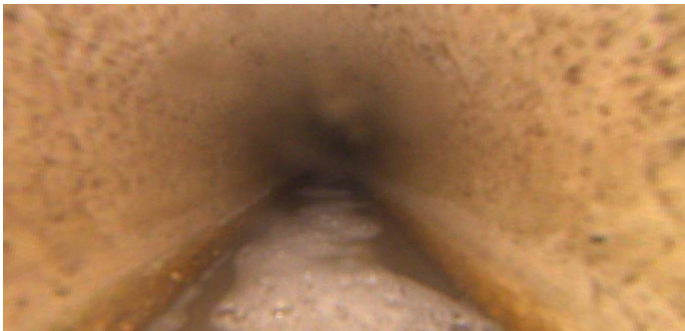
Code: **AMH**
Description: **Manhole**

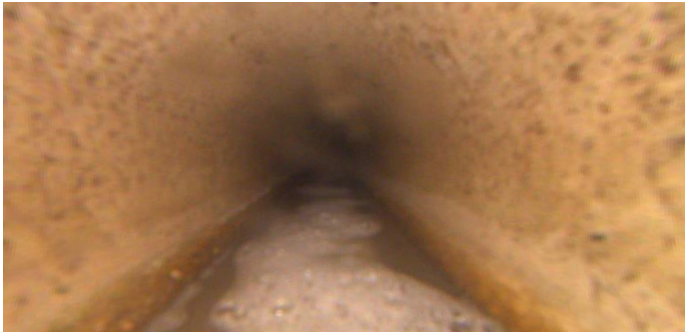
Code:	MWL
Description:	Water Level

Distance (ft):	.0
Structural Grade:	0
O&M Grade:	0
Clock Start/From:	
Clock To:	
1st Value:	
2nd Value:	
Value Percent:	5.000
Continuous Index:	
Within 8" of Joint:	NO
Remarks:

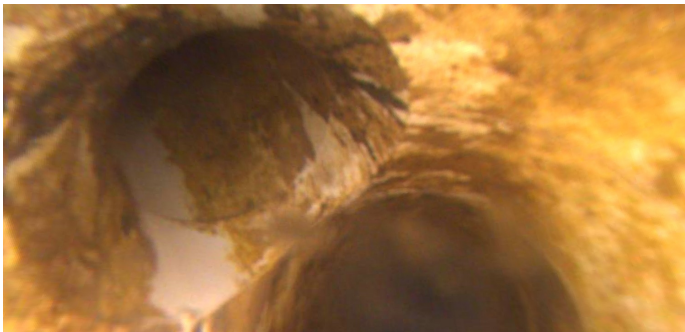
Code:	TF
Description:	Tap Factory

Distance (ft):	45.8
Structural Grade:	0
O&M Grade:	0
Clock Start/From:	11
Clock To:	
1st Value:	4.000
2nd Value:	
Value Percent:	
Continuous Index:	
Within 8" of Joint:	
Remarks:

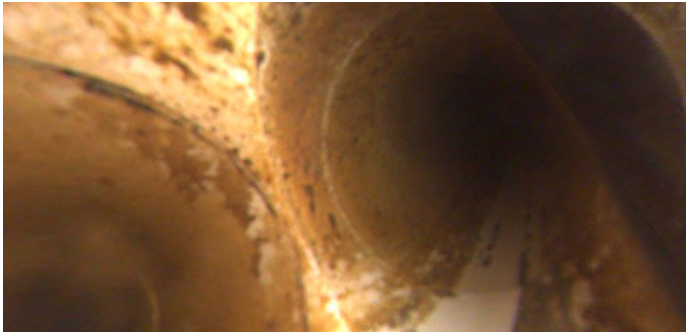
Code: **TF**
Description: **Tap Factory**

Distance (ft): **144.2**
Structural Grade: **0**
O&M Grade: **0**
Clock Start/From: **2**
Clock To:
1st Value: **4.000**
2nd Value:
Value Percent:
Continuous Index:
Within 8" of Joint:
Remarks:

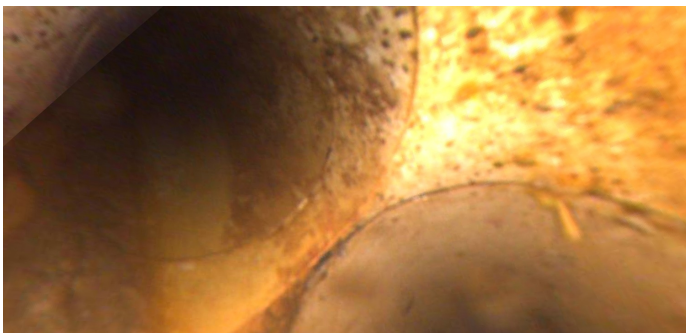
Code: **TF**
Description: **Tap Factory**

Distance (ft): **145.8**
Structural Grade: **0**
O&M Grade: **0**
Clock Start/From: **10**
Clock To:
1st Value: **4.000**
2nd Value:
Value Percent:
Continuous Index:
Within 8" of Joint:
Remarks:

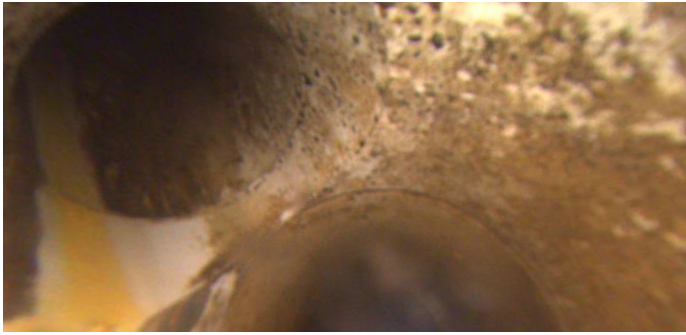
Code: **TF**
Description: **Tap Factory**

Distance (ft): **306.6**
Structural Grade: **0**
O&M Grade: **0**
Clock Start/From: **10**
Clock To:
1st Value: **4.000**
2nd Value:
Value Percent:
Continuous Index:
Within 8" of Joint:
Remarks:

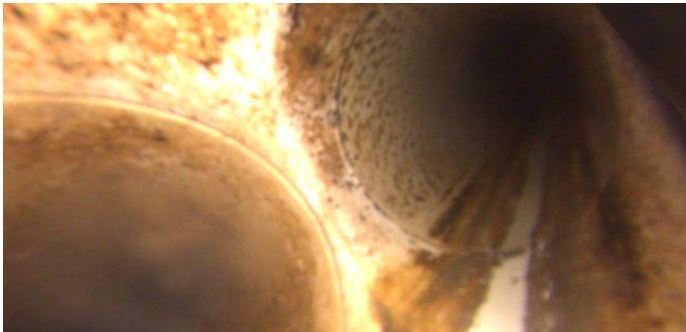
Code: **TF**
Description: **Tap Factory**

Distance (ft): **308.5**
Structural Grade: **0**
O&M Grade: **0**
Clock Start/From: **2**
Clock To:
1st Value: **4.000**
2nd Value:
Value Percent:
Continuous Index:
Within 8" of Joint:
Remarks:

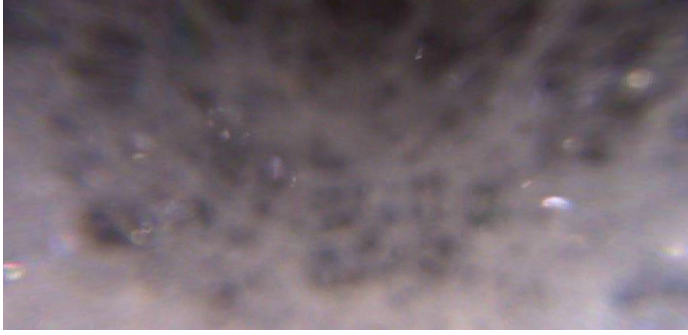
Code:	AMH
Description:	Manhole
Distance (ft):	355.3
Structural Grade:	0
O&M Grade:	0
Clock Start/From:	
Clock To:	
1st Value:	
2nd Value:	
Value Percent:	
Continuous Index:	
Within 8" of Joint:	NO
Remarks:	M-709-021
