Profile/Photo Observation Report

Date:	04/01/2018	Weather:		Coding:	PACP 6.0
Pipe Length (ft):	76.5	Owner:	NA	Pre Clean:	Not Known
P.O.#:		Surveyor:	Jen Costello	PSR:	P-709-023-024
Customer:		Clean Date:	01/01/1900	Shape:	C

Street:	AVOCET CIR	Flow Control:	Not Controlled
City:	Hobart, IN	Year Renewed:	
Location:	Sidewalk	Tape/Media #:	
Purpose:	Maintenance Related	Dia/Height:	8"
Use:	Sanitary	Material:	PVC
Drain Area:	NA	Lining:	Cured in Place
Category:	NA

Location Details:	Direction of Survey:	Upstream
US MH: M-709-024	DS MH: M-709-023	Total Length Surveyed (ft): 370.7

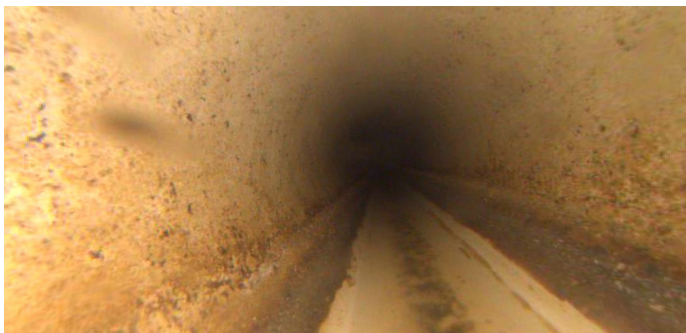
Code: **AMH**
Description: **Manhole**

Distance (ft): **.0**
Structural Grade: **0**
O&M Grade: **0**
Clock Start/From:
Clock To:
1st Value:
2nd Value:
Value Percent:
Continuous Index:
Within 8" of Joint: **NO**
Remarks: **M-709-023**

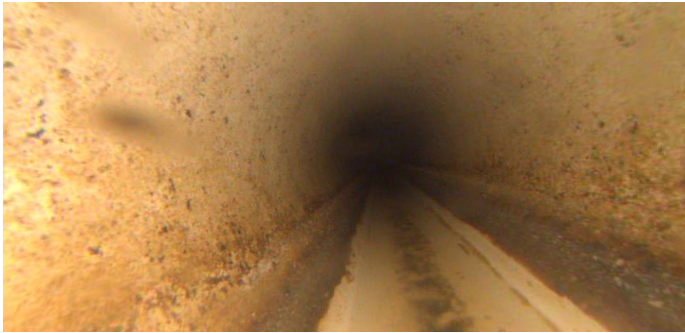
Code:	MWL
Description:	Water Level

Distance (ft):	.0
Structural Grade:	0
O&M Grade:	0
Clock Start/From:	
Clock To:	
1st Value:	
2nd Value:	
Value Percent:	5.000
Continuous Index:	
Within 8" of Joint:	NO
Remarks:

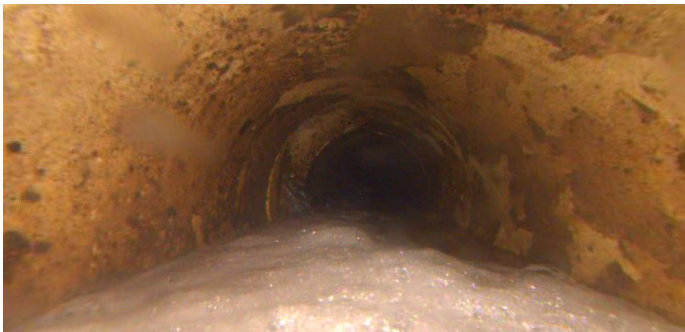
Code:	MWL
Description:	Water Level

Distance (ft):	42.7
Structural Grade:	0
O&M Grade:	0
Clock Start/From:	
Clock To:	
1st Value:	
2nd Value:	
Value Percent:	30.000
Continuous Index:	
Within 8" of Joint:	NO
Remarks:

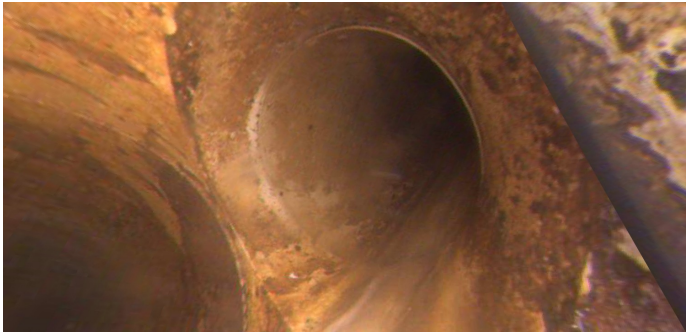
Code: **TFA**
Description: **Tap Factory Active**

Distance (ft): **44.3**
Structural Grade: **0**
O&M Grade: **0**
Clock Start/From: **10**
Clock To:
1st Value: **4.000**
2nd Value:
Value Percent:
Continuous Index:
Within 8" of Joint:
Remarks:

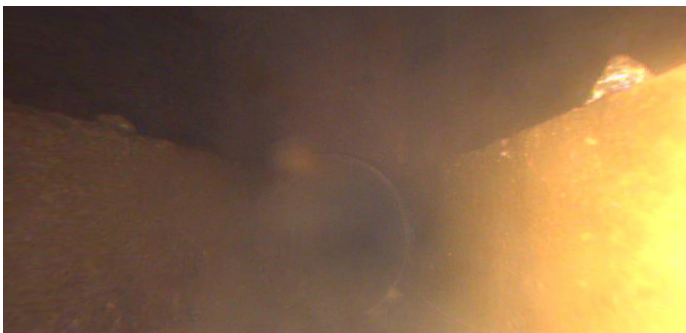
Code: **AMH**
Description: **Manhole**

Distance (ft): **81.8**
Structural Grade: **0**
O&M Grade: **0**
Clock Start/From:
Clock To:
1st Value:
2nd Value:
Value Percent:
Continuous Index:
Within 8" of Joint: **NO**
Remarks: **M-709-024 passes MH**
