## Profile/Photo Observation Report

Street:	<b>Avocet</b>	Flow Control:	<b>Not Controlled</b>
City:	<b>Hobart, IN</b>	Year Renewed:	
Location:	<b>Sidewalk</b>	Tape/Media #:	
Purpose:	<b>Maintenance Related</b>	Dia/Height:	<b>8"</b>
Use:	<b>Sanitary</b>	Material:	<b>PVC</b>
Drain Area:	<b>NA</b>	Lining:	<b>Cured in Place</b>
Category:	<b>NA</b>

Location Details:	Direction of Survey:	<b>Upstream</b>
US MH: <b>M-709-024</b>	DS MH: <b>M-709-023</b>	Total Length Surveyed (ft): <b>370.7</b>

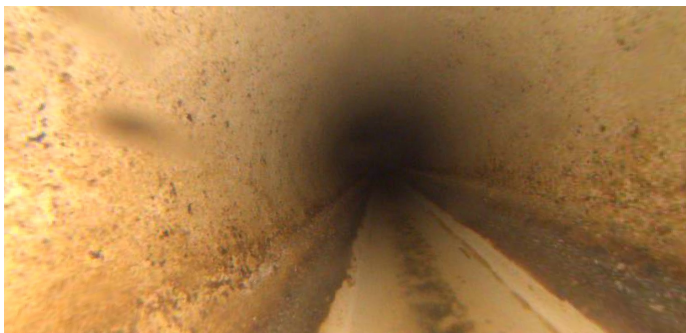
Code: **AMH**  
Description: **Manhole**

Distance (ft): **.0**  
Structural Grade: **0**  
O&M Grade: **0**  
Clock Start/From:  
Clock To:  
1st Value:  
2nd Value:  
Value Percent:  
Continuous Index:  
Within 8" of Joint: **NO**  
Remarks: **M-709-023**

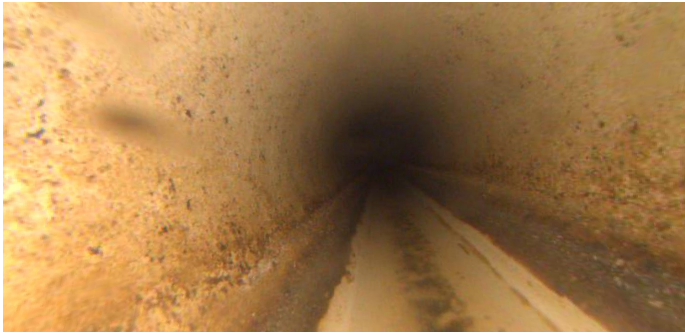
Code:	<b>MWL</b>
Description:	<b>Water Level</b>

Distance (ft):	<b>.0</b>
Structural Grade:	<b>0</b>
O&M Grade:	<b>0</b>
Clock Start/From:	
Clock To:	
1st Value:	
2nd Value:	
Value Percent:	<b>5.000</b>
Continuous Index:	
Within 8" of Joint:	<b>NO</b>
Remarks:

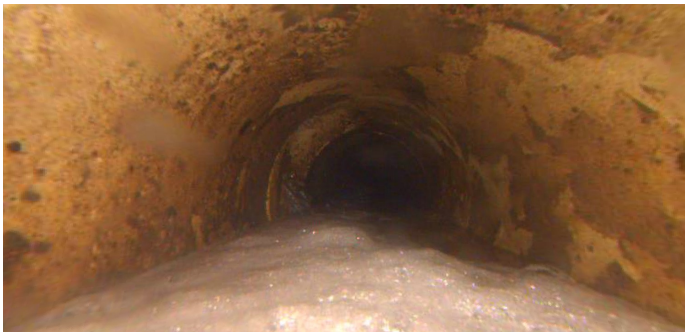
Code:	<b>MWL</b>
Description:	<b>Water Level</b>

Distance (ft):	<b>42.7</b>
Structural Grade:	<b>0</b>
O&M Grade:	<b>0</b>
Clock Start/From:	
Clock To:	
1st Value:	
2nd Value:	
Value Percent:	<b>30.000</b>
Continuous Index:	
Within 8" of Joint:	<b>NO</b>
Remarks:

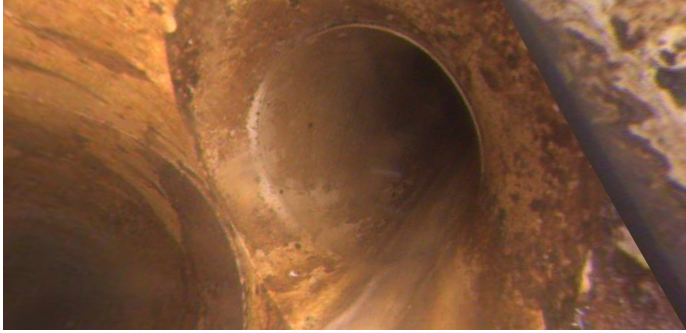
Code: **TFA**  
Description: **Tap Factory Active**

Distance (ft): **44.3**  
Structural Grade: **0**  
O&M Grade: **0**  
Clock Start/From: **10**  
Clock To:  
1st Value: **4.000**  
2nd Value:  
Value Percent:  
Continuous Index:  
Within 8" of Joint:  
Remarks:

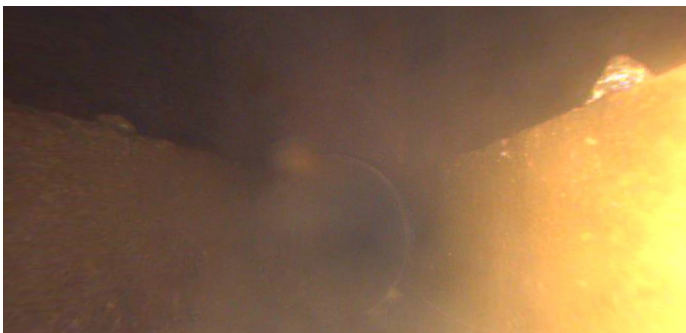
Code: **AMH**  
Description: **Manhole**

Distance (ft): **81.8**  
Structural Grade: **0**  
O&M Grade: **0**  
Clock Start/From:  
Clock To:  
1st Value:  
2nd Value:  
Value Percent:  
Continuous Index:  
Within 8" of Joint: **NO**  
Remarks: **M-709-024 passes MH**
