Profile/Photo Observation Report

Date:	04/01/2018	Weather:		Coding:	PACP 6.0
Pipe Length (ft):	204.9	Owner:	NA	Pre Clean:	Not Known
P.O.#:		Surveyor:	Jen Costello	PSR:	P-709-025-026
Customer:		Clean Date:	01/01/1900	Shape:	C

Street:	Avocet	Flow Control:	Not Controlled
City:	Hobart, IN	Year Renewed:	
Location:	Sidewalk	Tape/Media #:	
Purpose:	Maintenance Related	Dia/Height:	8"
Use:	Sanitary	Material:	PVC
Drain Area:	NA	Lining:	Cured in Place
Category:	NA		
Comment:

Location Details:		Direction of Survey:	Upstream
US MH:	M-709-026	DS MH:	M-709-025
		Total Length Surveyed (ft):	197.4

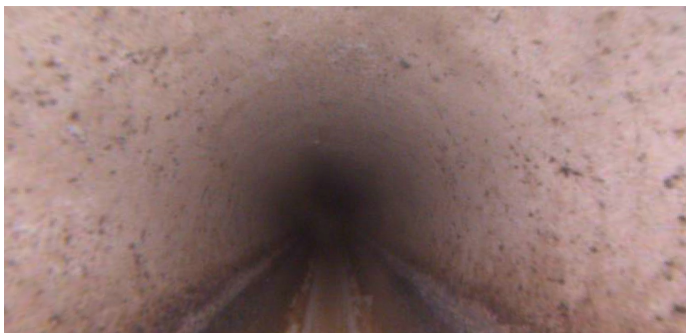
Code: **AMH**
Description: **Manhole**

Distance (ft): **.0**
Structural Grade: **0**
O&M Grade: **0**
Clock Start/From:
Clock To:
1st Value:
2nd Value:
Value Percent:
Continuous Index:
Within 8" of Joint: **NO**
Remarks: **M-709-025**

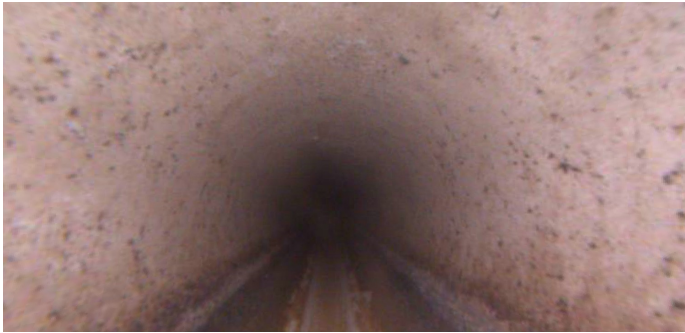
Code:	MWL
Description:	Water Level

Distance (ft):	.0
Structural Grade:	0
O&M Grade:	0
Clock Start/From:	
Clock To:	
1st Value:	
2nd Value:	
Value Percent:	5.000
Continuous Index:	
Within 8" of Joint:	NO
Remarks:

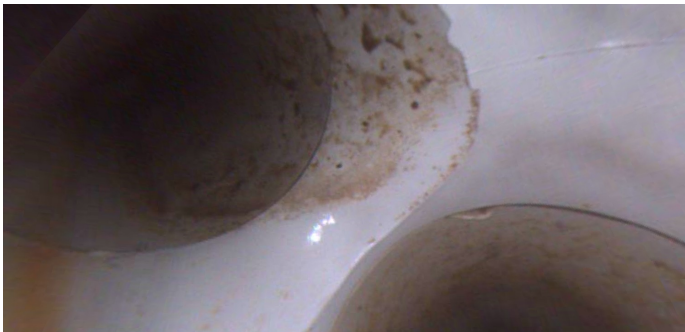
Code:	TF
Description:	Tap Factory

Distance (ft):	71.0
Structural Grade:	0
O&M Grade:	0
Clock Start/From:	10
Clock To:	
1st Value:	4.000
2nd Value:	
Value Percent:	
Continuous Index:	
Within 8" of Joint:	
Remarks:

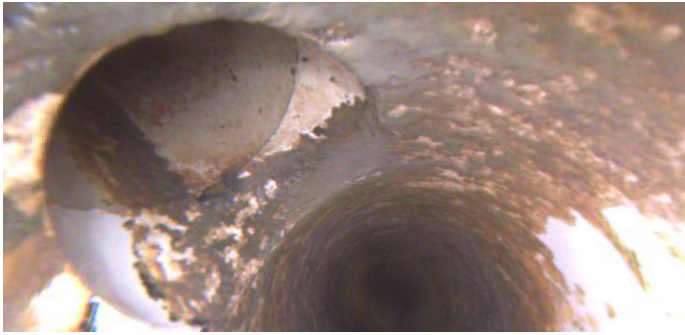
Code: **TF**
Description: **Tap Factory**

Distance (ft): **172.3**
Structural Grade: **0**
O&M Grade: **0**
Clock Start/From: **10**
Clock To:
1st Value: **4.000**
2nd Value:
Value Percent:
Continuous Index:
Within 8" of Joint:
Remarks:

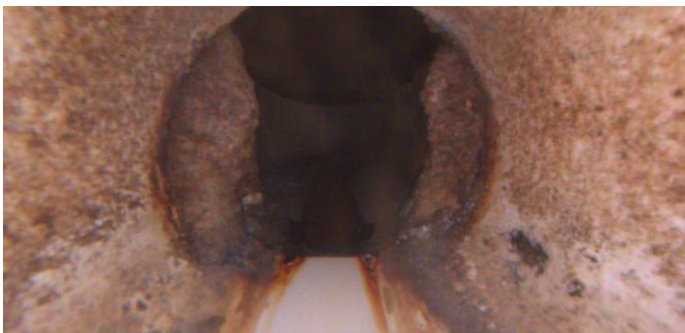
Code: **DAE**
Description: **Deposits Attached Encrustation**

Distance (ft): **195.0**
Structural Grade: **0**
O&M Grade: **3**
Clock Start/From: **8**
Clock To: **4**
1st Value:
2nd Value:
Value Percent: **20.000**
Continuous Index:
Within 8" of Joint: **YES**
Remarks:

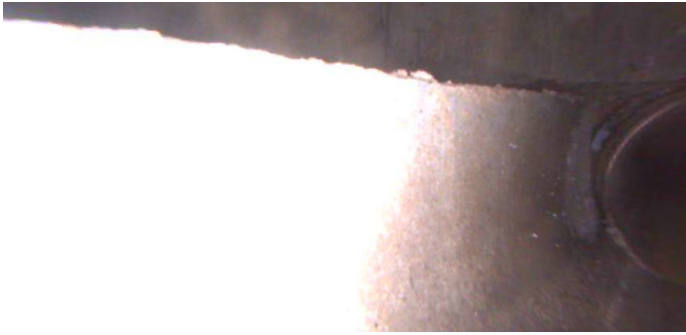
Code: **AMH**
Description: **Manhole**

Distance (ft): **197.4**
Structural Grade: **0**
O&M Grade: **0**
Clock Start/From:
Clock To:
1st Value:
2nd Value:
Value Percent:
Continuous Index:
Within 8" of Joint: **NO**
Remarks: **M-709-026**
