Profile/Photo Observation Report

Date:	03/19/2018	Weather:		Coding:	PACP 6.0
Pipe Length (ft):	153.1	Owner:	NA	Pre Clean:	Not Known
P.O.#:		Surveyor:	John Kuglmaier	PSR:	P-709-028-029
Customer:		Clean Date:	01/01/1900	Shape:	C

Street:	AVOCET CIR	Flow Control:	Not Controlled
City:	Hobart, IN	Year Renewed:	
Location:	Yard	Tape/Media #:	
Purpose:	Maintenance Related	Dia/Height:	8"
Use:	Sanitary	Material:	PVC
Drain Area:	NA	Lining:	
Category:	NA		
Comment:

Location Details:		Direction of Survey:	Downstream
US MH:	M-709-029	DS MH:	M-709-028
		Total Length Surveyed (ft):	151.7

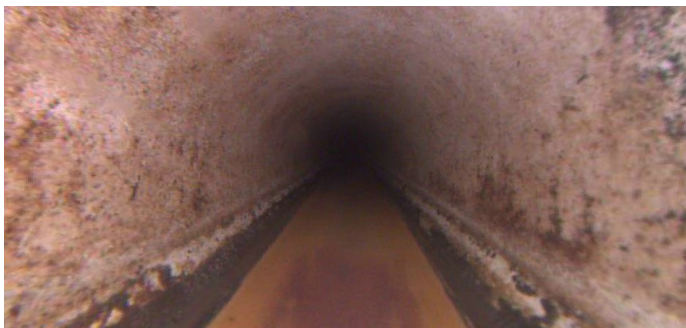
Code: **AMH**
Description: **Manhole**

Distance (ft): **.0**
Structural Grade: **0**
O&M Grade: **0**
Clock Start/From:
Clock To:
1st Value:
2nd Value:
Value Percent:
Continuous Index:
Within 8" of Joint: **NO**
Remarks: **M-709-029**

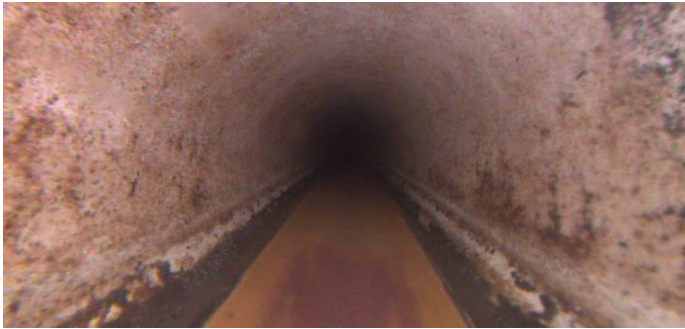
Code:	MWL
Description:	Water Level

Distance (ft):	.0
Structural Grade:	0
O&M Grade:	0
Clock Start/From:	
Clock To:	
1st Value:	
2nd Value:	
Value Percent:	15.000
Continuous Index:	
Within 8" of Joint:	NO
Remarks:

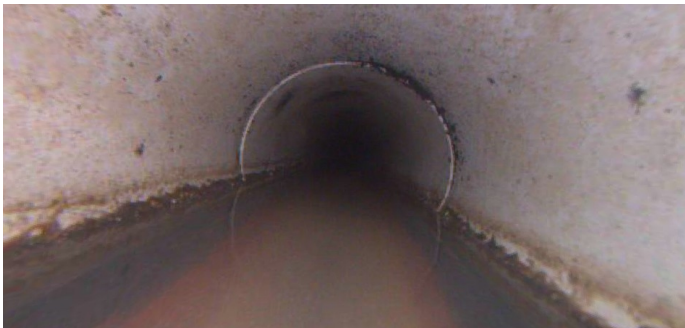
Code:	MWL
Description:	Water Level

Distance (ft):	11.5
Structural Grade:	0
O&M Grade:	0
Clock Start/From:	
Clock To:	
1st Value:	
2nd Value:	
Value Percent:	25.000
Continuous Index:	
Within 8" of Joint:	NO
Remarks:

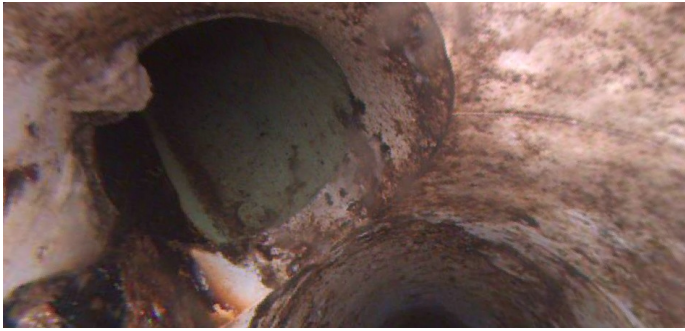
Code: **TF**
Description: **Tap Factory**

Distance (ft): **50.0**
Structural Grade: **0**
O&M Grade: **0**
Clock Start/From: **10**
Clock To:
1st Value: **4.000**
2nd Value:
Value Percent:
Continuous Index:
Within 8" of Joint:
Remarks:

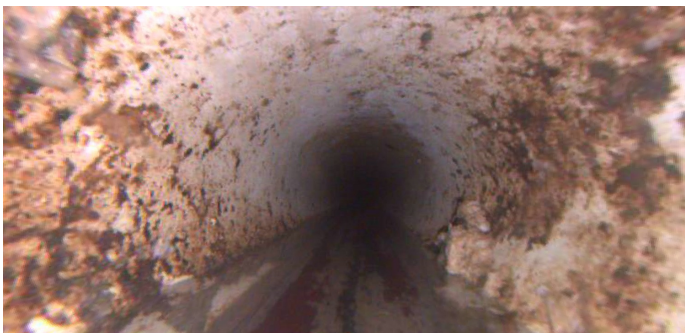
Code: **DAGS**
Description: **Deposits Attached Grease**

Distance (ft): **50.5**
Structural Grade: **0**
O&M Grade: **2**
Clock Start/From: **8**
Clock To: **4**
1st Value:
2nd Value:
Value Percent: **5.000**
Continuous Index:
Within 8" of Joint: **NO**
Remarks:

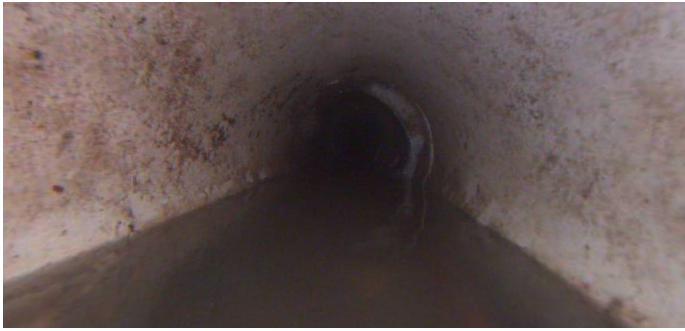
Code: **MWL**
Description: **Water Level**

Distance (ft): **98.2**
Structural Grade: **0**
O&M Grade: **0**
Clock Start/From:
Clock To:
1st Value:
2nd Value:
Value Percent: **30.000**
Continuous Index:
Within 8" of Joint: **NO**
Remarks:

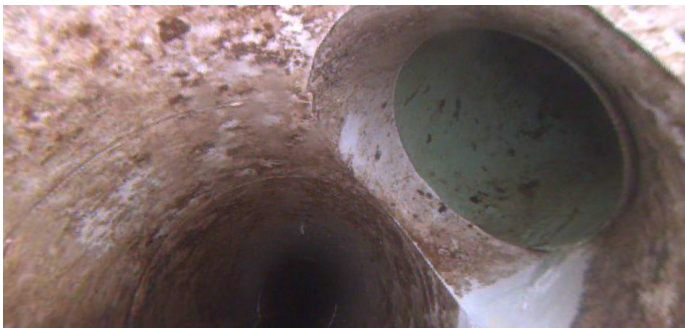
Code: **TF**
Description: **Tap Factory**

Distance (ft): **99.5**
Structural Grade: **0**
O&M Grade: **0**
Clock Start/From: **2**
Clock To:
1st Value: **4.000**
2nd Value:
Value Percent:
Continuous Index:
Within 8" of Joint:
Remarks:

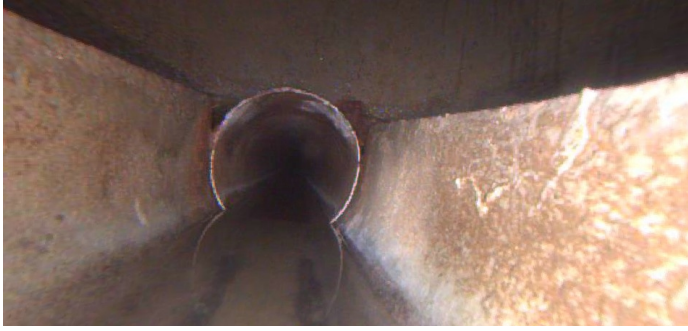
Code:	AMH
Description:	Manhole
Distance (ft):	151.7
Structural Grade:	0
O&M Grade:	0
Clock Start/From:	
Clock To:	
1st Value:	
2nd Value:	
Value Percent:	
Continuous Index:	
Within 8" of Joint:	NO
Remarks:	M-709-028
