## Profile/Photo Observation Report

Street:	<b>WAXWING CIR</b>	Flow Control:	<b>Not Controlled</b>
City:	<b>Hobart, IN</b>	Year Renewed:	
Location:	<b>Yard</b>	Tape/Media #:	
Purpose:	<b>Maintenance Related</b>	Dia/Height:	<b>8"</b>
Use:	<b>Sanitary</b>	Material:	<b>PVC</b>
Drain Area:	<b>NA</b>	Lining:	
Category:	<b>NA</b>		
Comment:

Location Details:		Direction of Survey:	<b>Downstream</b>
US MH:	<b>M-709-030</b>	DS MH:	<b>M-709-031</b>
		Total Length Surveyed (ft):	<b>51.3</b>

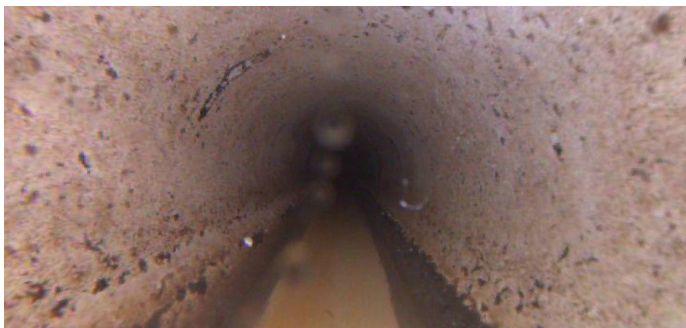
Code: **AMH**  
Description: **Manhole**

Distance (ft): **.0**  
Structural Grade: **0**  
O&M Grade: **0**  
Clock Start/From:  
Clock To:  
1st Value:  
2nd Value:  
Value Percent:  
Continuous Index:  
Within 8" of Joint: **NO**  
Remarks: **M-709-030**

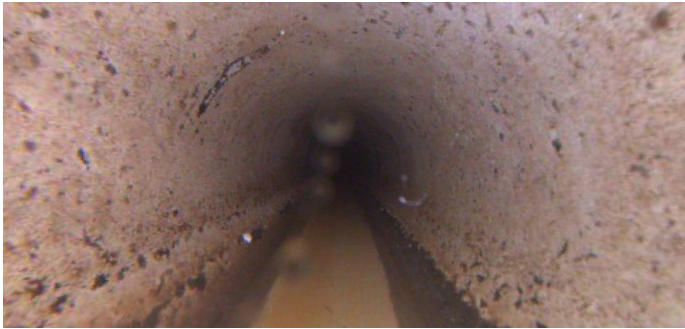
Code:	<b>MWL</b>
Description:	<b>Water Level</b>

Distance (ft):	<b>.0</b>
Structural Grade:	<b>0</b>
O&M Grade:	<b>0</b>
Clock Start/From:	
Clock To:	
1st Value:	
2nd Value:	
Value Percent:	<b>5.000</b>
Continuous Index:	
Within 8" of Joint:	<b>NO</b>
Remarks:

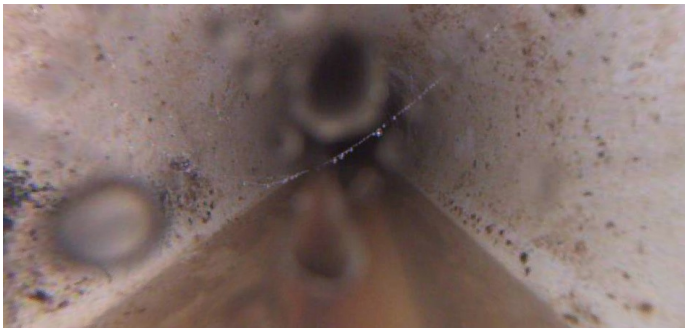
Code:	<b>MWL</b>
Description:	<b>Water Level</b>

Distance (ft):	<b>28.0</b>
Structural Grade:	<b>0</b>
O&M Grade:	<b>0</b>
Clock Start/From:	
Clock To:	
1st Value:	
2nd Value:	
Value Percent:	<b>20.000</b>
Continuous Index:	
Within 8" of Joint:	<b>NO</b>
Remarks:

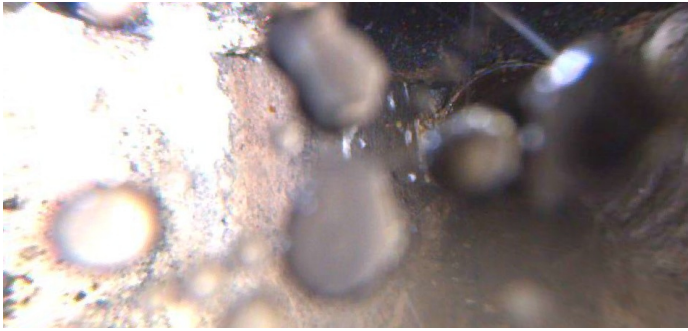
Code:	<b>AMH</b>
Description:	<b>Manhole</b>
Distance (ft):	<b>51.3</b>
Structural Grade:	<b>0</b>
O&M Grade:	<b>0</b>
Clock Start/From:	
Clock To:	
1st Value:	
2nd Value:	
Value Percent:	
Continuous Index:	
Within 8" of Joint:	<b>NO</b>
Remarks:	<b>M-709-031</b>
