Profile/Photo Observation Report

Street:	WAXWING CIR	Flow Control:	Not Controlled
City:	Hobart, IN	Year Renewed:	
Location:	Yard	Tape/Media #:	
Purpose:	Maintenance Related	Dia/Height:	8"
Use:	Sanitary	Material:	PVC
Drain Area:	NA	Lining:	
Category:	NA		
Comment:

Location Details:		Direction of Survey:	Upstream
US MH:	M-709-032	DS MH:	M-709-031
		Total Length Surveyed (ft):	113.0

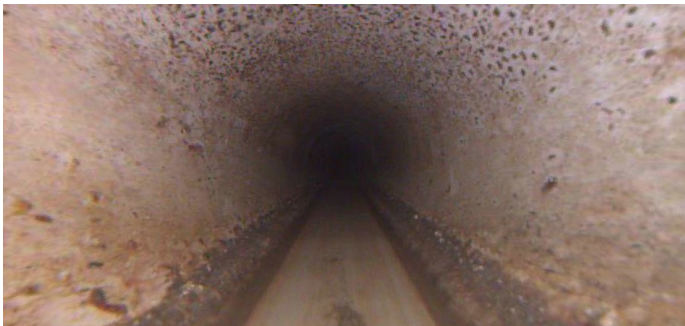
Code: **AMH**
Description: **Manhole**

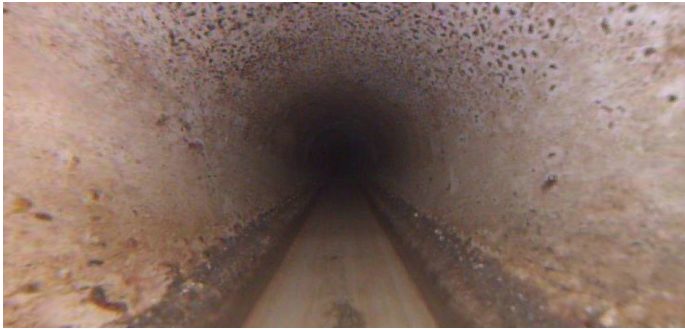
Code:	MWL
Description:	Water Level

Distance (ft):	.0
Structural Grade:	0
O&M Grade:	0
Clock Start/From:	
Clock To:	
1st Value:	
2nd Value:	
Value Percent:	10.000
Continuous Index:	
Within 8" of Joint:	NO
Remarks:

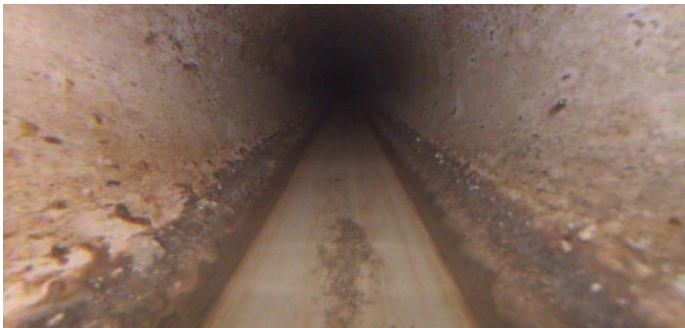
Code:	DAGS
Description:	Deposits Attached Grease

Distance (ft):	.0
Structural Grade:	0
O&M Grade:	2
Clock Start/From:	4
Clock To:	8
1st Value:	
2nd Value:	
Value Percent:	10.000
Continuous Index:	S01
Within 8" of Joint:	NO
Remarks:

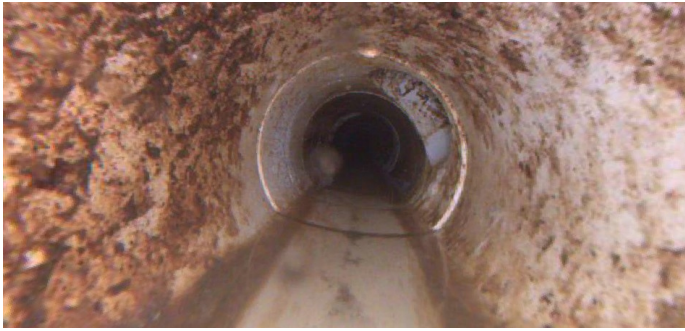
Code: **DAGS**
Description: **Deposits Attached Grease**

Distance (ft): **22.9**
Structural Grade: **0**
O&M Grade: **2**
Clock Start/From: **4**
Clock To: **8**
1st Value:
2nd Value:
Value Percent: **10.000**
Continuous Index: **F01**
Within 8" of Joint: **NO**
Remarks: **Clock positions vary**

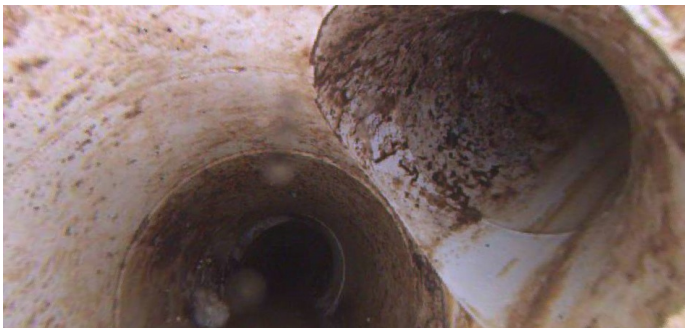
Code: **TF**
Description: **Tap Factory**

Distance (ft): **23.8**
Structural Grade: **0**
O&M Grade: **0**
Clock Start/From: **2**
Clock To:
1st Value: **4.000**
2nd Value:
Value Percent:
Continuous Index:
Within 8" of Joint:
Remarks:

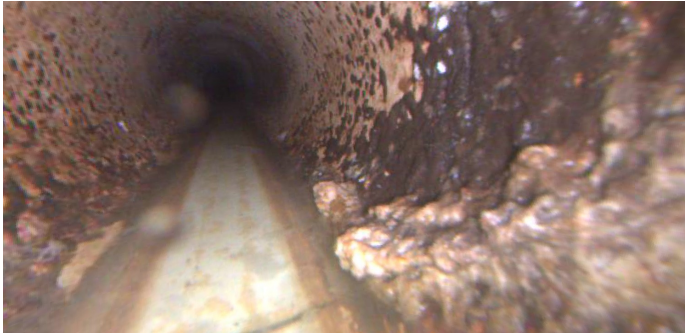
Code: **DAGS**
Description: **Deposits Attached Grease**

Distance (ft): **67.5**
Structural Grade: **0**
O&M Grade: **2**
Clock Start/From: **2**
Clock To: **4**
1st Value:
2nd Value:
Value Percent: **10.000**
Continuous Index:
Within 8" of Joint: **NO**
Remarks:

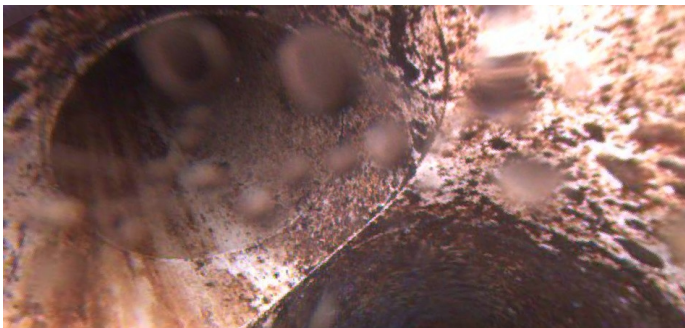
Code: **TF**
Description: **Tap Factory**

Distance (ft): **102.9**
Structural Grade: **0**
O&M Grade: **0**
Clock Start/From: **10**
Clock To:
1st Value: **4.000**
2nd Value:
Value Percent:
Continuous Index:
Within 8" of Joint:
Remarks:
