Profile/Photo Observation Report

Street:	e 37th ave	Flow Control:	Not Controlled
City:	Hobart, IN	Year Renewed:	
Location:	Other	Tape/Media #:	
Purpose:	Not Known	Dia/Height:	10"
Use:	Sanitary	Material:	PVC
Drain Area:	NA	Lining:	
Category:	NA		
Comment:

Location Details:		Direction of Survey:	Upstream
US MH:	M-802-002	DS MH:	M-802-003
		Total Length Surveyed (ft):	22.6

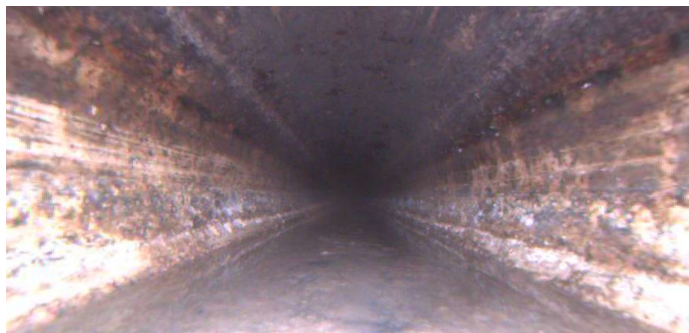
Code: **DAGS**
Description: **Deposits Attached Grease**

Distance (ft): **.0**
Structural Grade: **0**
O&M Grade: **2**
Clock Start/From: **8**
Clock To: **4**
1st Value:
2nd Value:
Value Percent: **5.000**
Continuous Index: **S01**
Within 8" of Joint: **NO**
Remarks:

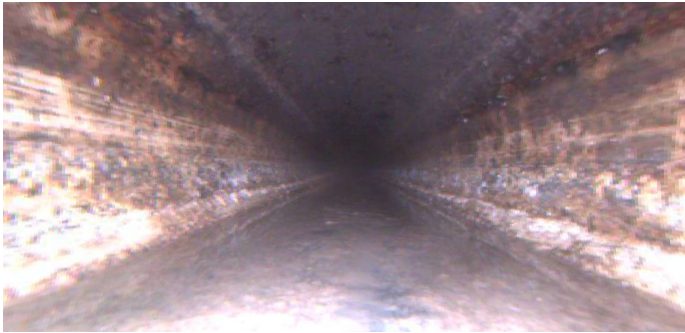
Code:	AMH
Description:	Manhole

Distance (ft):	.0
Structural Grade:	0
O&M Grade:	0
Clock Start/From:	
Clock To:	
1st Value:	
2nd Value:	
Value Percent:	
Continuous Index:	
Within 8" of Joint:	NO
Remarks:	M-802-003

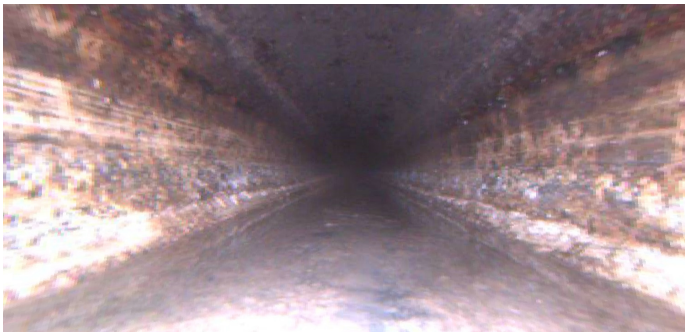
Code:	MWL
Description:	Water Level

Distance (ft):	.0
Structural Grade:	0
O&M Grade:	0
Clock Start/From:	
Clock To:	
1st Value:	
2nd Value:	
Value Percent:	5.000
Continuous Index:	
Within 8" of Joint:	NO
Remarks:

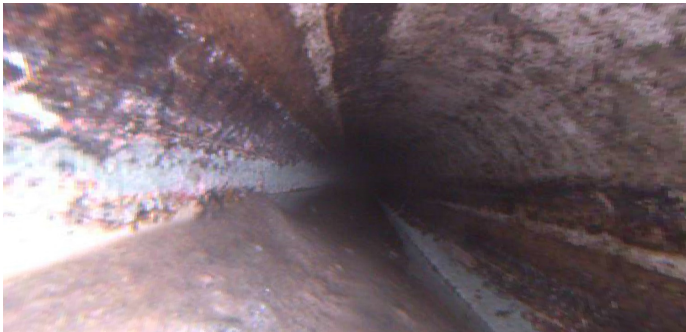
Code: **MSA**
Description: **Abandoned Survey**

Distance (ft): **22.6**
Structural Grade: **0**
O&M Grade: **0**
Clock Start/From:
Clock To:
1st Value:
2nd Value:
Value Percent:
Continuous Index:
Within 8" of Joint: **NO**
Remarks: **camera stopped**

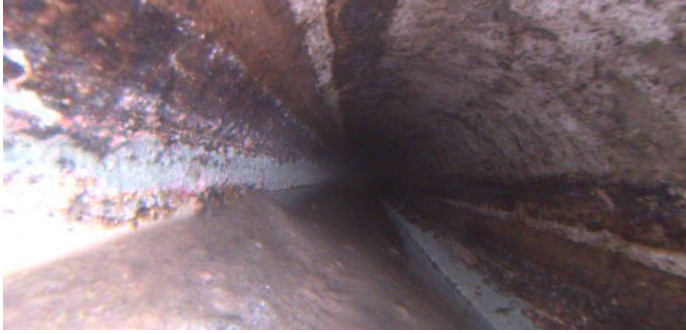
Code:	DAGS
Description:	Deposits Attached Grease
Distance (ft):	22.6
Structural Grade:	0
O&M Grade:	2
Clock Start/From:	8
Clock To:	4
1st Value:	
2nd Value:	
Value Percent:	5.000
Continuous Index:	F01
Within 8" of Joint:	NO
Remarks:
