Profile/Photo Observation Report

Street:	N HOBART RD	Flow Control:	Not Controlled
City:	Hobart, IN	Year Renewed:	
Location:	Other	Tape/Media #:	
Purpose:	Not Known	Dia/Height:	10"
Use:	Sanitary	Material:	PVC
Drain Area:	NA	Lining:	
Category:	NA		
Comment:

Location Details:		Direction of Survey:	Downstream
US MH:	M-802-003	DS MH:	M-802-005
		Total Length Surveyed (ft):	103.2

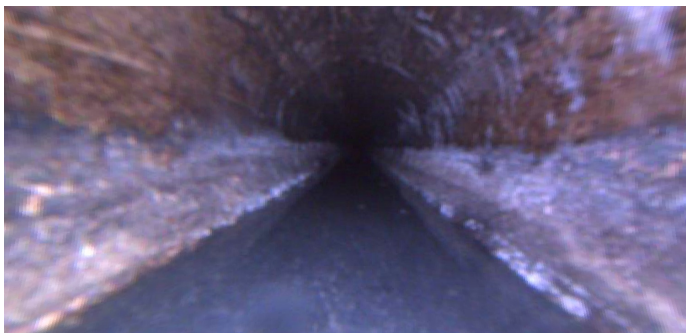
Code: **AMH**
Description: **Manhole**

Distance (ft): **.0**
Structural Grade: **0**
O&M Grade: **0**
Clock Start/From:
Clock To:
1st Value:
2nd Value:
Value Percent:
Continuous Index:
Within 8" of Joint: **NO**
Remarks: **M-802-003**

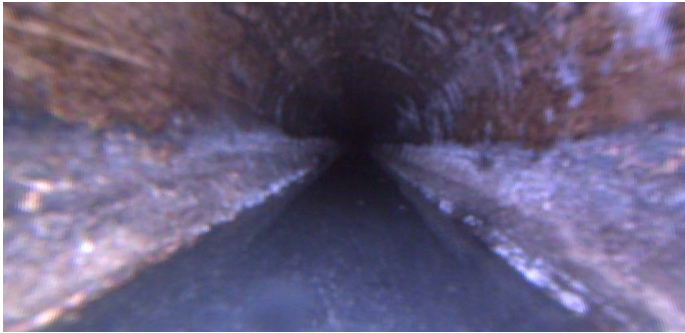
Code:	MWL
Description:	Water Level

Distance (ft):	.0
Structural Grade:	0
O&M Grade:	0
Clock Start/From:	
Clock To:	
1st Value:	
2nd Value:	
Value Percent:	10.000
Continuous Index:	
Within 8" of Joint:	NO
Remarks:

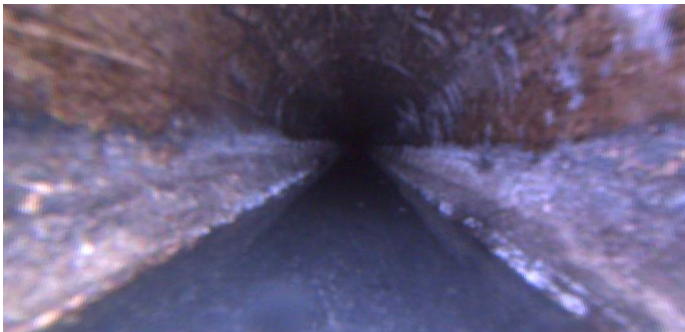
Code:	DAGS
Description:	Deposits Attached Grease

Distance (ft):	.0
Structural Grade:	0
O&M Grade:	2
Clock Start/From:	7
Clock To:	5
1st Value:	
2nd Value:	
Value Percent:	5.000
Continuous Index:	S01
Within 8" of Joint:	YES
Remarks:	WANDER

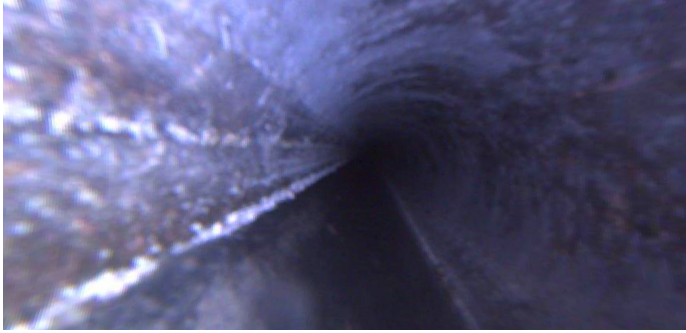
Code: **MSA**
Description: **Abandoned Survey**

Distance (ft): **103.2**
Structural Grade: **0**
O&M Grade: **0**
Clock Start/From:
Clock To:
1st Value:
2nd Value:
Value Percent:
Continuous Index:
Within 8" of Joint: **NO**
Remarks: **ROBOT HAS STOPPED; POSSIBLE
TURNED OVER**

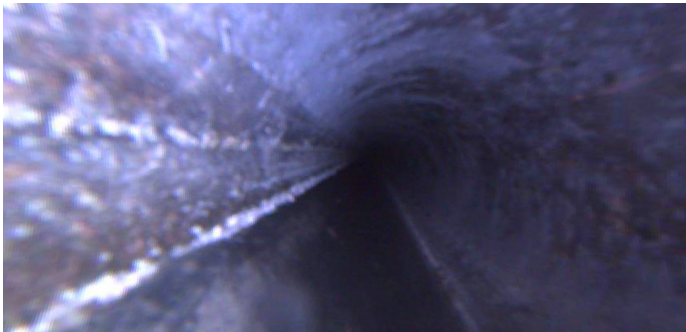
Code: **DAGS**
Description: **Deposits Attached Grease**

Distance (ft): **103.2**
Structural Grade: **0**
O&M Grade: **2**
Clock Start/From: **7**
Clock To: **5**
1st Value:
2nd Value:
Value Percent: **5.000**
Continuous Index: **F01**
Within 8" of Joint: **YES**
Remarks: **WANDER**
