Profile/Photo Observation Report

Street:	N HOBART RD	Flow Control:	Not Controlled
City:	Hobart, IN	Year Renewed:	
Location:	Main Highway - Suburban/Rural	Tape/Media #:	
Purpose:	Resurvey	Dia/Height:	10"
Use:	Sanitary	Material:	VCP
Drain Area:	NA	Lining:	
Category:	NA		
Comment:

Location Details:		Direction of Survey:	Downstream
US MH:	M-802-008	DS MH:	M-902-068
		Total Length Surveyed (ft):	44.4

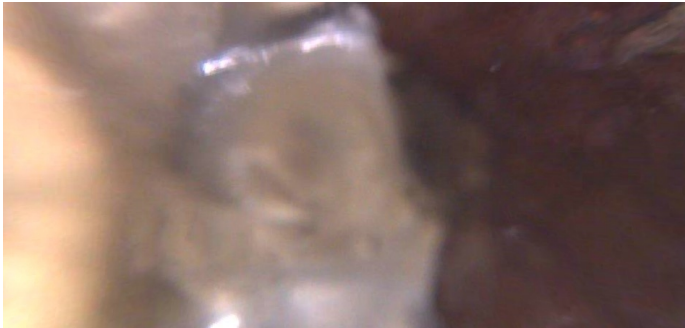
Code: **MSA**
Description: **Abandoned Survey**

Distance (ft): **44.4**
Structural Grade: **0**
O&M Grade: **0**
Clock Start/From:
Clock To:
1st Value:
2nd Value:
Value Percent:
Continuous Index:
Within 8" of Joint: **NO**
Remarks: **DAZ**
